First Application of a Plasma Coating on an Inner Diameter

Landing Gear Systems

March 15, 2005

HCAT Meeting

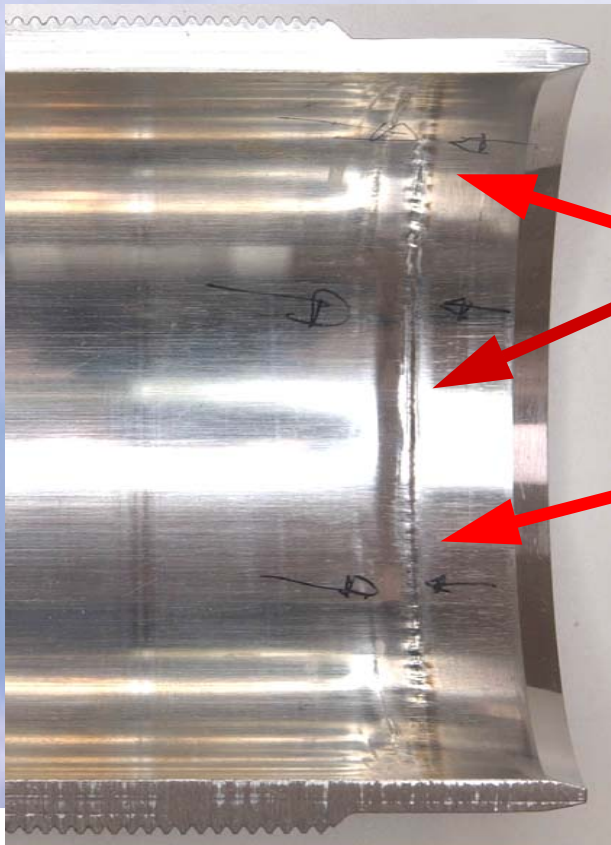
Actuator Barrel

- Groove caused by abrasive seal and piston wear combined with hydraulic fluid erosion and polishing

Groove location lines up with seal location when gear is down (actuator is retracted)

Flow erosion marks

Wear is typically over 90-180 degree arc of barrel inside diameter

Root Cause: Low Amplitude Vibration

- **The vibration dries out the bore/seal interface, increasing friction and heat**
- **This erodes the barrel bore, allowing flow erosion to begin**
- **The piston seal cap extrudes through the barrel groove and fluid flow erodes the elastomer energizer ring beneath it**

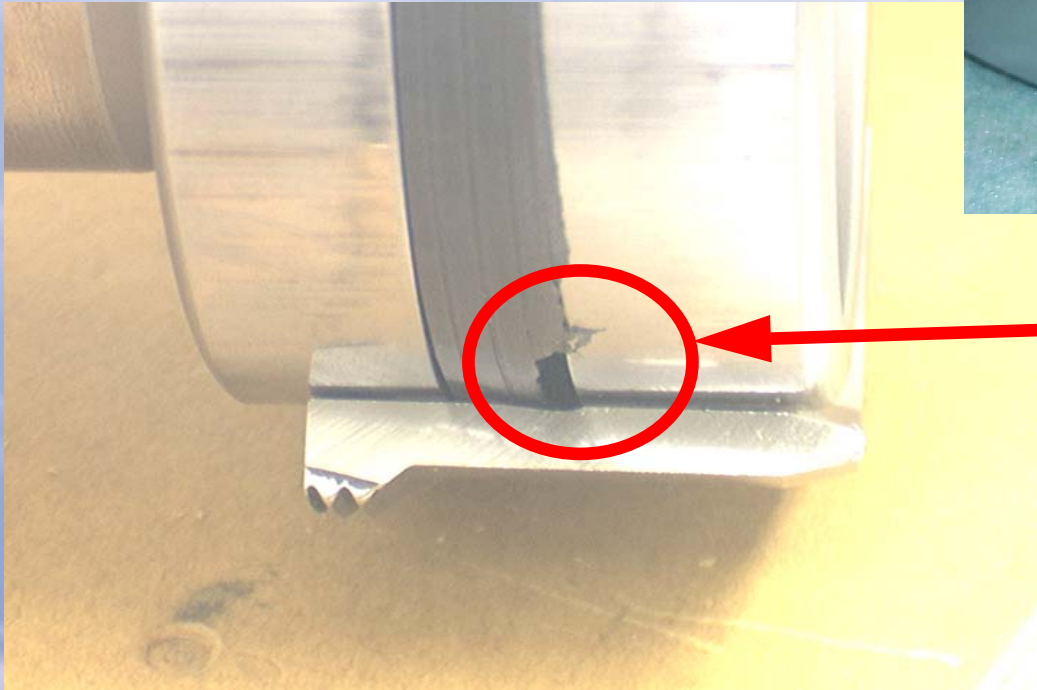
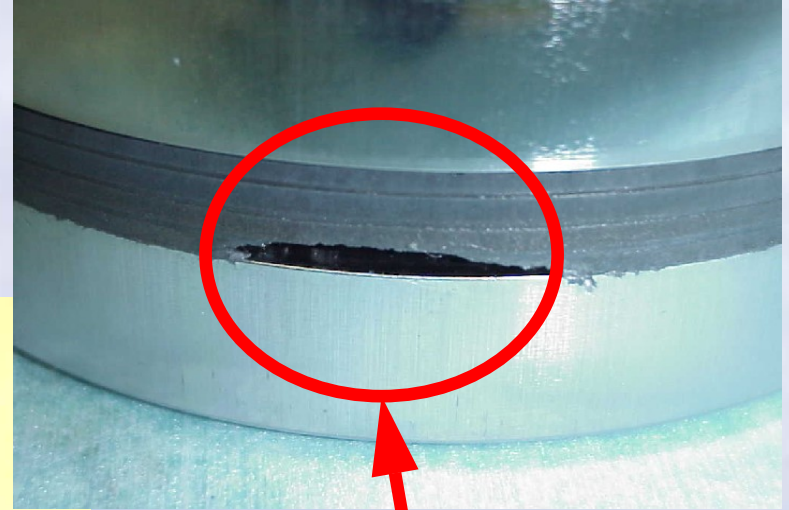
Main Gear Actuator

Worn piston seal

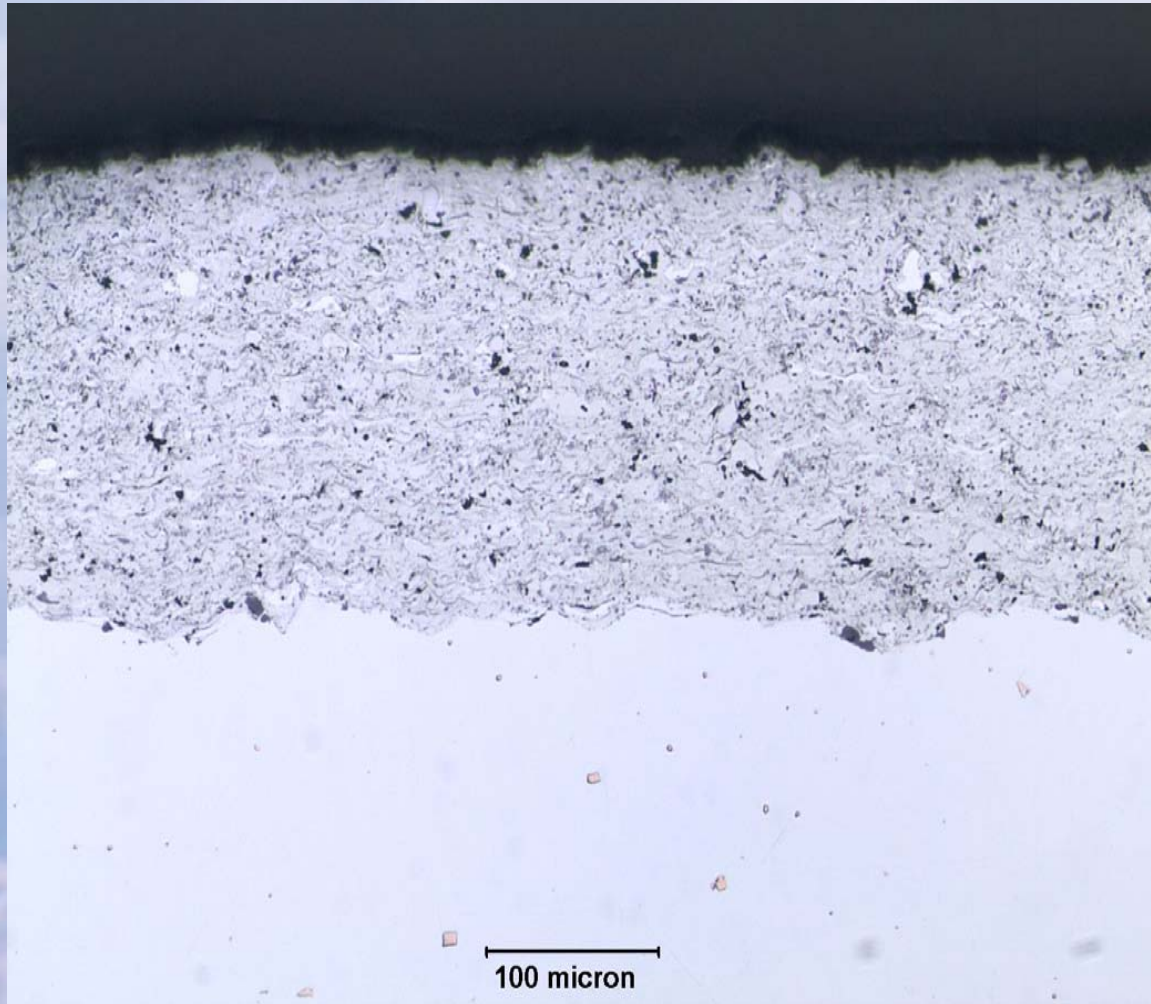
AMS2437C Met Sample

- Porosity < 2.0%
- Bond 6539 PSI – Min. 6500 PSI
- HV300 547 – Min. 500
- Finish 11-12Ra Micro inches
- Tp, Bearing Area Ratio - 100
