# P-3 HVOF Piston WC-Co Coating Analysis

# P-3 HVOF Strut

# P-3 Strut Service History

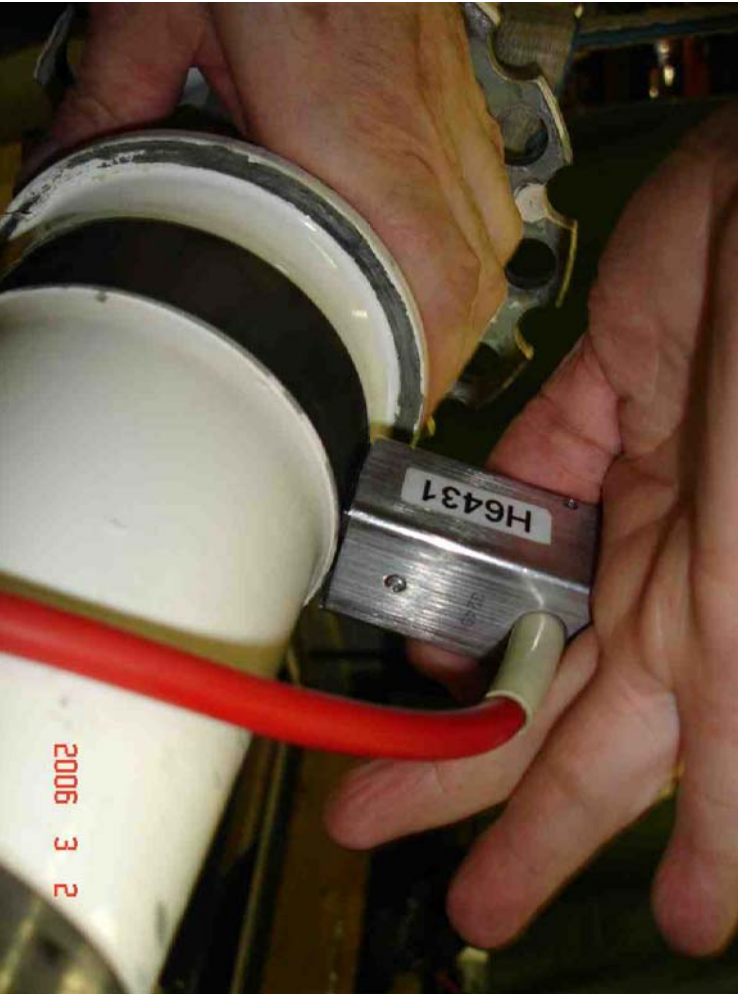
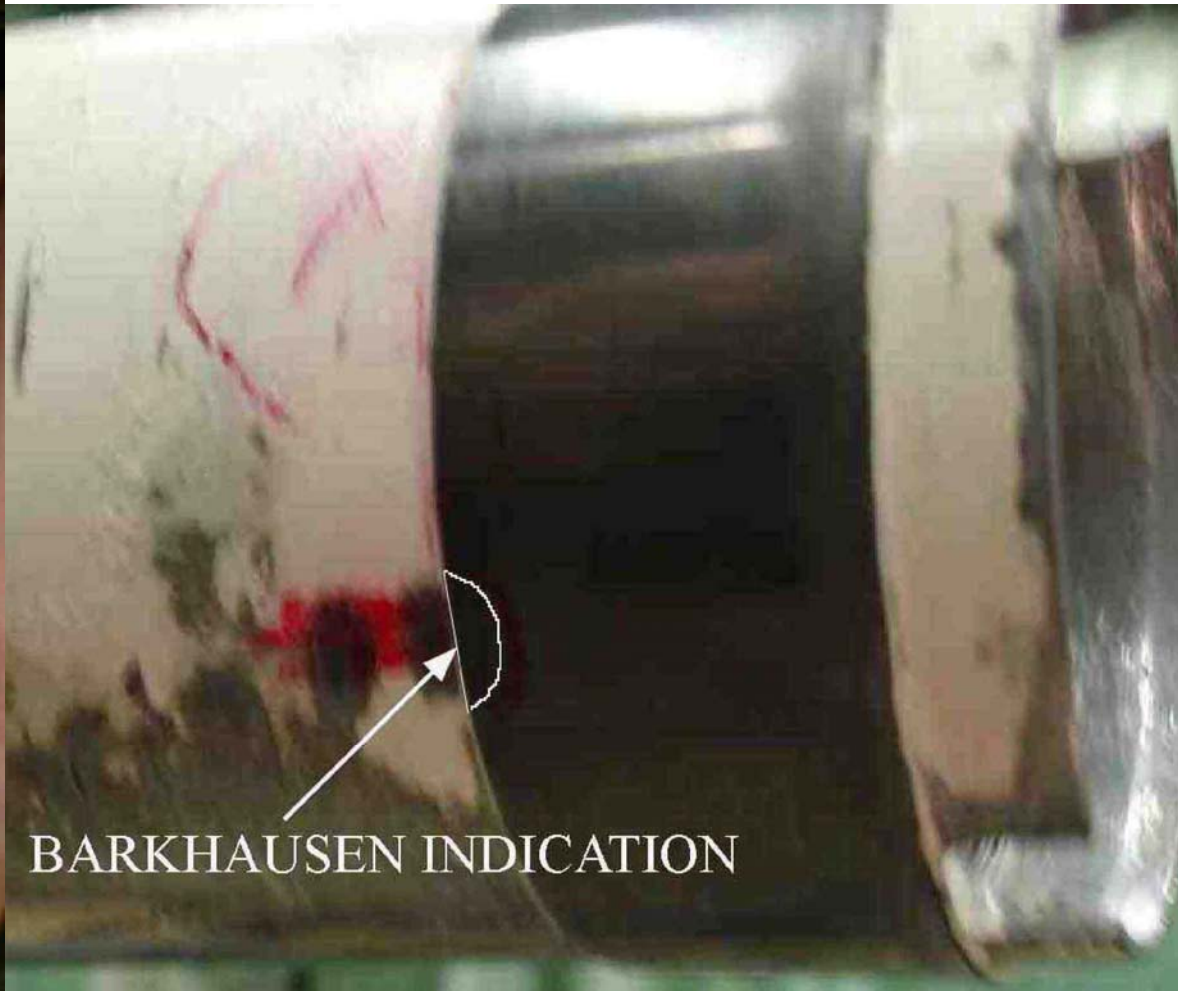
# Barkhausen Axle Journal

- Teardown Heroux-Devtek
- Presented in A-5 Spring & Fall 06
- Barkhausen Indication Axle Journal
- FPI Indications (Journal & Barrel)
- Surface Roughness Changes (Barrel)
- Black Spots Visible (Barrel)

- Coatings analyzed by Heroux Devtek
- Barkhausen indication axle journal
  - No burns- shot peen effect
- FPI indications (journal & barrel)
  - None after polish
- Surface roughness changes (barrel)
  - Phenolic bearing wear (Kamatics)
  - Packings normal (Greene Tweed)
- Black spots visible (barrel)
  - Details follow.....

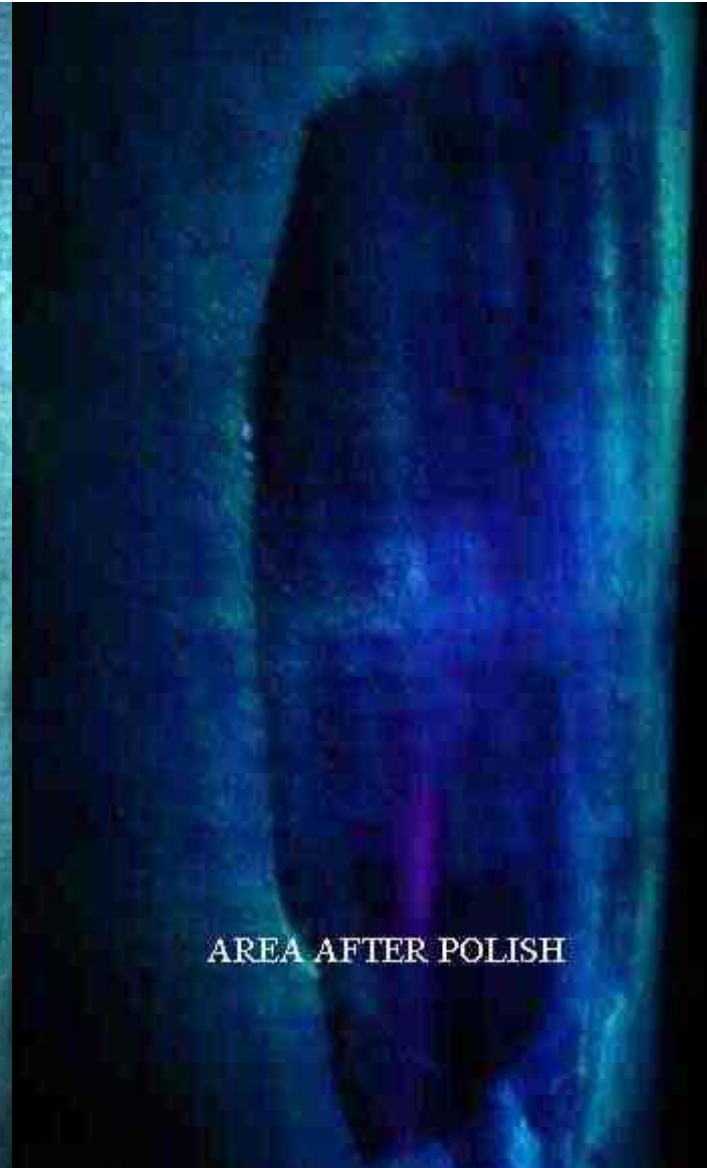
FPI INDICATION

AREA AFTER POLISH

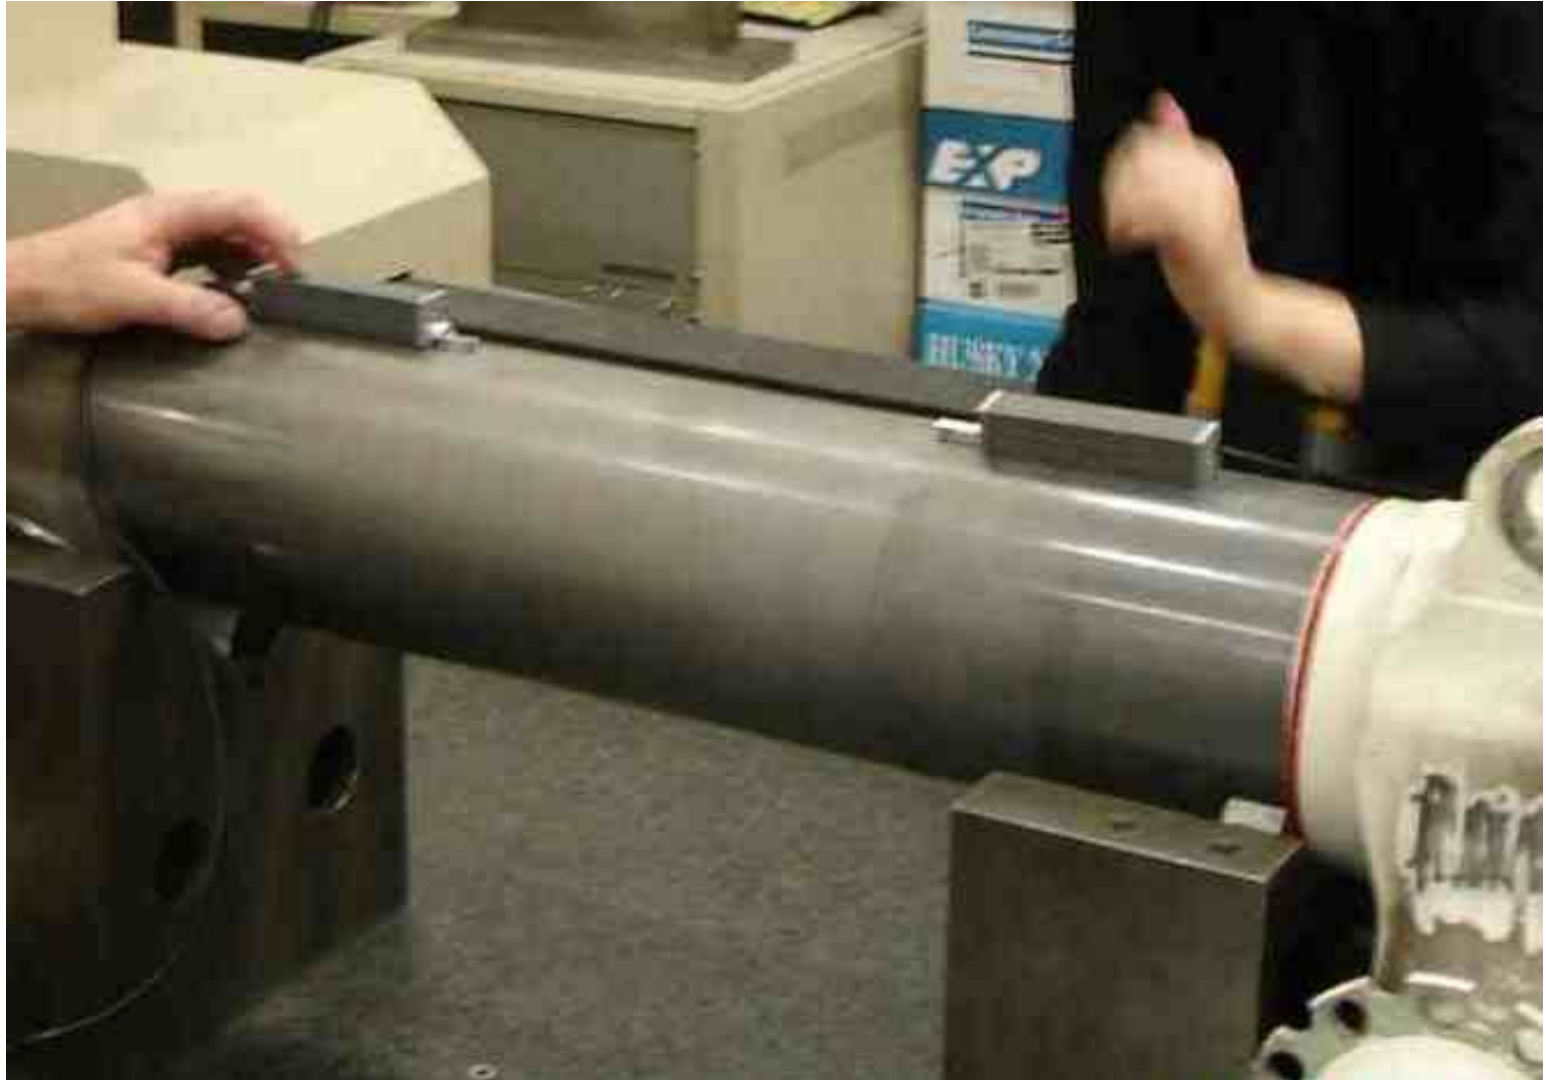
# Surface Roughness Inspection

Table 5- P-3 Piston Barrel Surface Finish Results		
Barrel ID	Forward Average Ra	Aft Average Ra
Top	2	3
¼ Down	5	4
Middle	7	7
Static Position	12*	12*
Bottom	57	40

\* Area is "dirty" possible lower bearing phenolic material embedded.

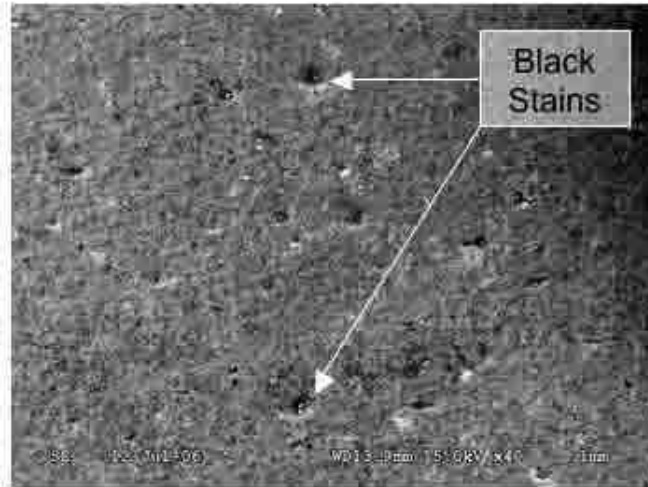
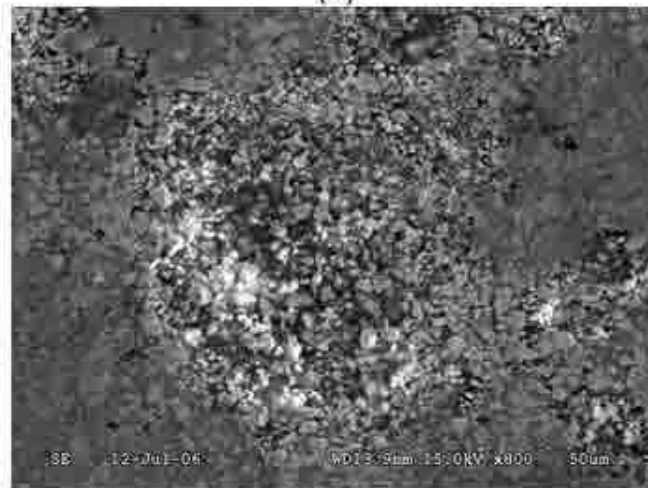
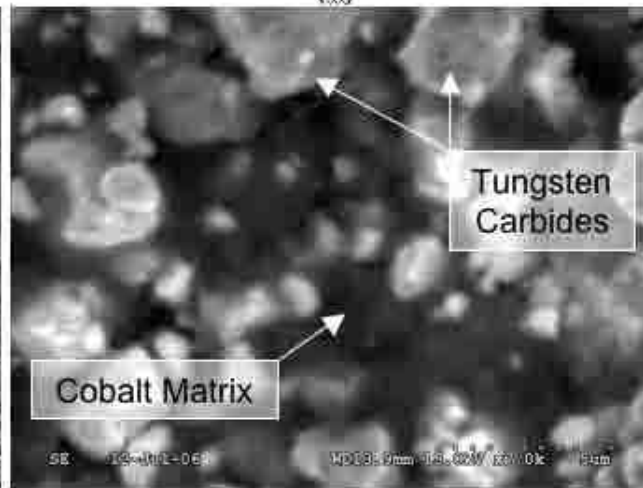
Secondary electron images of HVOF coating surface on the left side of the barrel OD: (a) x40, (b) x120, (c) x800 and (d) x7000 magnification.

- Black spots are actually shallow pits
  - Selective leaching Co corrosive attack
  - Pit size
    - Larger/deeper than ave. HVOF porosity
    - Largest pits 10 mils dia. x 1.5 mils deep
  - EDS x-ray Spectra of pits
    - Na, Cl, K, Ca (seawater, cleaners)
    - O (corrosion bi-product)
- Axle journal “indications”
  - No indication remained after polish
  - No cracking found- coupons sectioned

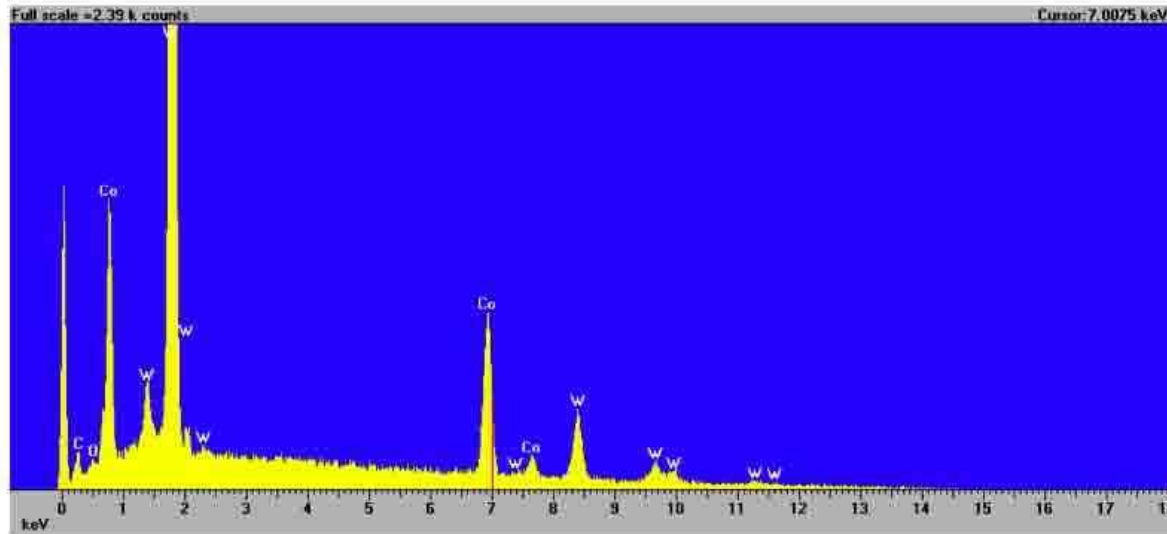
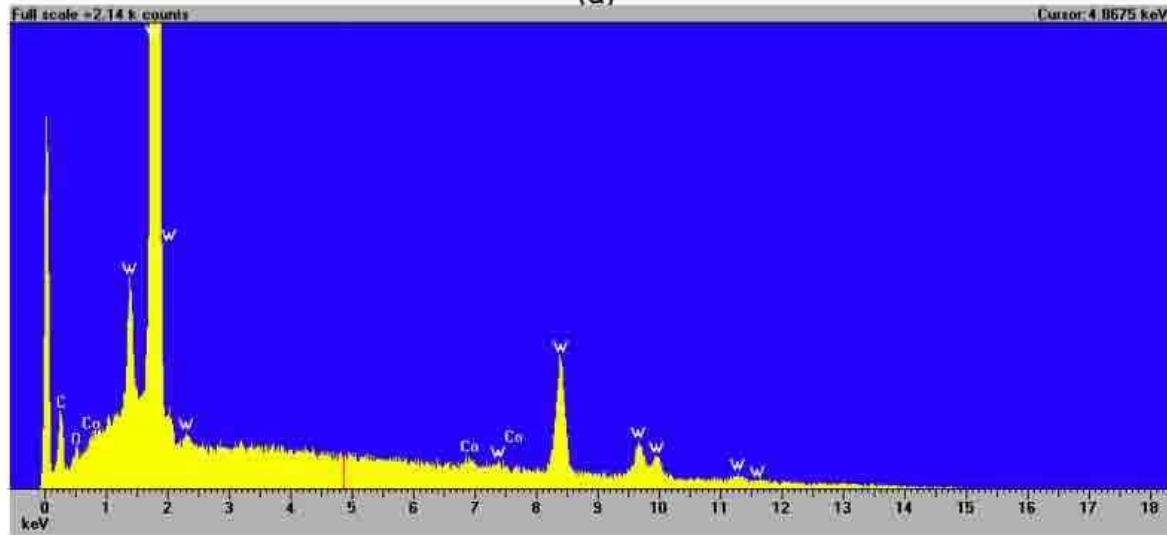
# EDS Un-pitted Area

EDS x-ray spectra of unpitted area: (a) matrix and (b) carbide particle.

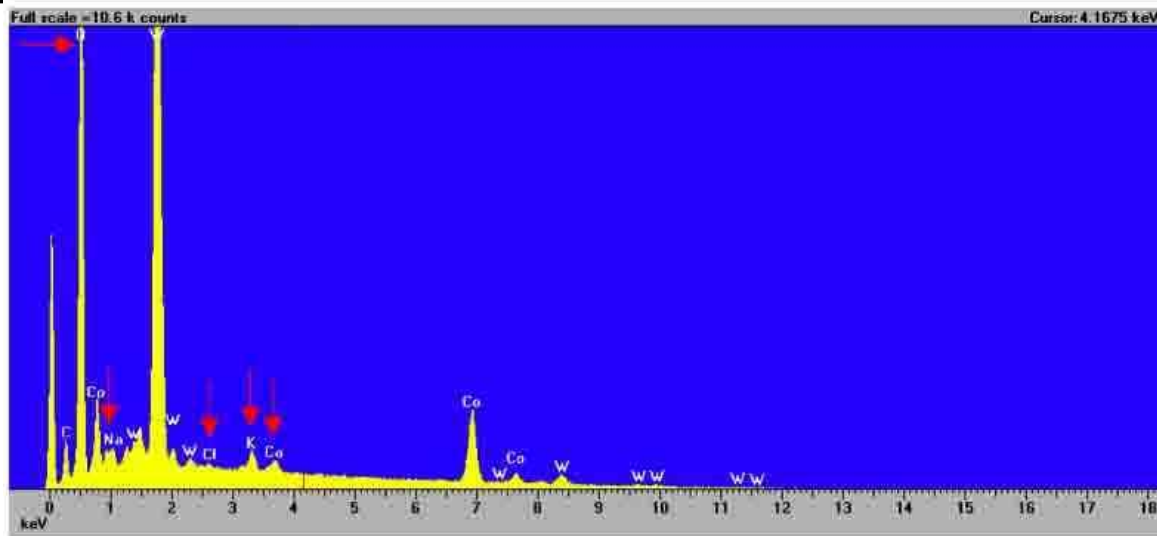
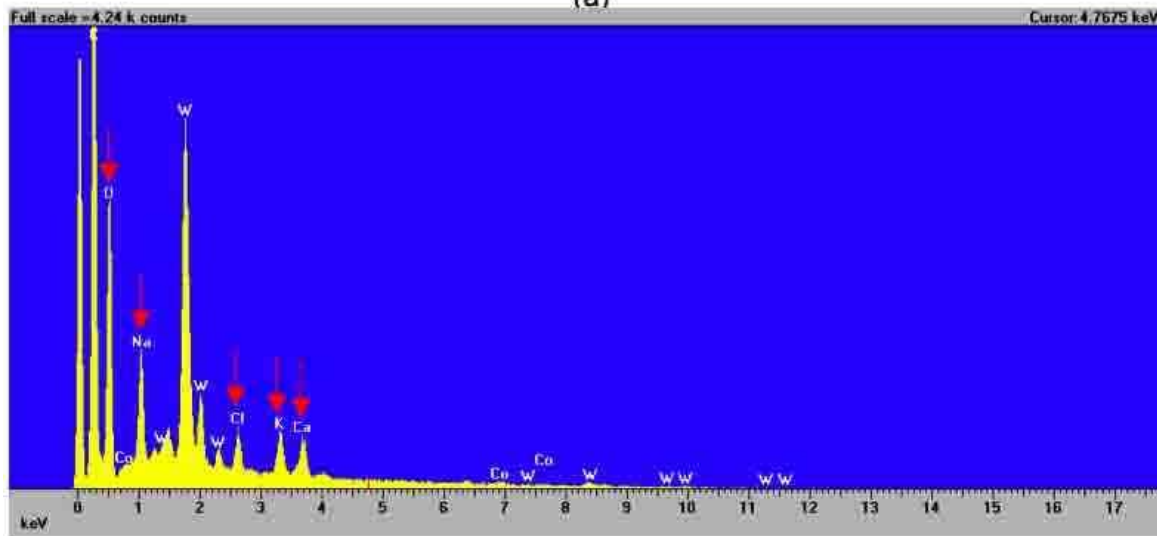
# EDS Pitted Area

EDS x-ray spectra of pits: (a) analysis of matrix and (b) carbide particle showing high peaks for O and the presence of Na, Cl, K and Ca (red arrows).

- HVOF coating degraded in service
  - Surface finish
  - Black spots (pits)
- Coating degradation didn't impact life
  - Superfinish during overhaul
  - Piston could have returned to service
- Possible improvements
  - Lined lower bearing
  - Lower bearing seal type/material
  - WC Co Cr in lieu of WC Co

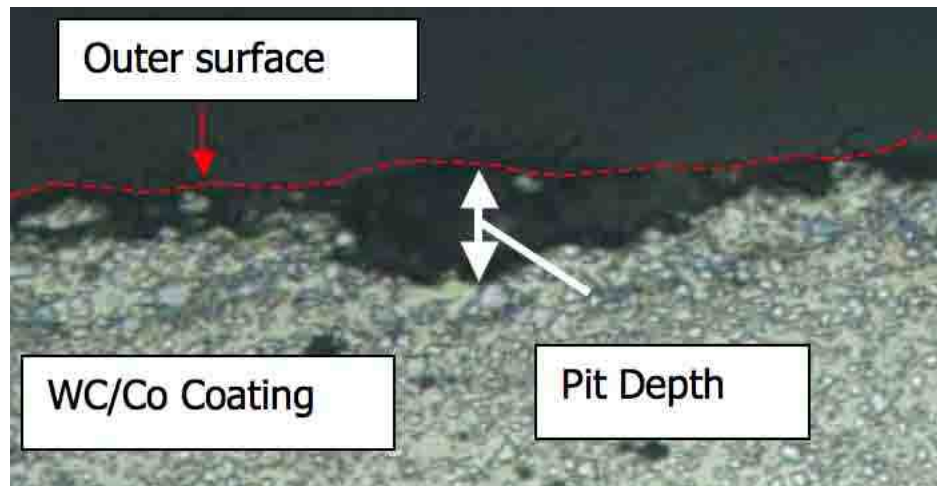
# NADEP JAX Coating Analysis

- One set of coupons send to JAX
- Black spots Analysis supports HD
- WC Co corrosive attack
  - Pits Larger/deeper than ave. HVOF porosity

- Axle Journal
  - No cracks present
