FINAL BRIEFING: HYDRAULIC ACTUATOR JTP FATIGUE TESTING

HCAT Review Meeting

15-17 March 2005

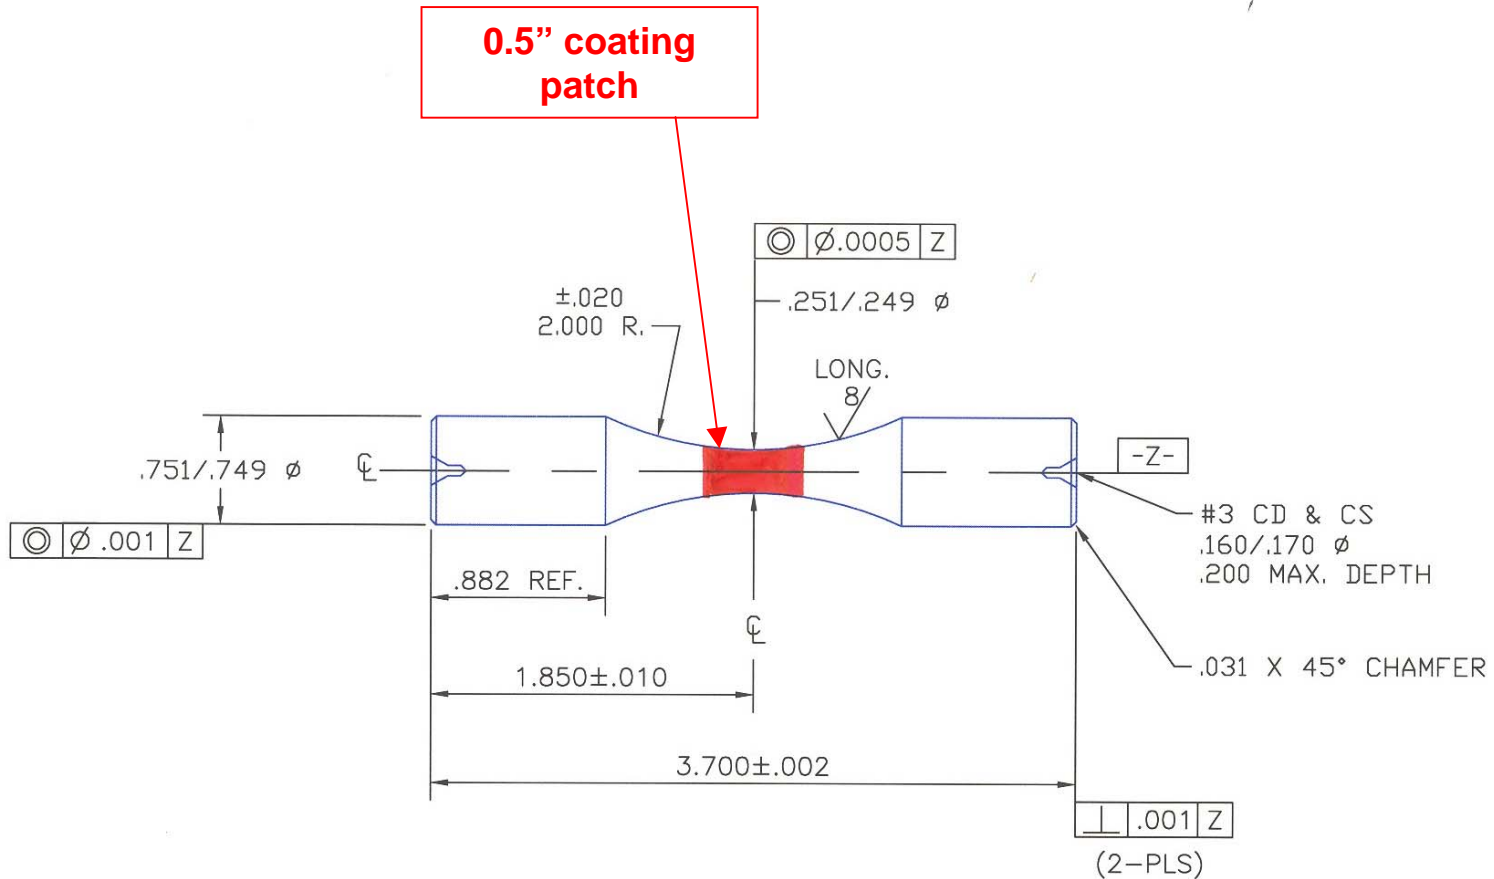
Drawn:		  Metcut Research Inc. Cincinnati, Ohio 45209-1196	Desc.: FATIGUE SPECIMEN	
Mfg.:			Cust. Dwg. #: 981105-1	
Q.C.:			Date Issued: 11/5/98	
Test:			Rev:	Dwg. #: 1288

DRAWING NOT TO SCALE!

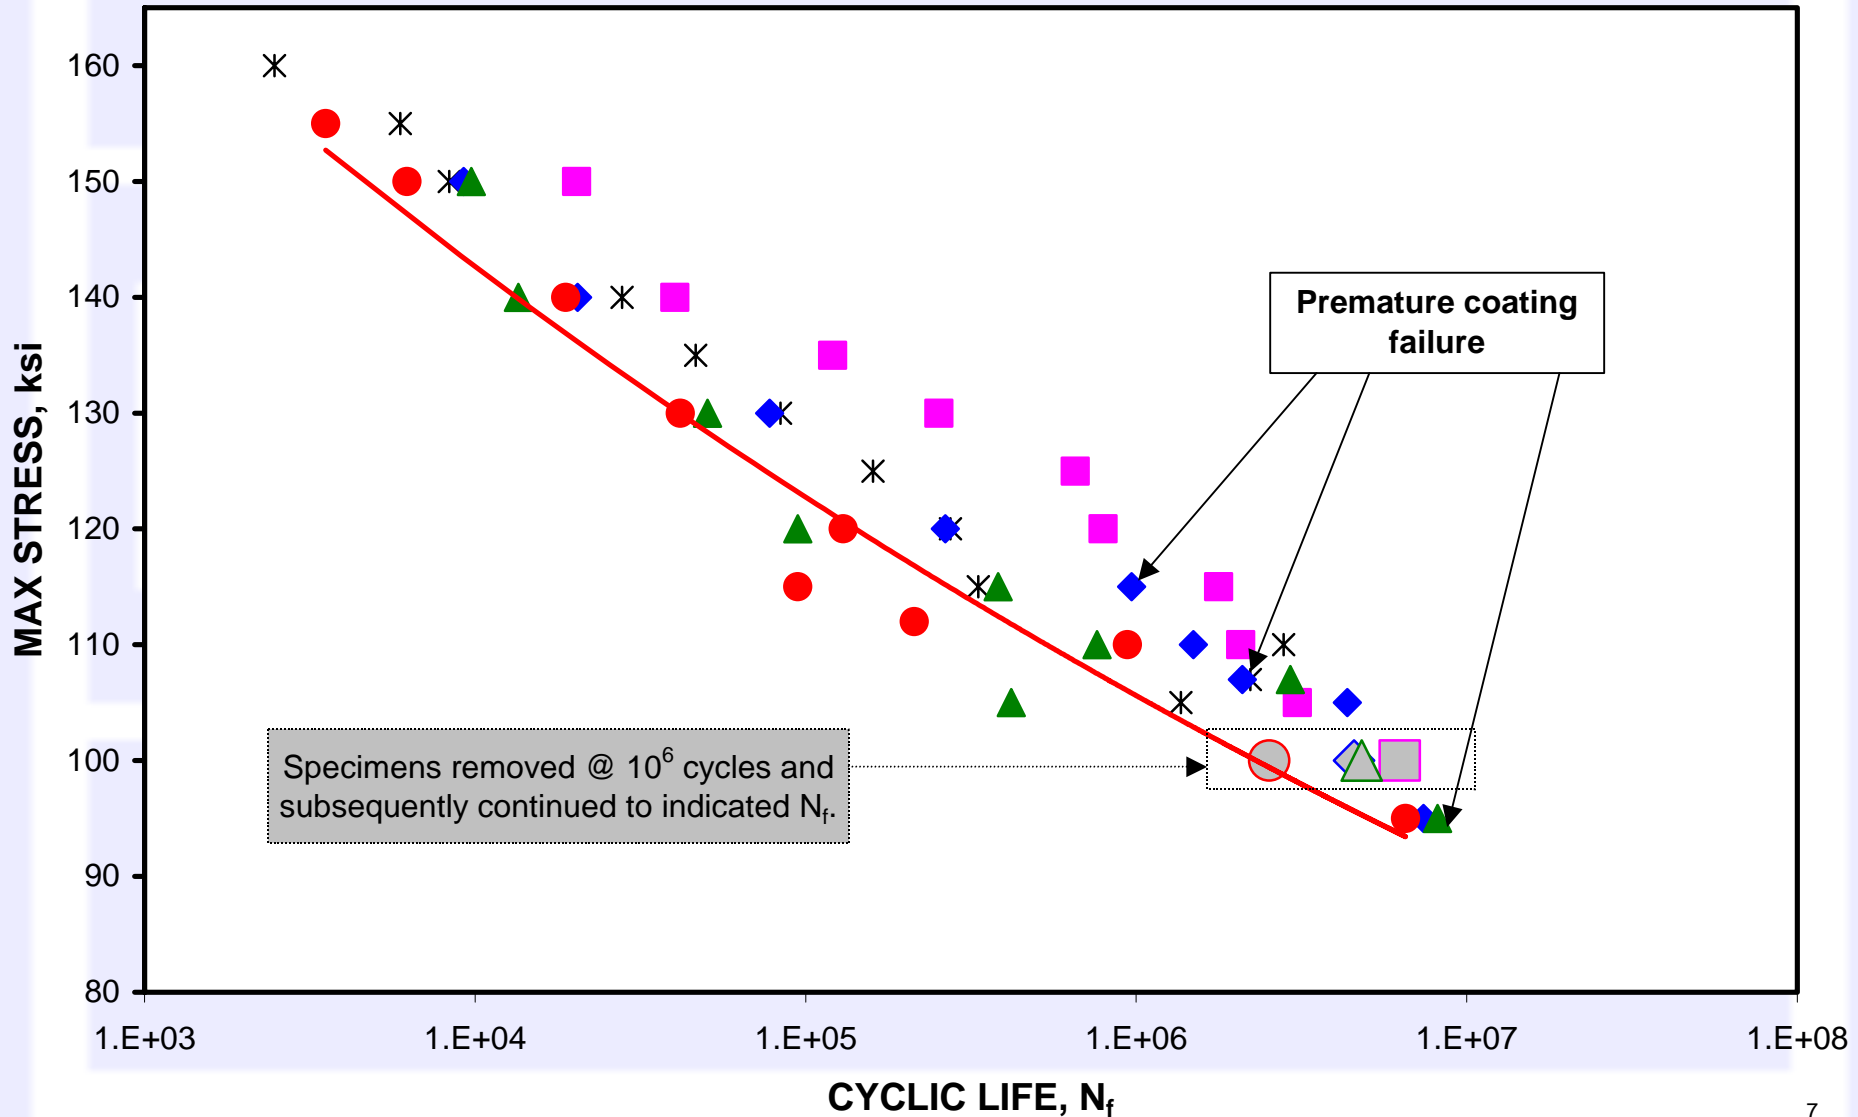
HCAT HYDRAULIC ACTUATOR FATIGUE PROGRAM PH15-5 SUBSTRATE

✱ Uncoated Baseline
◆ WC-Co-Cr
■ T-400
▲ Cr2C3
● EHC
— Power (EHC)

- On PH15-5
 - T-400 outperforms EHC
 - WC-Co-Cr and Cr₂C₃ are equivalent to EHC
- On 4340
 - T-400 outperforms EHC at lower stress levels
 - WC-Co-Cr and Cr₂C₃ are ~ equivalent to EHC
- On Ti-6-4
 - EHC outperforms Cr₂C₃
 - WC-Co-Cr and T-400 are ~ equivalent to EHC

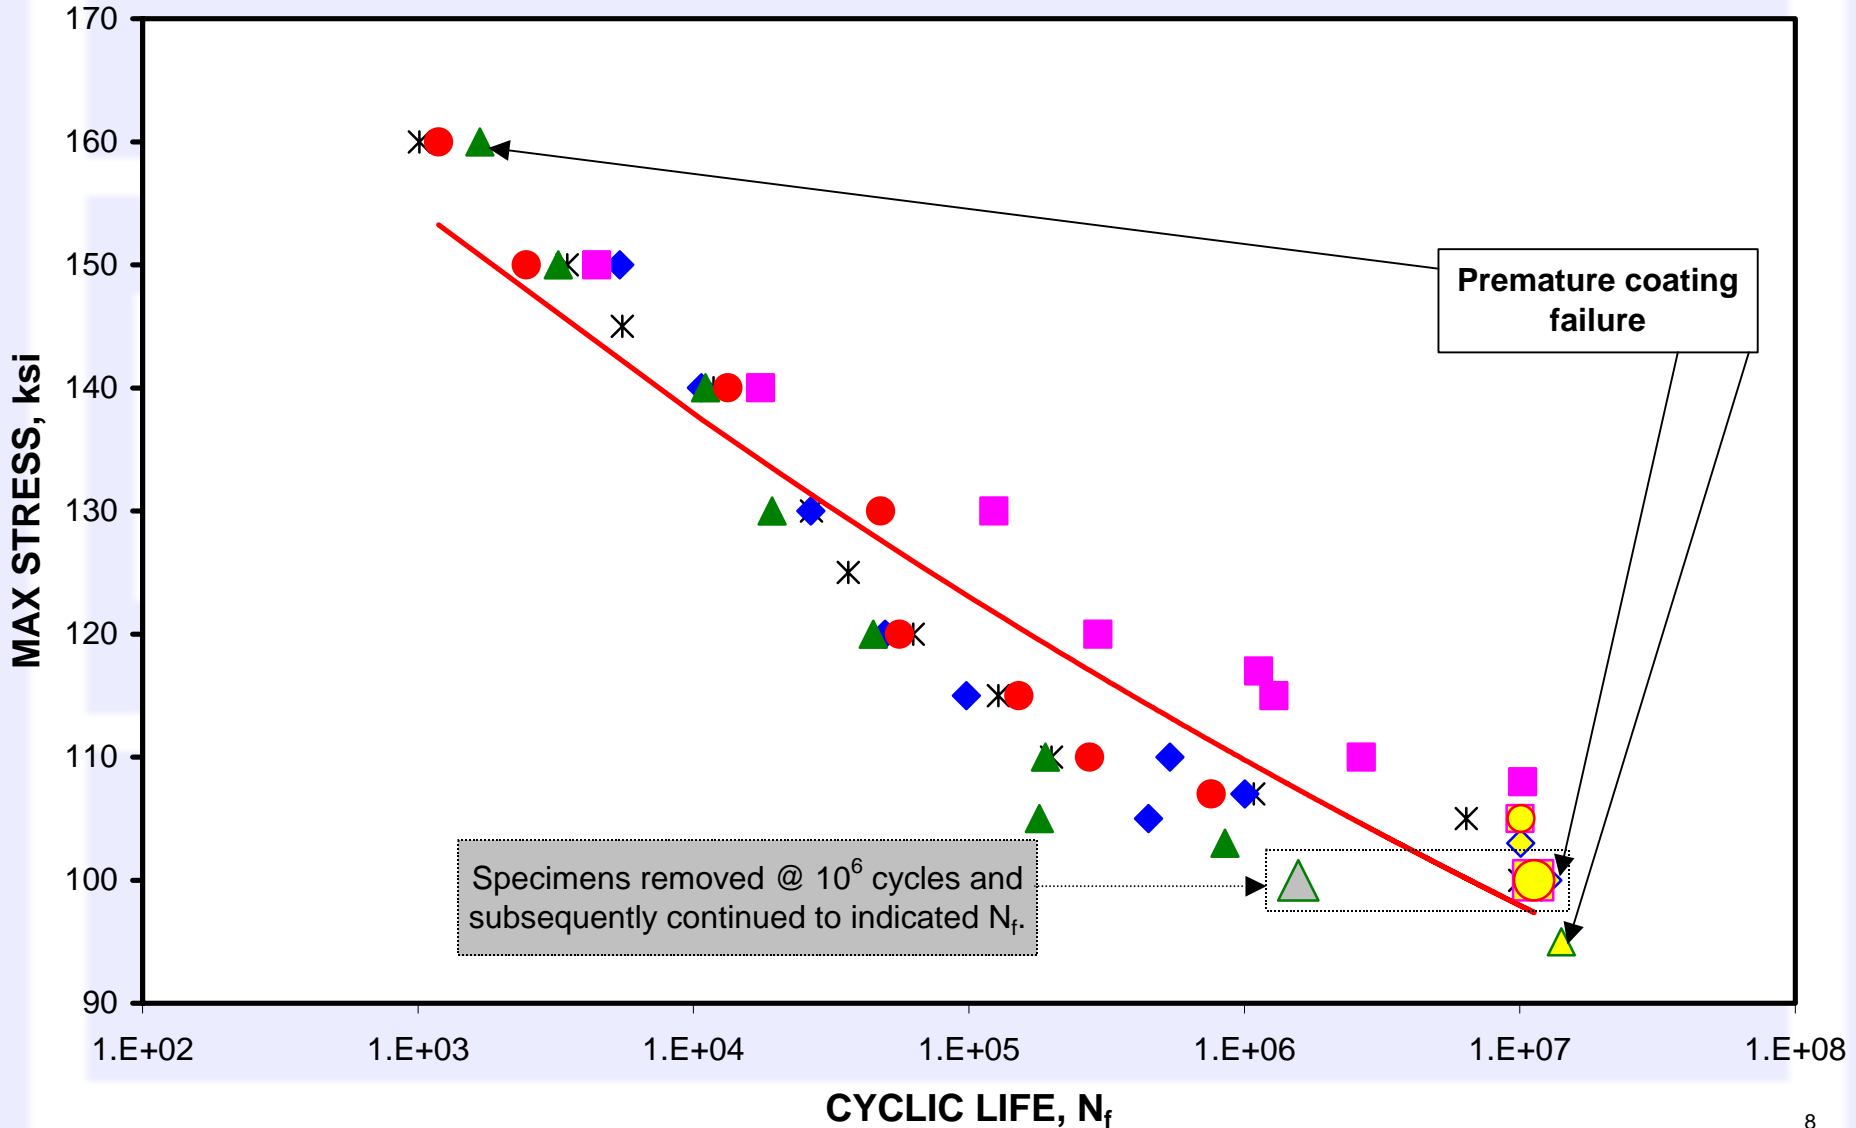
HCAT HYDRAULIC ACTUATOR FATIGUE PROGRAM 4340 SUBSTRATE

✱ Uncoated Baseline
◆ WC-Co-Cr
■ T-400
▲ Cr2C3
● EHC
— Power (EHC)

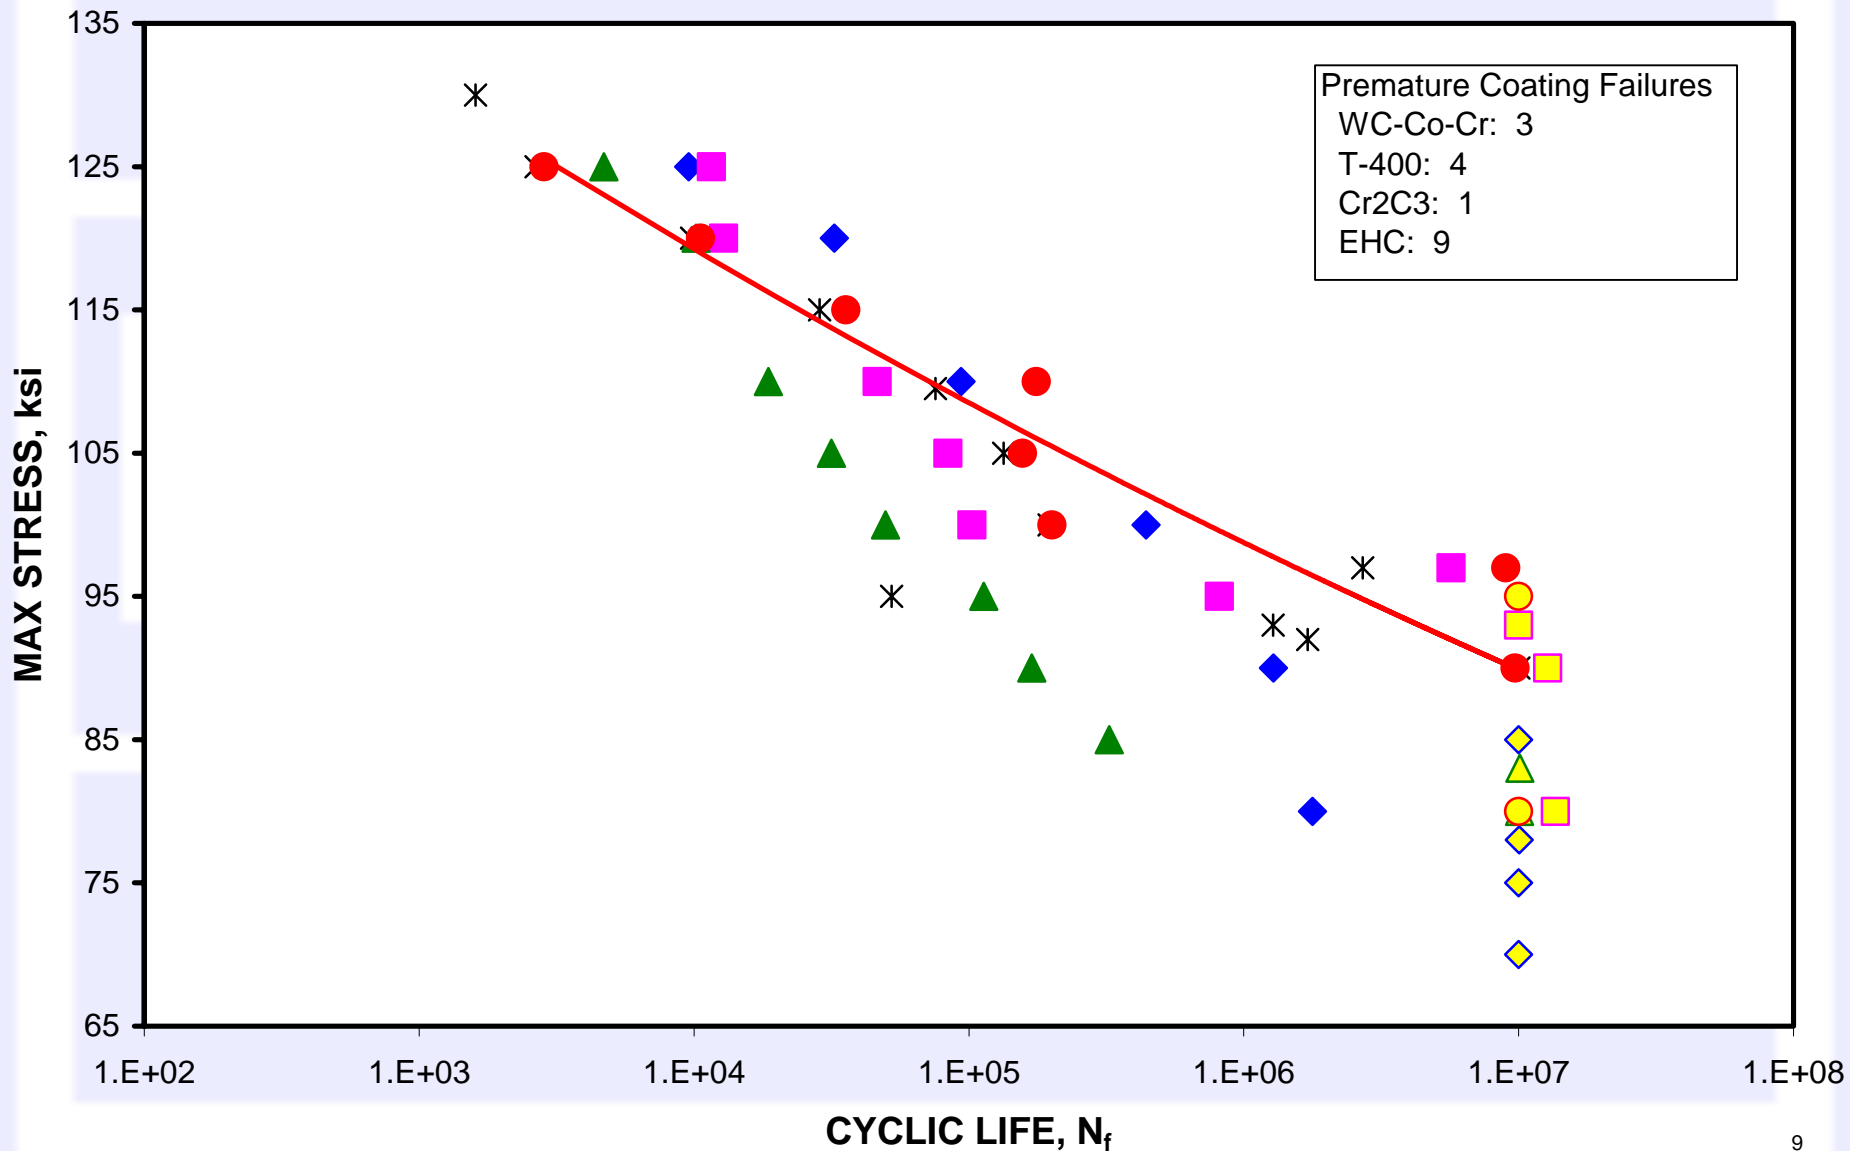
HCAT HYDRAULIC ACTUATOR FATIGUE PROGRAM Ti-6Al-4V SUBSTRATE

✱ Uncoated Baseline ◆ WC-Co-Cr ■ T-400 ▲ Cr2C3 ● EHC — Power (EHC)

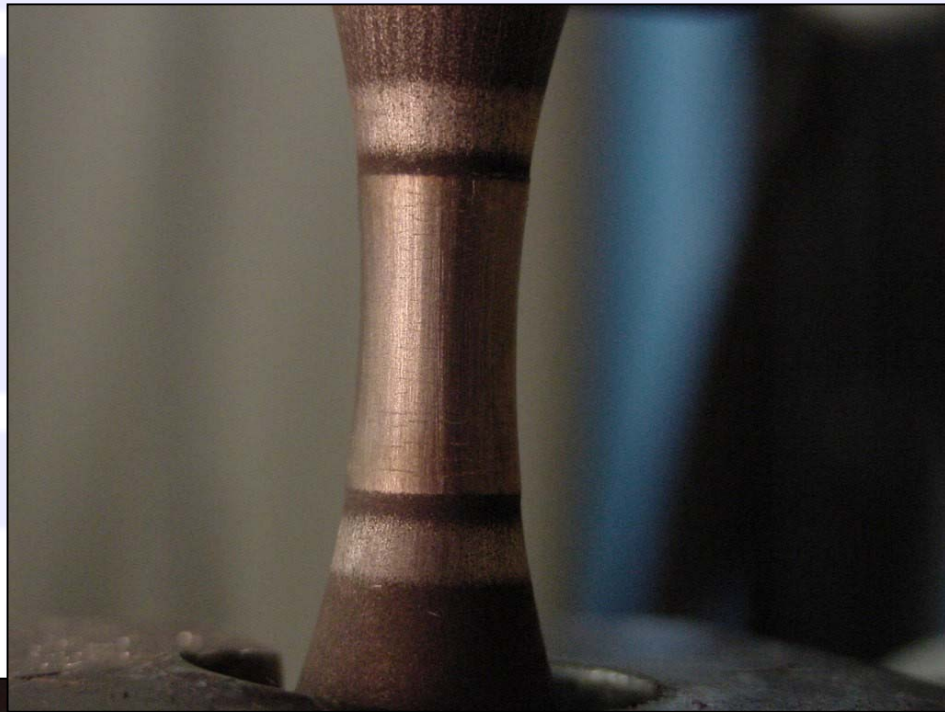
Specimen 4340-F10. WC-Co-Cr on 4340
Stress = 103 ksi. Removal at 10,082,265 cycles
Ring cracking at ~ 9.5M cycles

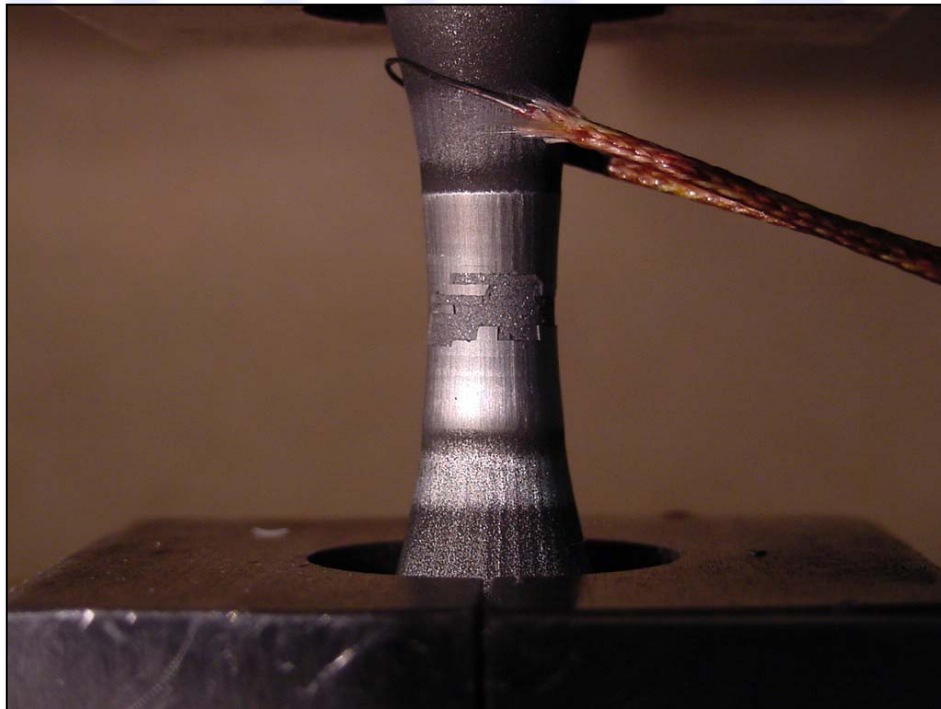
Specimen 4340-F27. Cr_2C_3 on 4340
Stress = 160 ksi. $N_f = 1,679$ cycles
Spalling at 1,630 cycles

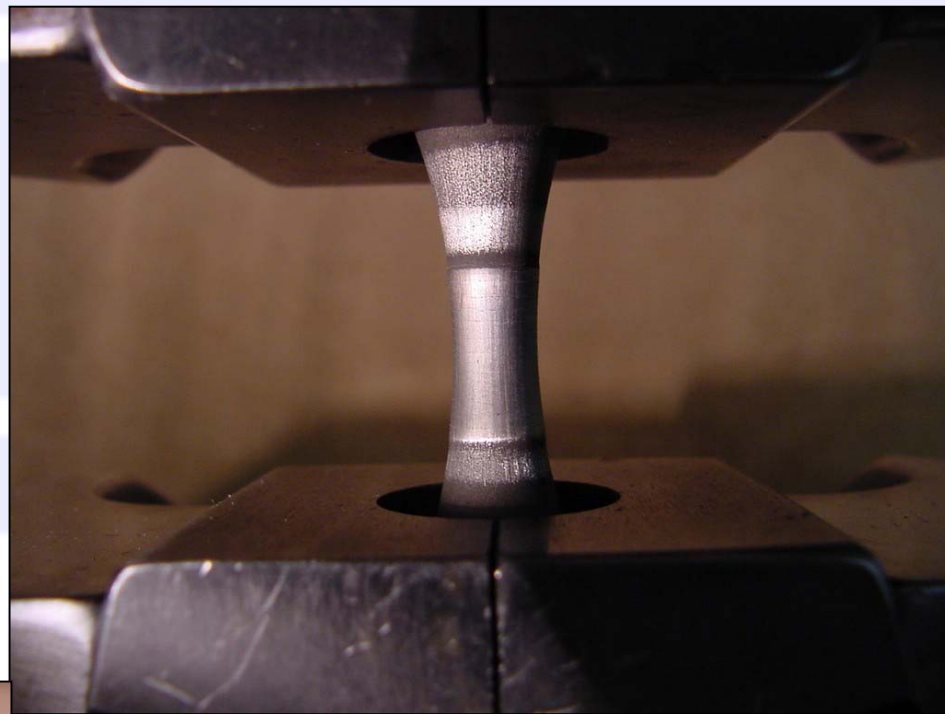
Specimen PH15-5-F10. WC-Co-Cr on PH-15-5

Stress = 107 ksi. $N_f = 2,096,472$ cycles

Ring cracking at 1,758,000 cycles

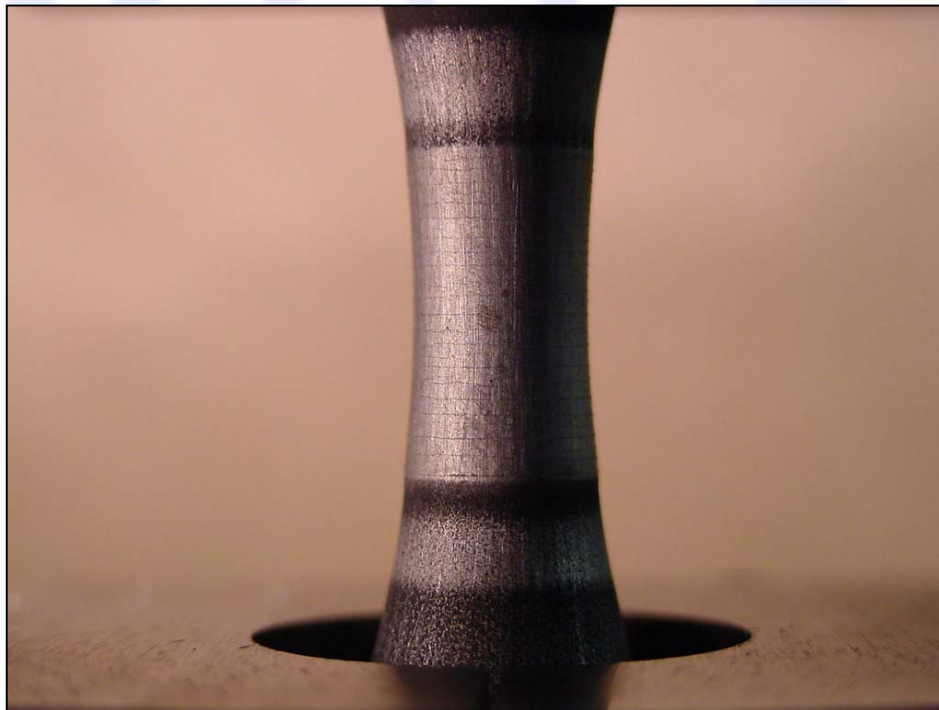
Specimen PH15-5-F27. Cr₂C₃ on PH15-5

Stress = 95 ksi. $N_f = 8,162,621$ cycles

Ring cracking at ~ 6M cycles

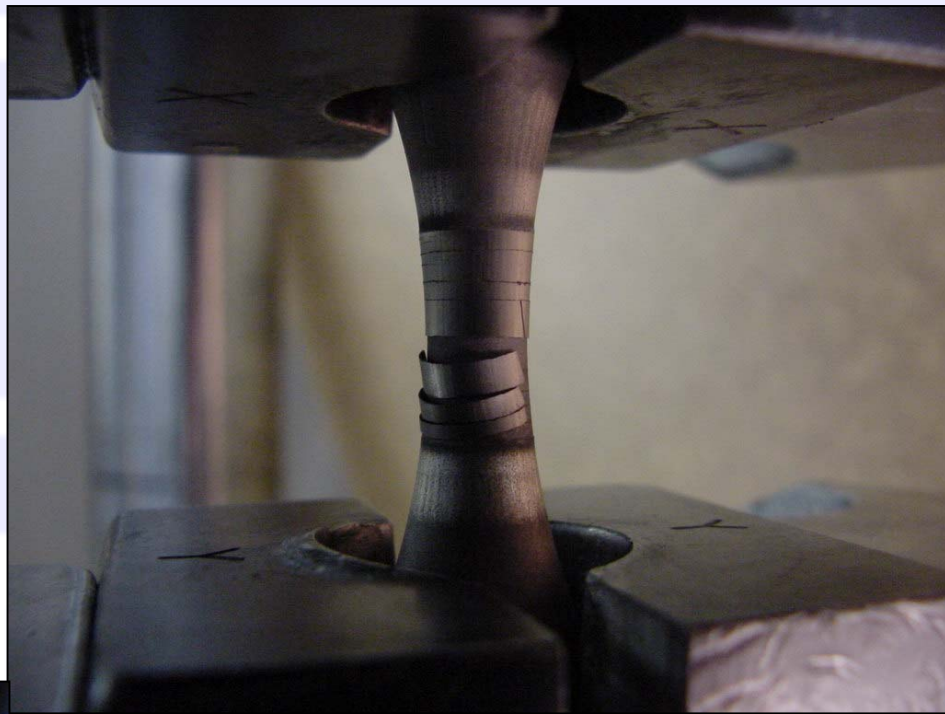
Specimen Ti-F9. WC-Co-Cr on Ti-6-4
Stress = 85 ksi. Removal at 10,000,075 cycles
Coating spalled at ~ 2.8M cycles

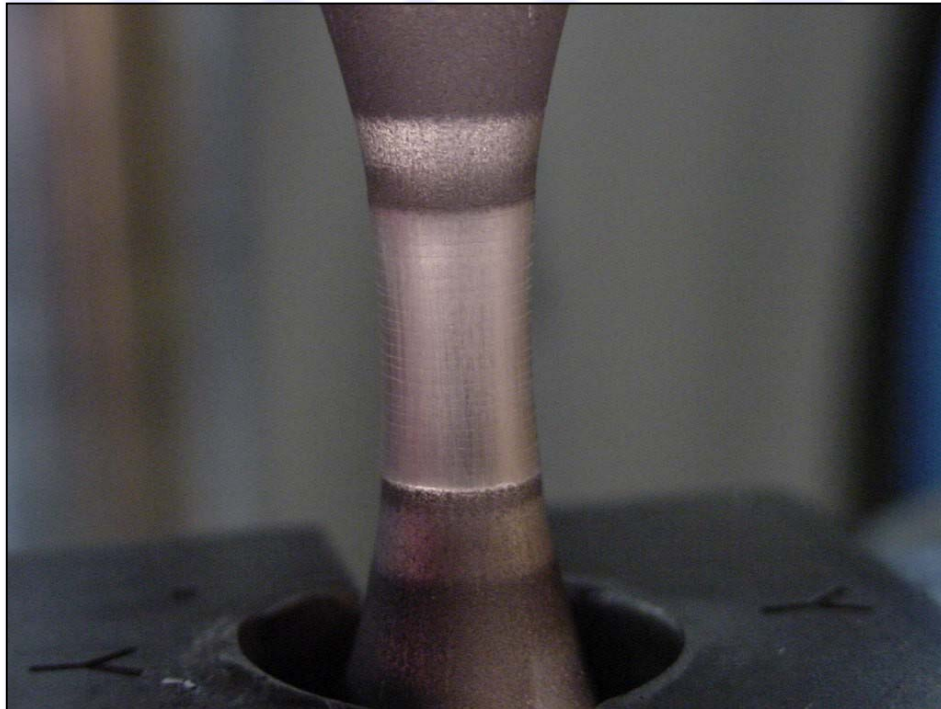
Specimen Ti-F30. Cr_2C_3 on Ti-6-4
Stress = 83 ksi. Removal at 10,096,664 cycles
Ring cracking at ~ 4.4M cycles

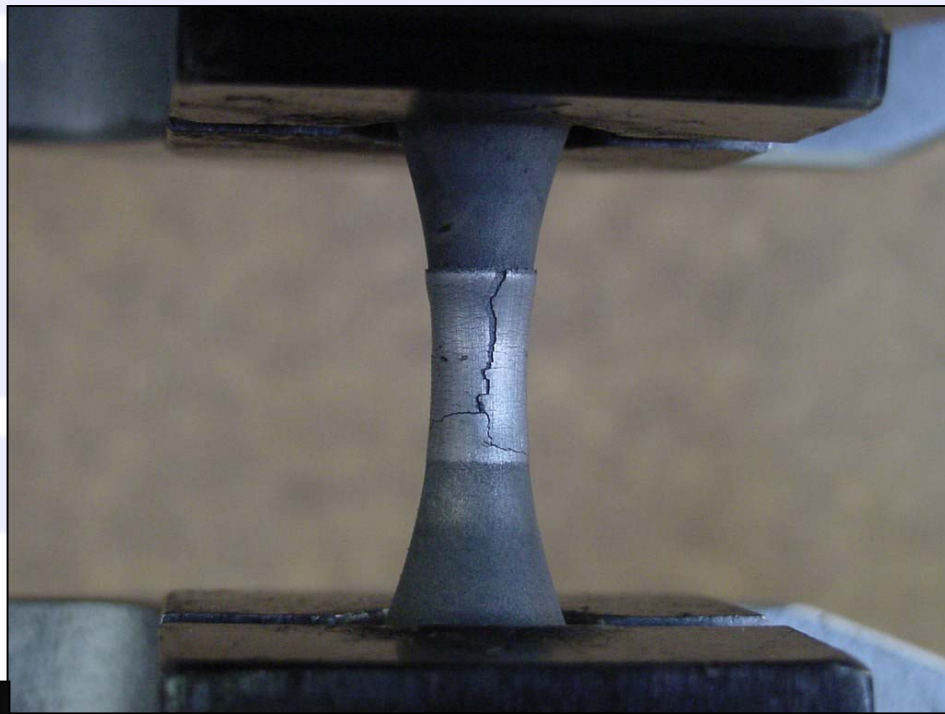
Specimen Ti-F14. T-400 on Ti-6-4
Stress = 90 ksi. Removal at 12,741,786 cycles
Coating cracked at ~ 9.2M cycles

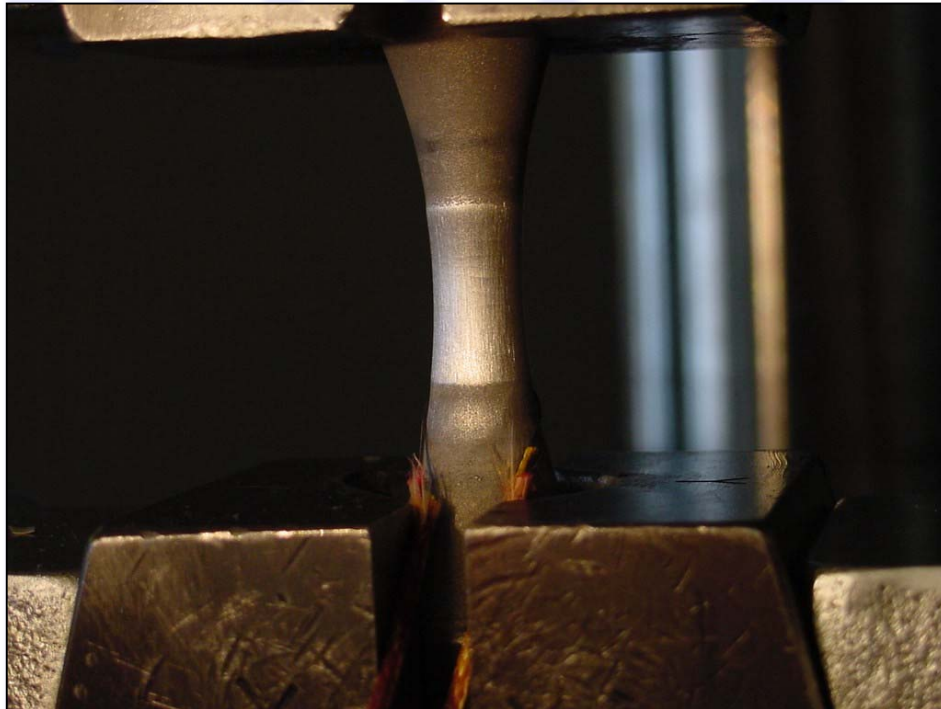
Specimen Ti-F20. T-400 on Ti-6-4
Stress = 125 ksi. $N_f = 11,562$ cycles
“Diffuse” ring cracking at 3,380 cycles

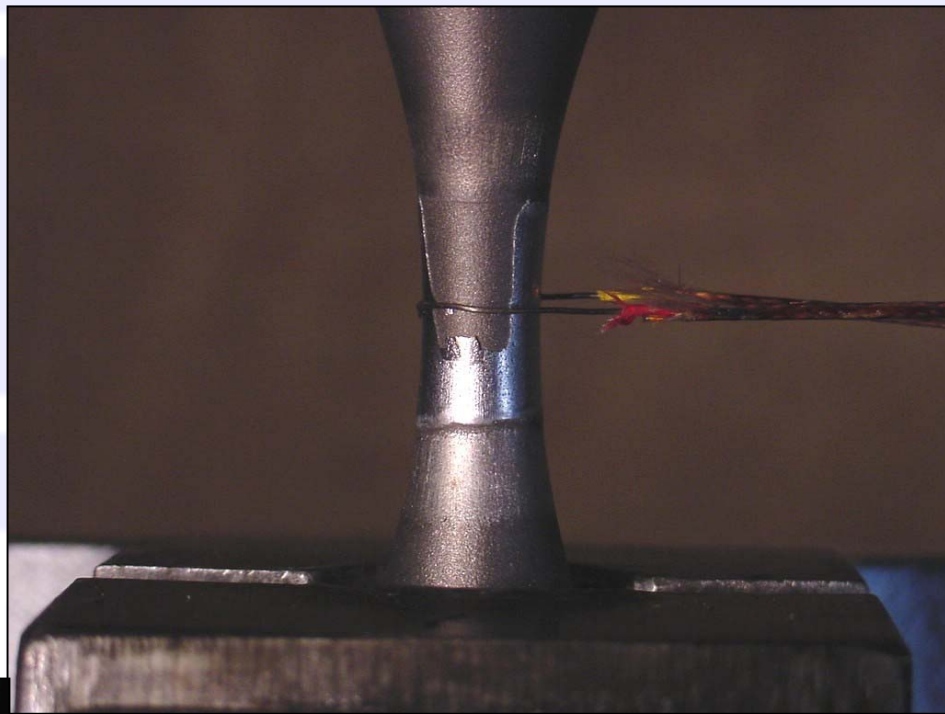
Specimen Ti-F49. EHC on Ti-6-4
Stress = 125 ksi. $N_f = 2,843$ cycles
Coating spalled at 97 cycles

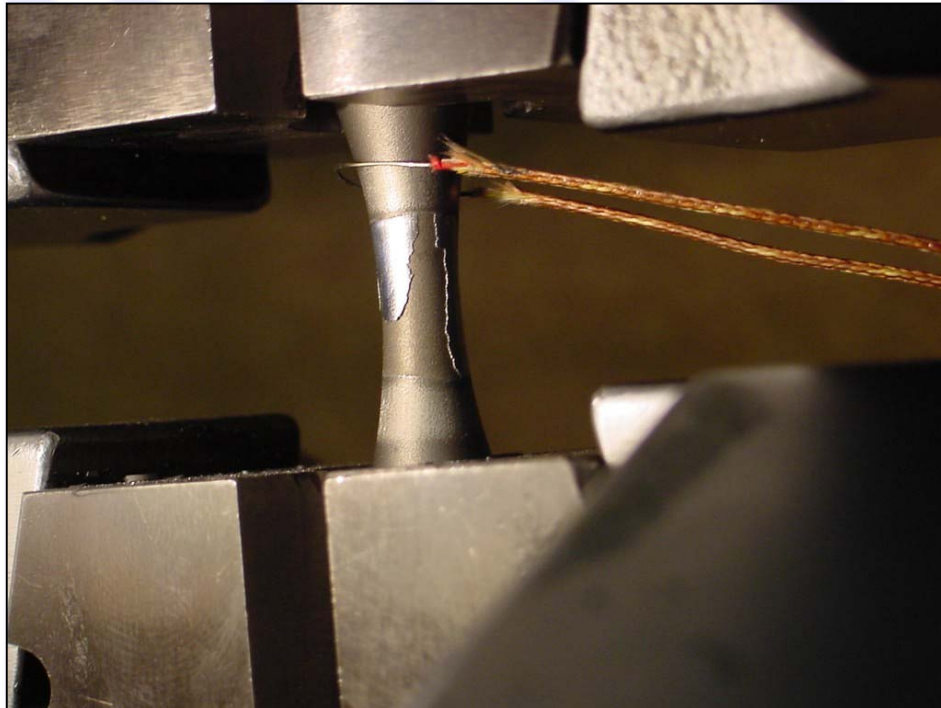
Specimen Ti-F46. EHC on Ti-6-4
Stress = 110 ksi. $N_f = 175,958$ cycles
Coating spalled at 1,425 cycles

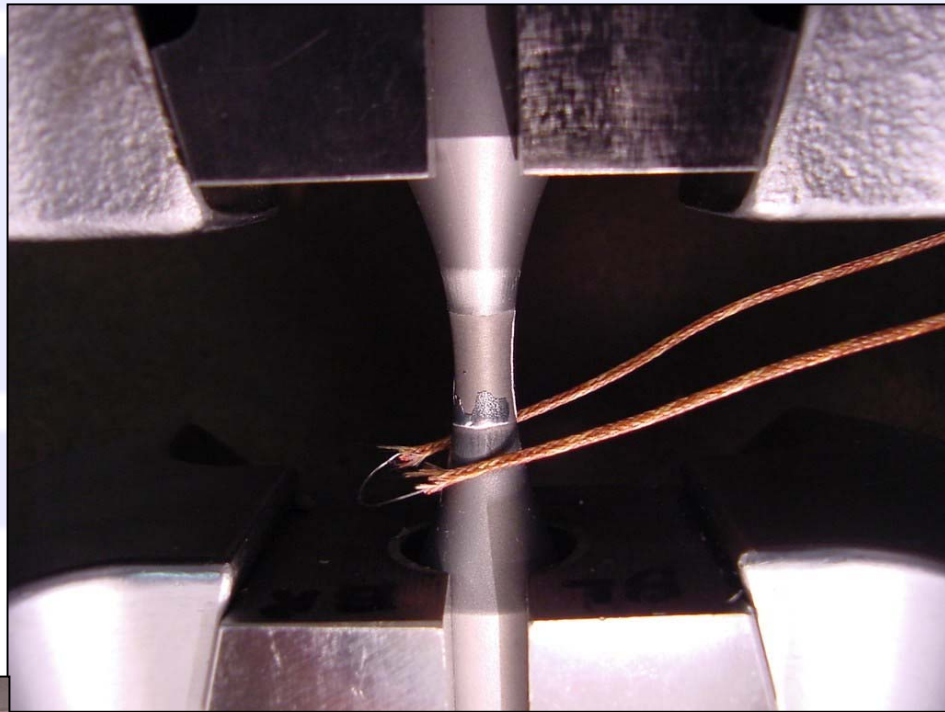
Specimen Ti-F42. EHC on Ti-6-4
Stress = 100 ksi. $N_f = 200,320$ cycles
Coating spalled at 336 cycles

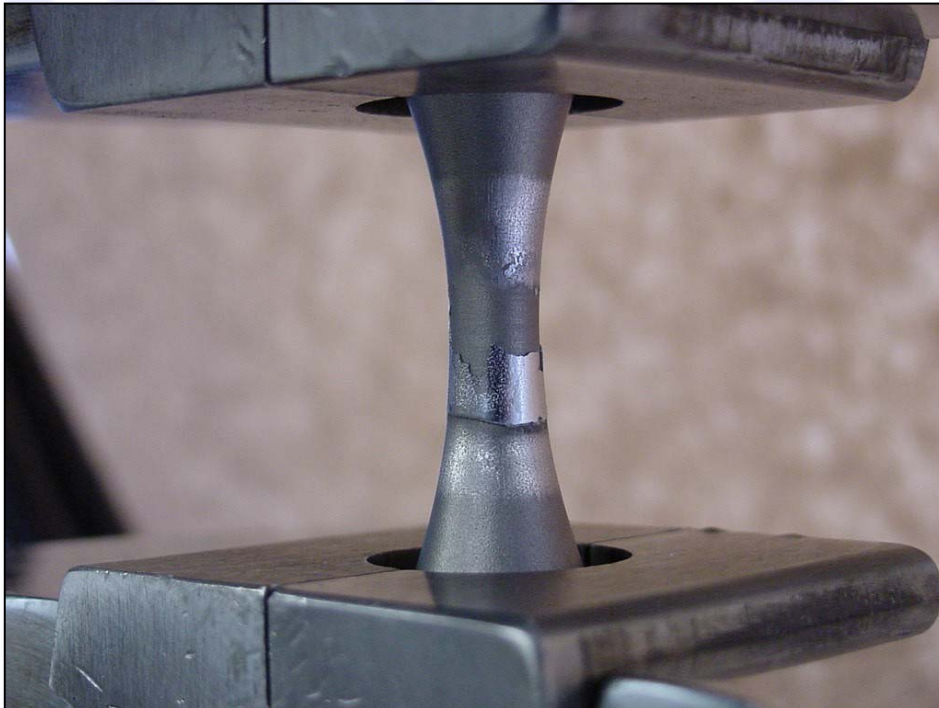
Specimen Ti-F45. EHC on Ti-6-4
Stress = 95 ksi. Removal at 10,000,114 cycles
Coating spalled at ~ 1300 cycles

- Coating durability on Ti-6-4 was significantly worse than on the other substrates, particularly for EHC
- For HVOF coatings, premature coating failure primarily was due to ring cracking
- For T-400, ring cracking was less well-defined than for the other HVOF coatings
- EHC on Ti-6-4 exhibited severe spalling at all stress levels
