JCAT Update

Cadmium Alternative Studies for C-17 P² Projects

Stephen P. Gaydos

March 16, 2005

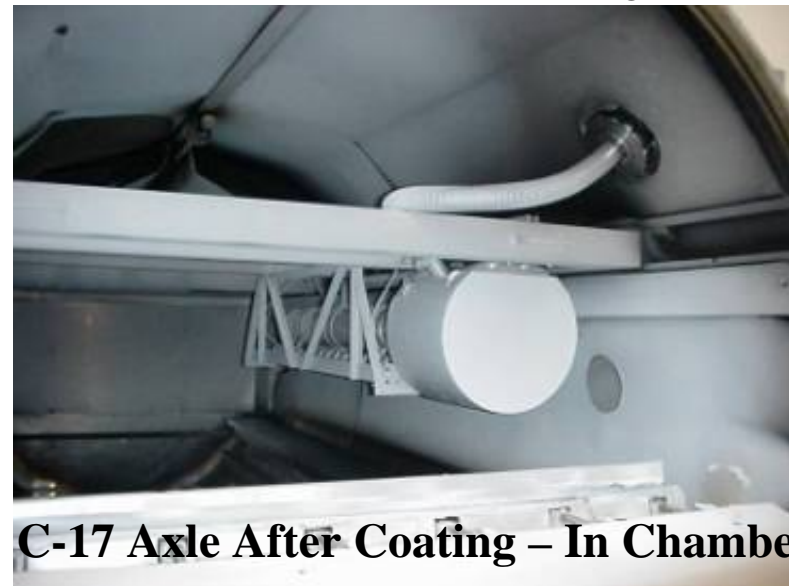
C-17 Axle After Coating - In Chamber

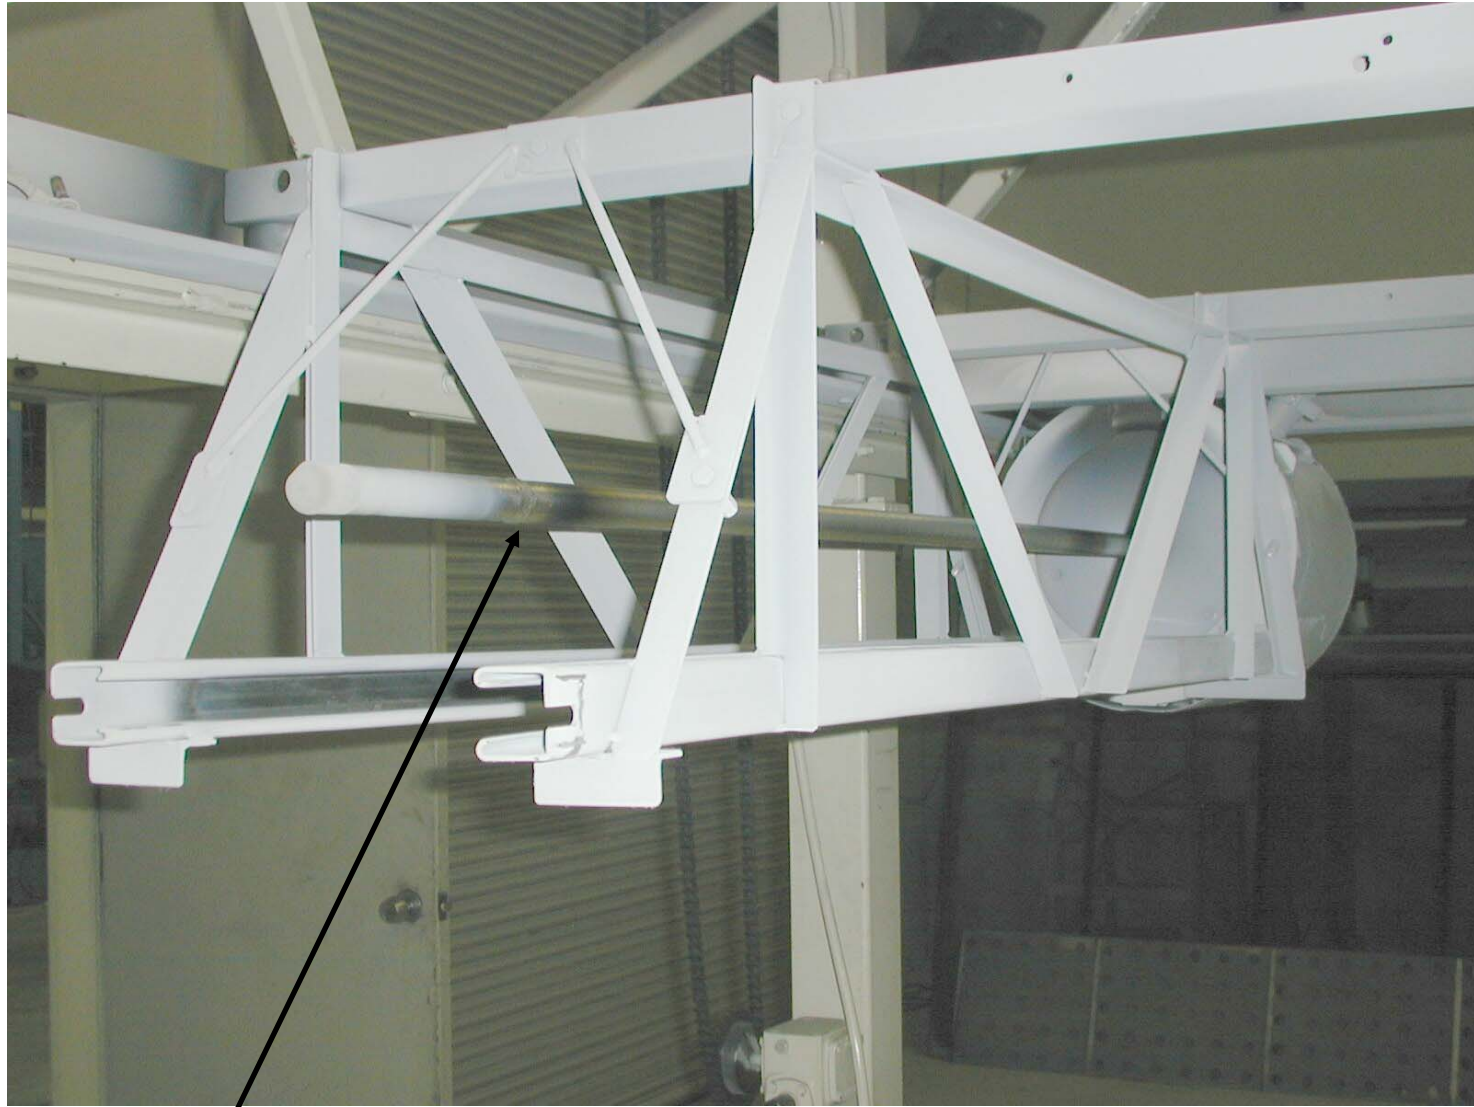
Long Aluminum Sputter Probe on IVD Rack

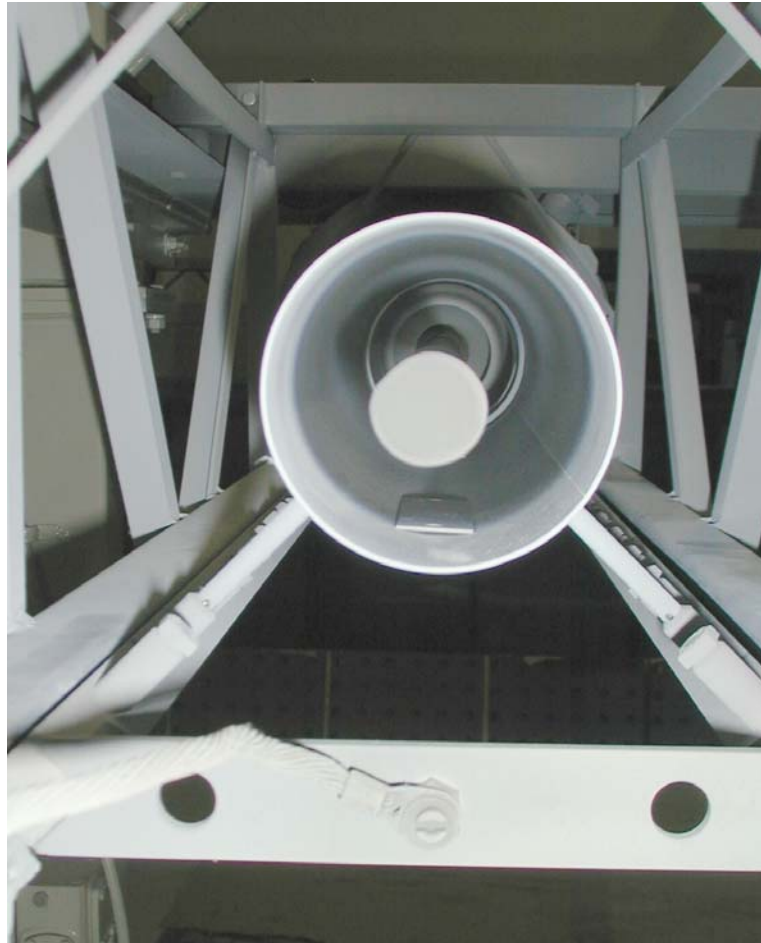
Sputter Probe Aligned In Center of Part

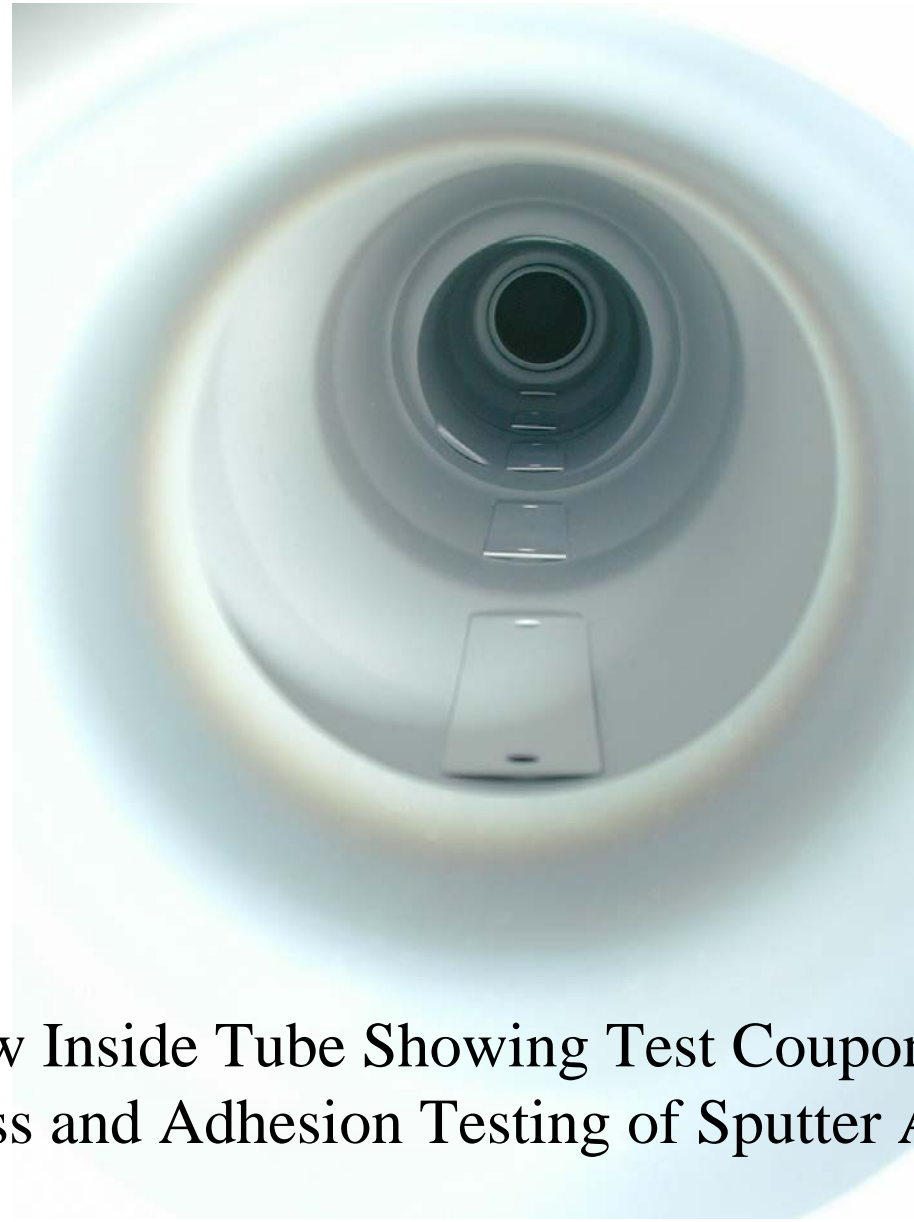
View Inside Tube Showing Test Coupons for Thickness and Adhesion Testing of Sputter Al Coating

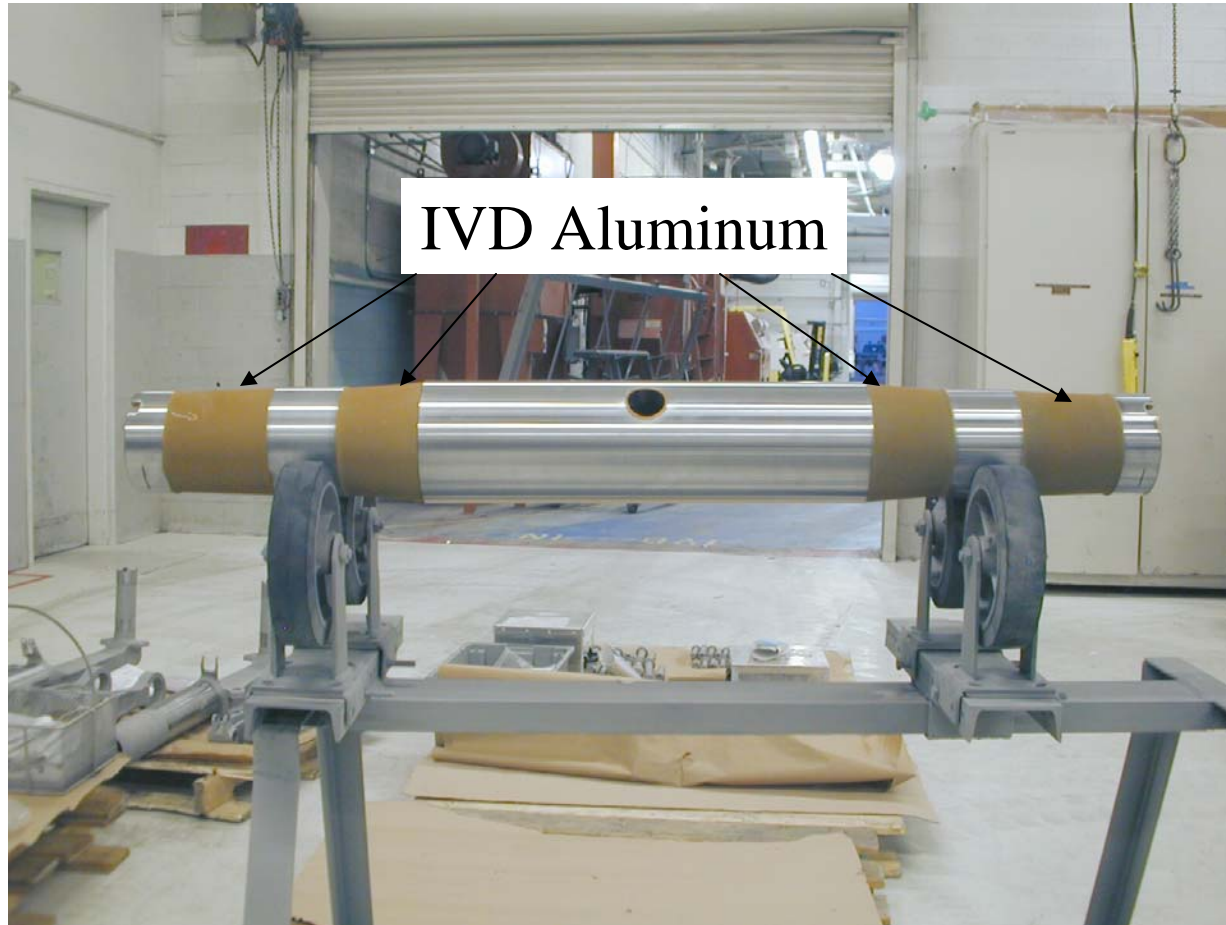
C-17 Axle After Conversion Coating

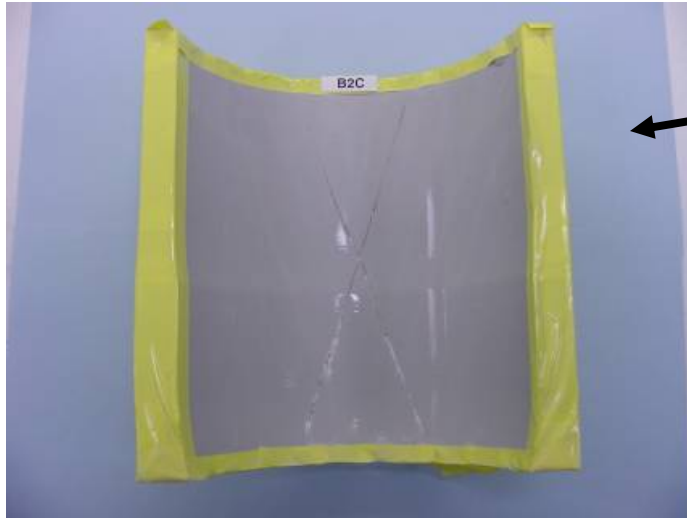
Sputter Aluminum + Primer +
Polyurethane Topcoat –
NO CORROSION!

- Axles B, C and D Subjected to Unscribed and Scribed Salt Spray (ASTM B 117)
 - B = Sputter Aluminum + Paint
 - C = Bare Steel + Paint + CPC
 - D = Sputter Aluminum Only
- ID Surface of Axles Tested for 1000 Hour Exposure

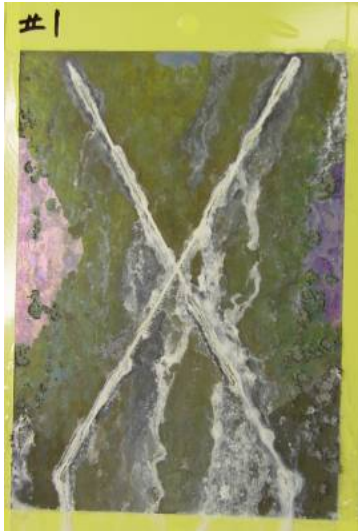
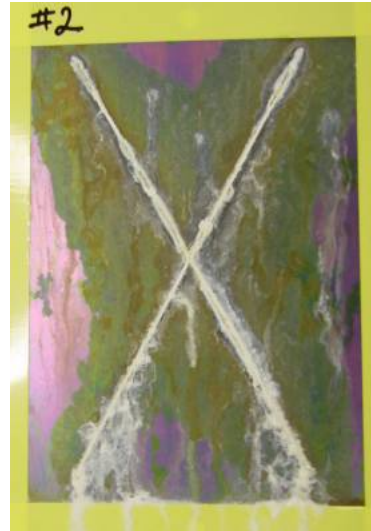
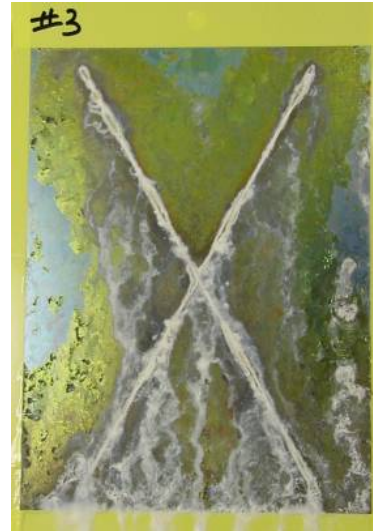
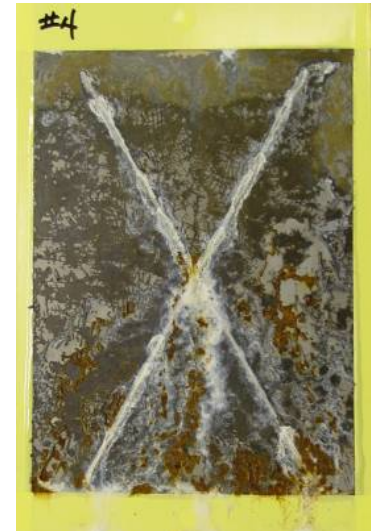
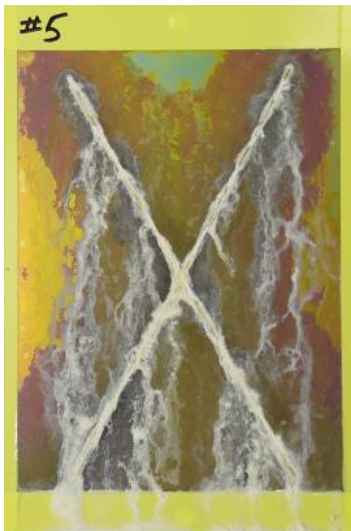
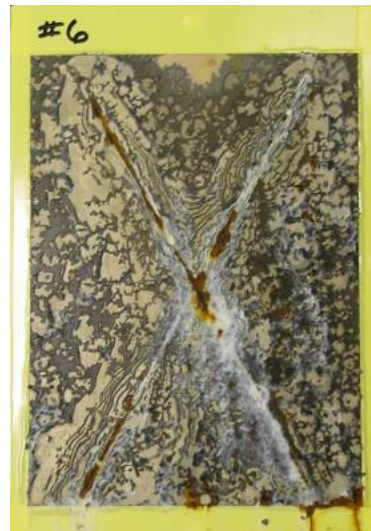
- Develop and Evaluate LHE Alkaline Zn-Ni
 - Work with an Experienced Plating Vendor
- Evaluated Seven Potential Formulations
 - Corrosion (Scribed and Unscribed)
 - Thickness / Composition
 - Hydrogen Embrittlement
- Not All Zn-Ni Perform the Same Way
 - See Corrosion Test Results

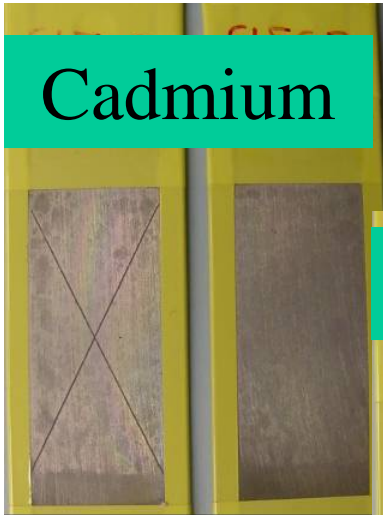
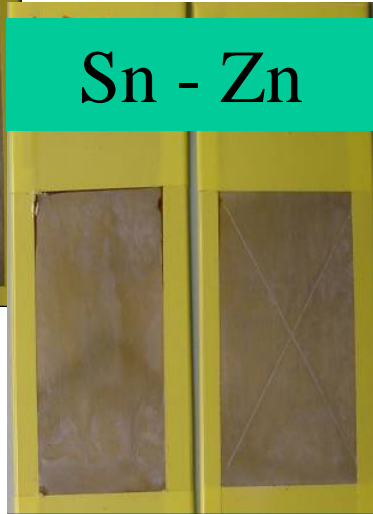
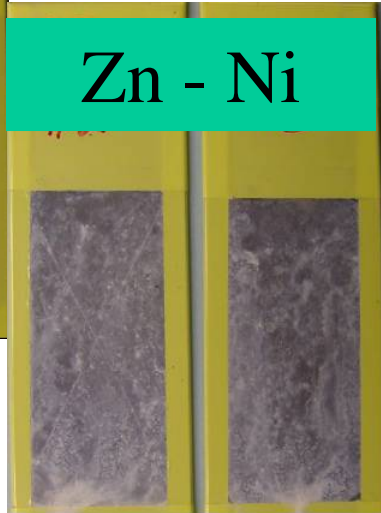
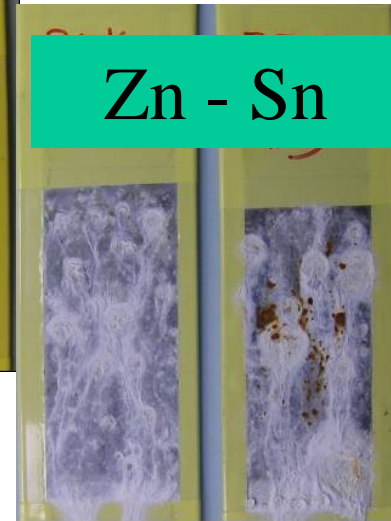
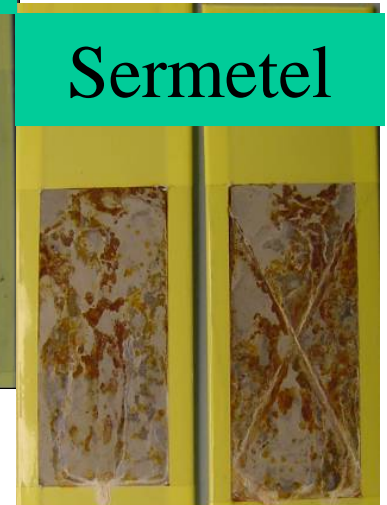
After 672 Hours in Salt Spray

- Need Brush Cadmium Alternative Repair for High Strength Steels
 - No Bake after Plating!
 - Zn-Ni
 - Sn-Zn
 - Zn-Sn
 - Others
- Sn-Zn is Very Promising
 - Acceptable Corrosion and HE Performance
 - More Testing Required
