# ***HCAT Progress Report January 2007***

***Ben Evans  
Materials and Process Technology  
Goodrich Landing Gear***

## Fatigue of Entire MLG - Dash-8 Series 400.

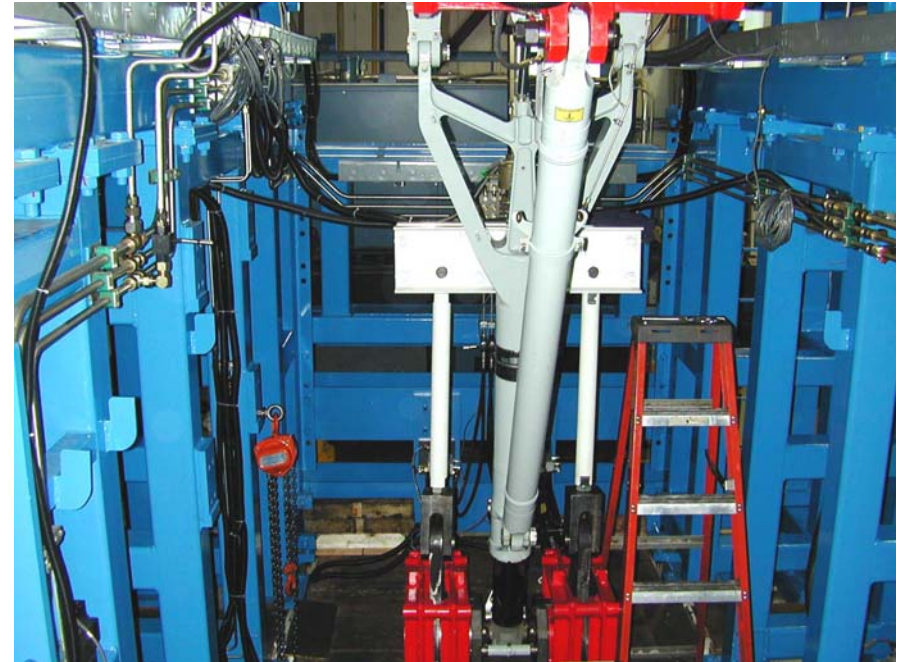
- 14 parts have been HVOF coated (piston, axle, and pins).
- The testing requires 10 layer of testing, each layer includes 32 blocks of test conditions (load location, magnitude, direction and number of cycles).
- Testing considered successful when the gear withstands 5 lives of fatigue loads without initiation of detectable fatigue cracks. 1st life inspection revealed no issues.
- Gear has completed the required 5 lives of testing.

- Testing considered successful when the gear withstands 5 lives of fatigue loads without initiation of detectable fatigue cracks.
- Test result is acceptable.

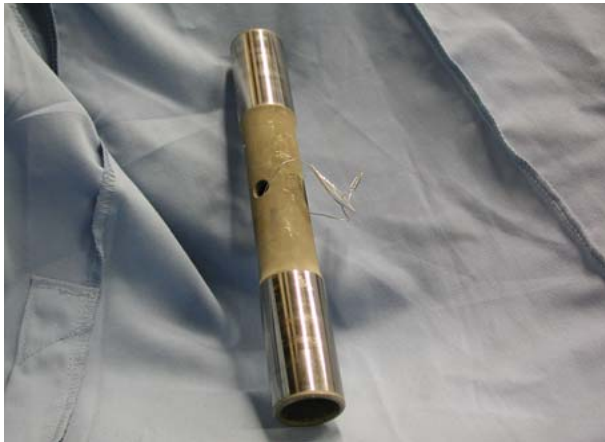
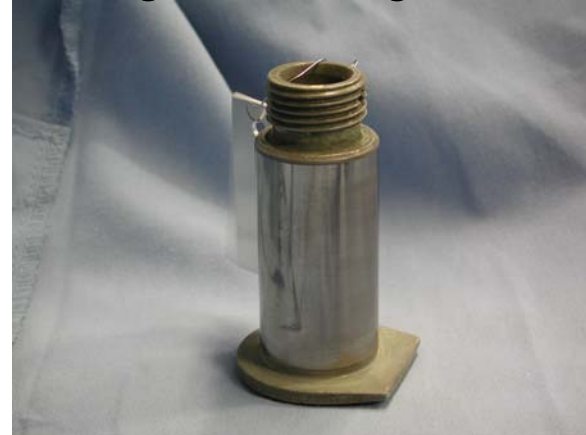
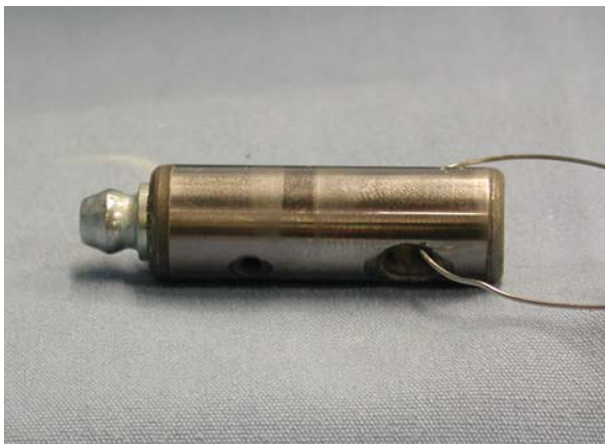
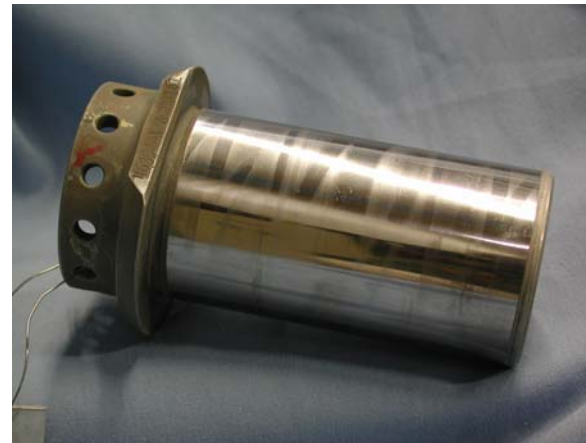
### Dash 8 Pins After 2 Lives of Fatigue Testing

- Pins showed some “shadowing” from the mating parts but no measureable wear.
- No cracks, chips, spalls, etc. were noted.
- All pins were acceptable.

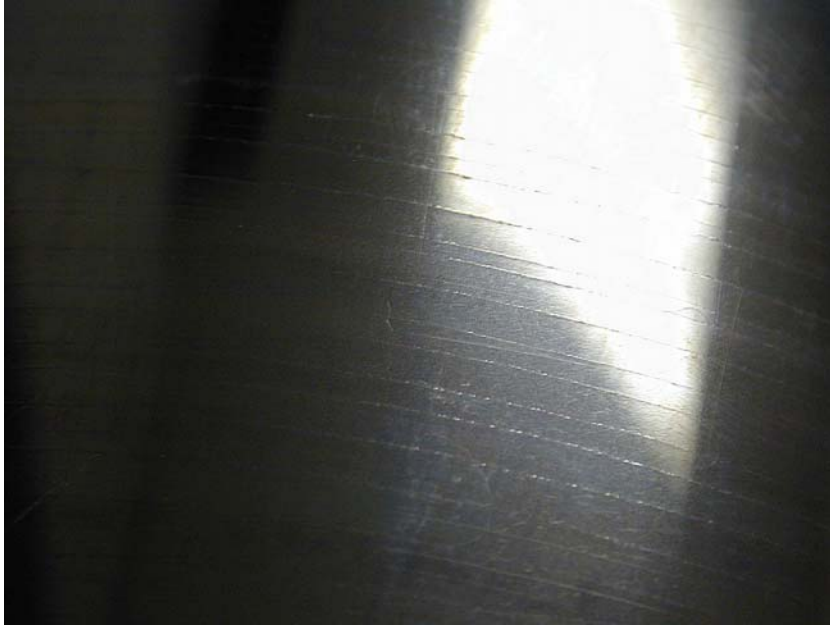
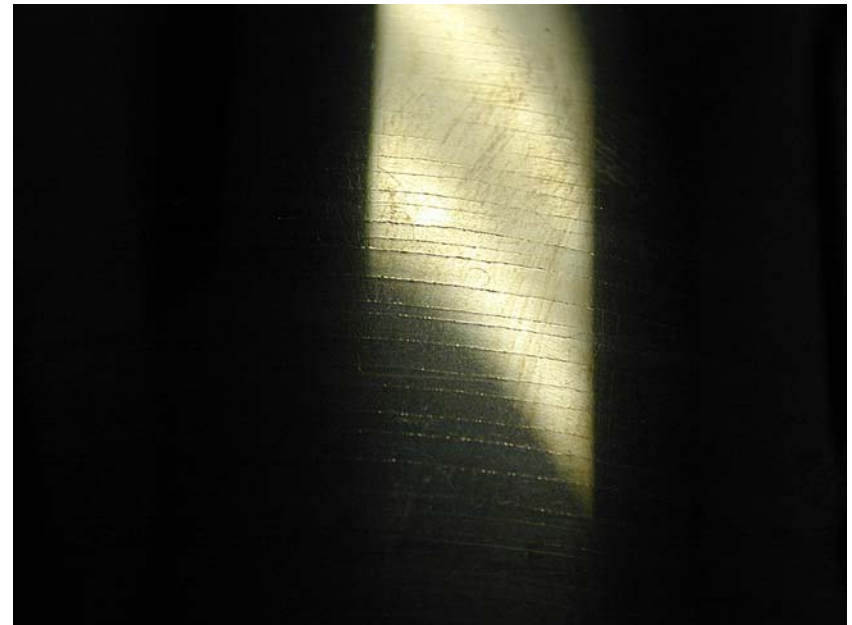
Cracks in piston coating observed after 5 lives of testing. After 5 lives the cracks showed increased fraying on the edges and were more detectable by the finger nail test.

The piston was Barkhausen noise (rollscan) and no damage to the substrate was detected.

- Location of cracks corresponds with the 2.8" stroke, and highest spectrum loads:

- **QUESTIONS – WAY FORWARD**
- Is microcracking a functional concern? Depends on seal design and stress levels. Elastomeric seals are more forgiving than PTFE cap seals.
  - Cracks appeared after two lives,
  - Major overhauls after  $\sim 1/3$  -  $1/2$  life,
  - Not uncommon to strip and re-chrome pistons at major overhaul
- Will the HVOF eventually spall? Is corrosion an issue?
- What is the threshold for the onset of cracking?

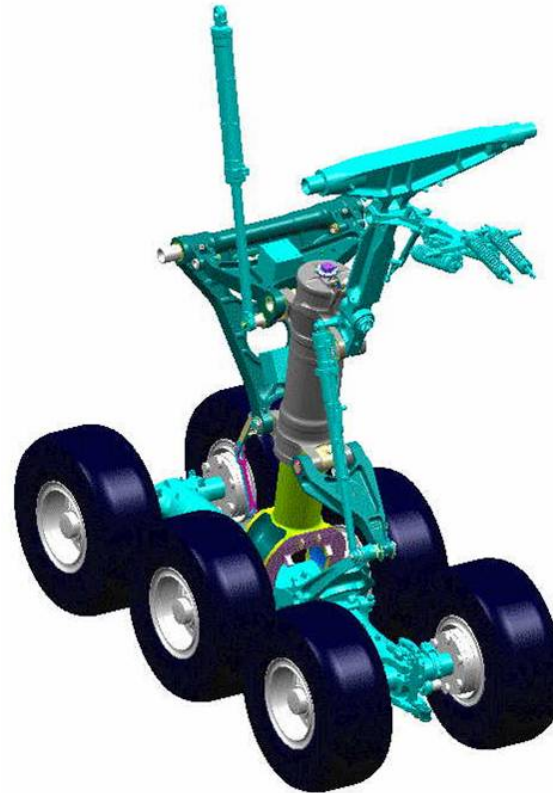
Goodrich is using HVOF on landing gear.

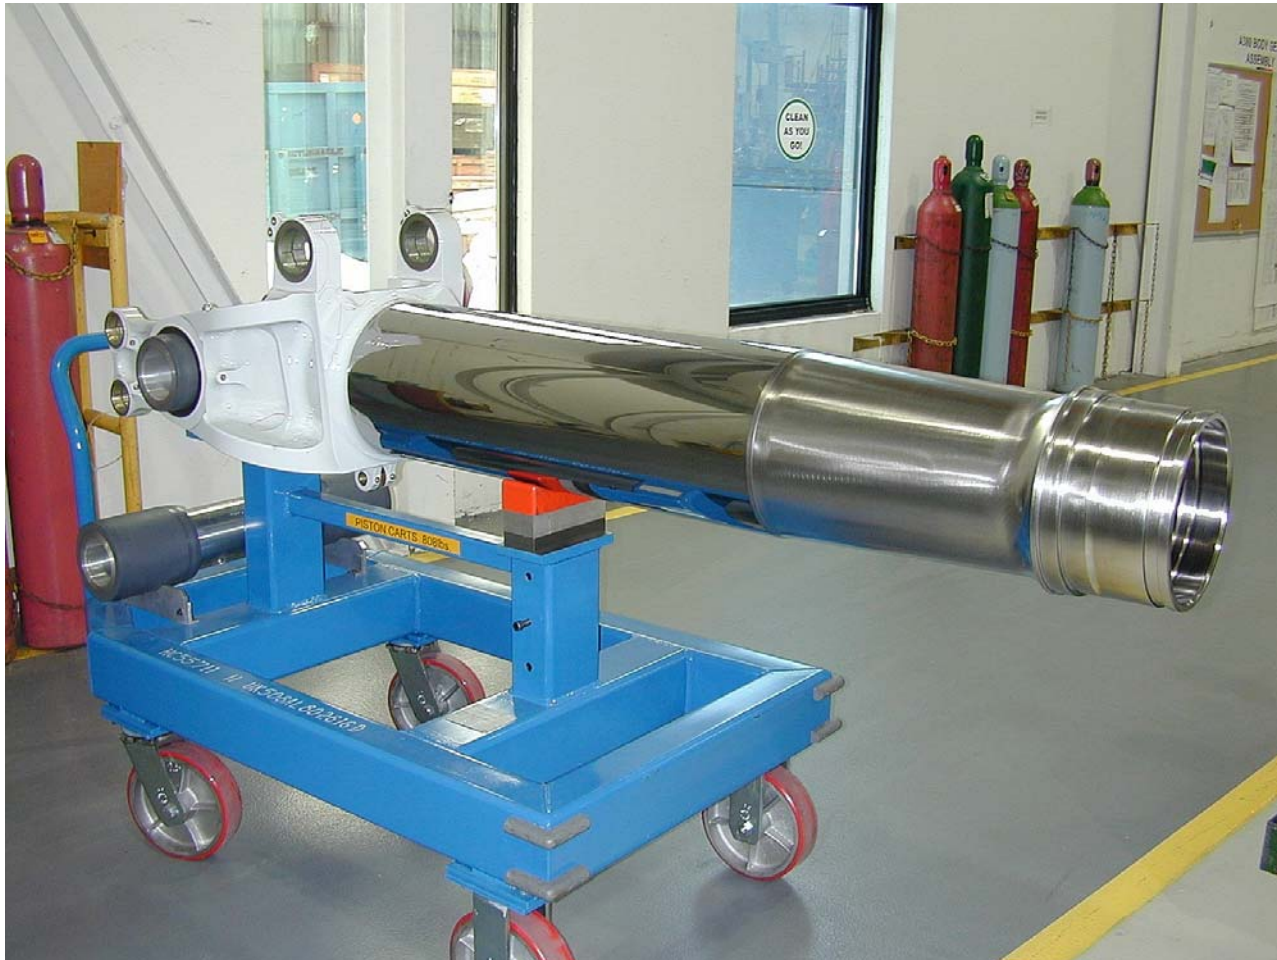
### A380 Piston

- The Airbus A380 design is the first Goodrich Landing Gear with HVOF coating as a hard chrome replacement.
- The A380 has achieved air worthiness certification.
- HVOF has performed very well.

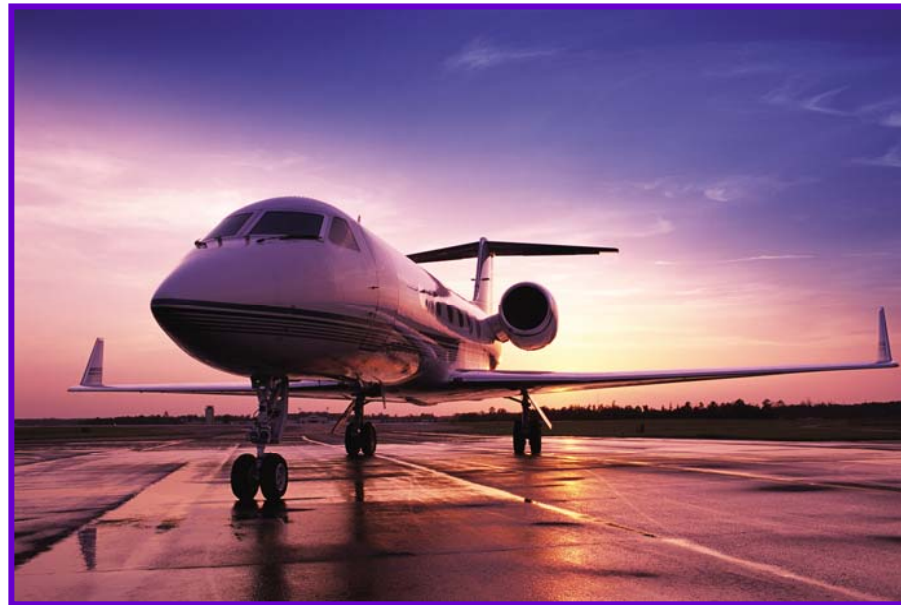
- Goodrich is working with Gulfstream introducing HVOF as a replacement for hard chrome on sustaining programs.
