Crack detection in HVOF coatings by ultrasonic vibrothermography.

Jean-Gabriel Legoux,
Jean-Marc Piau and Hakim Bendada

- To develop a non destructive inspection technique enabling the detection of closed cracks inside WC-HVOF coatings

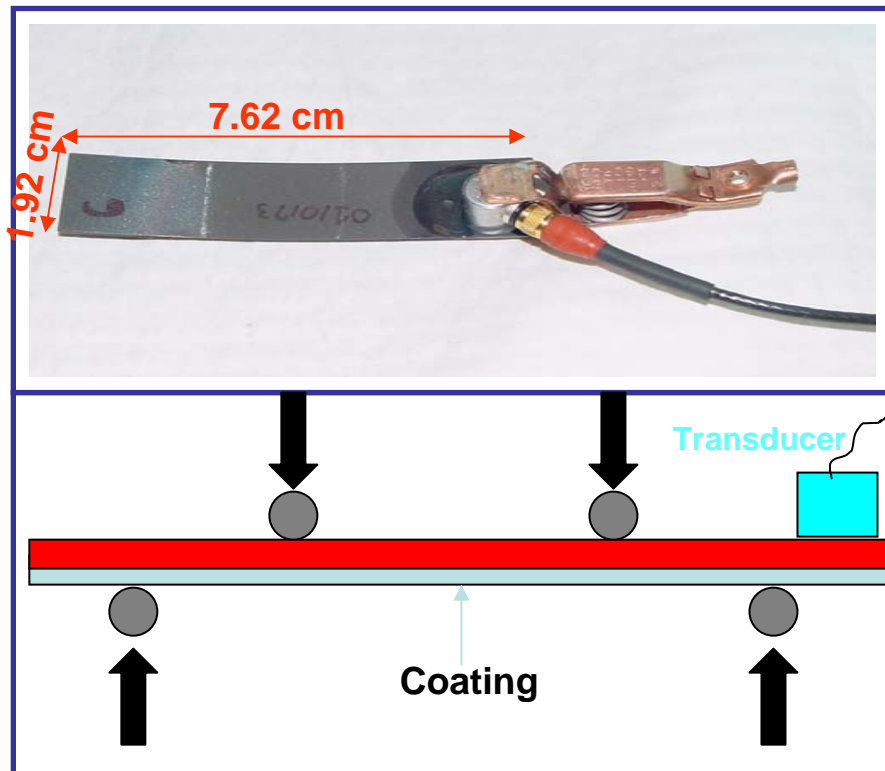
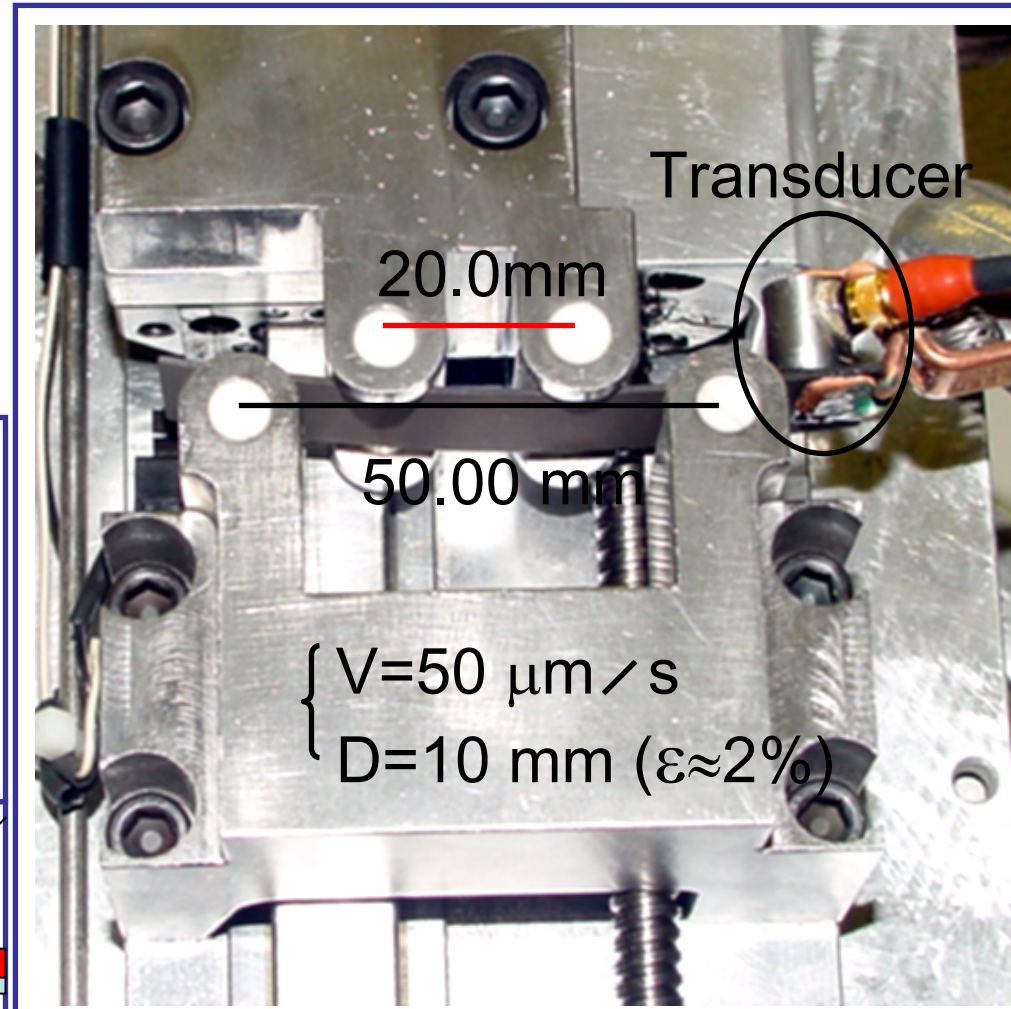
Four-Point Bend Test

Performed by simultaneously applying a certain strain rate, measuring and analysing the characteristics of Acoustic Emissions.

Under-Bending Test \Rightarrow Tensile Stresses

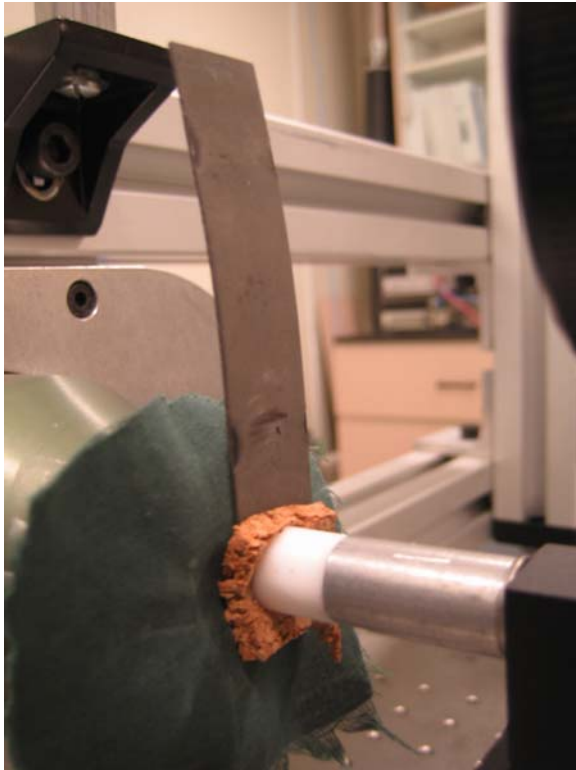
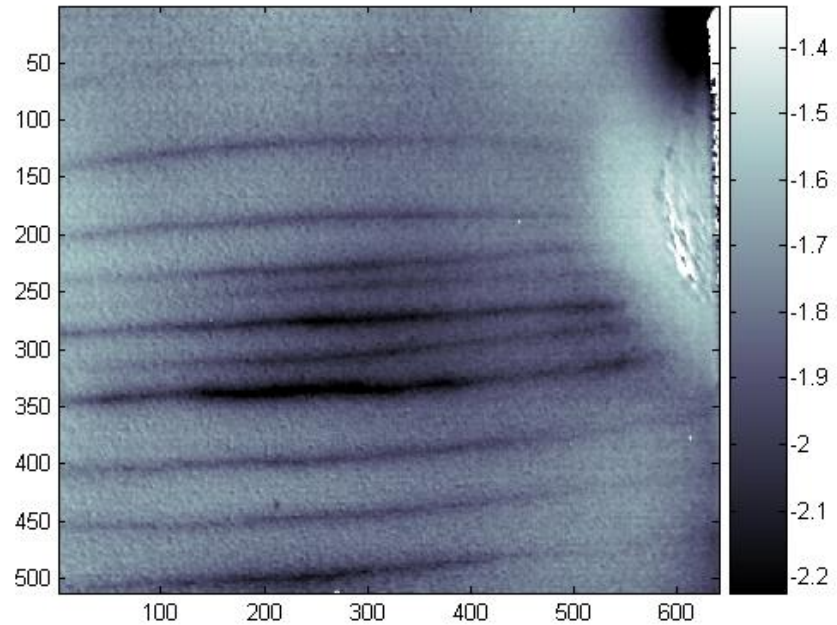
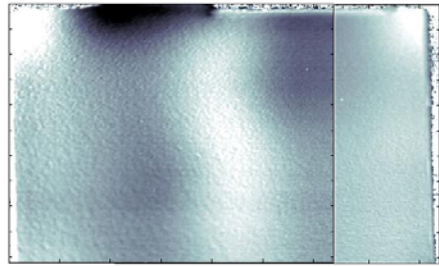
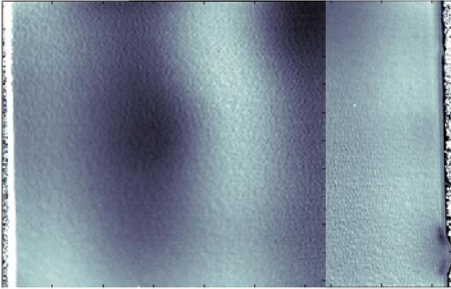
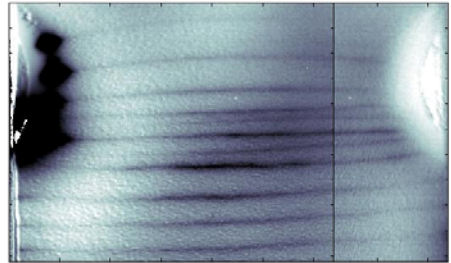
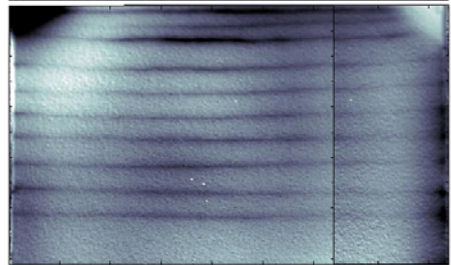
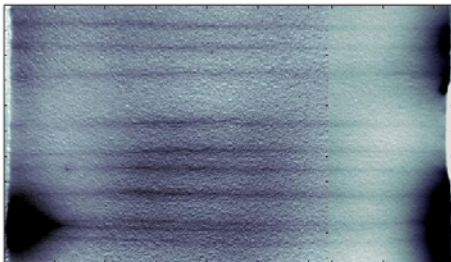
Détection de micro fissures

Tungsten Carbide Coating

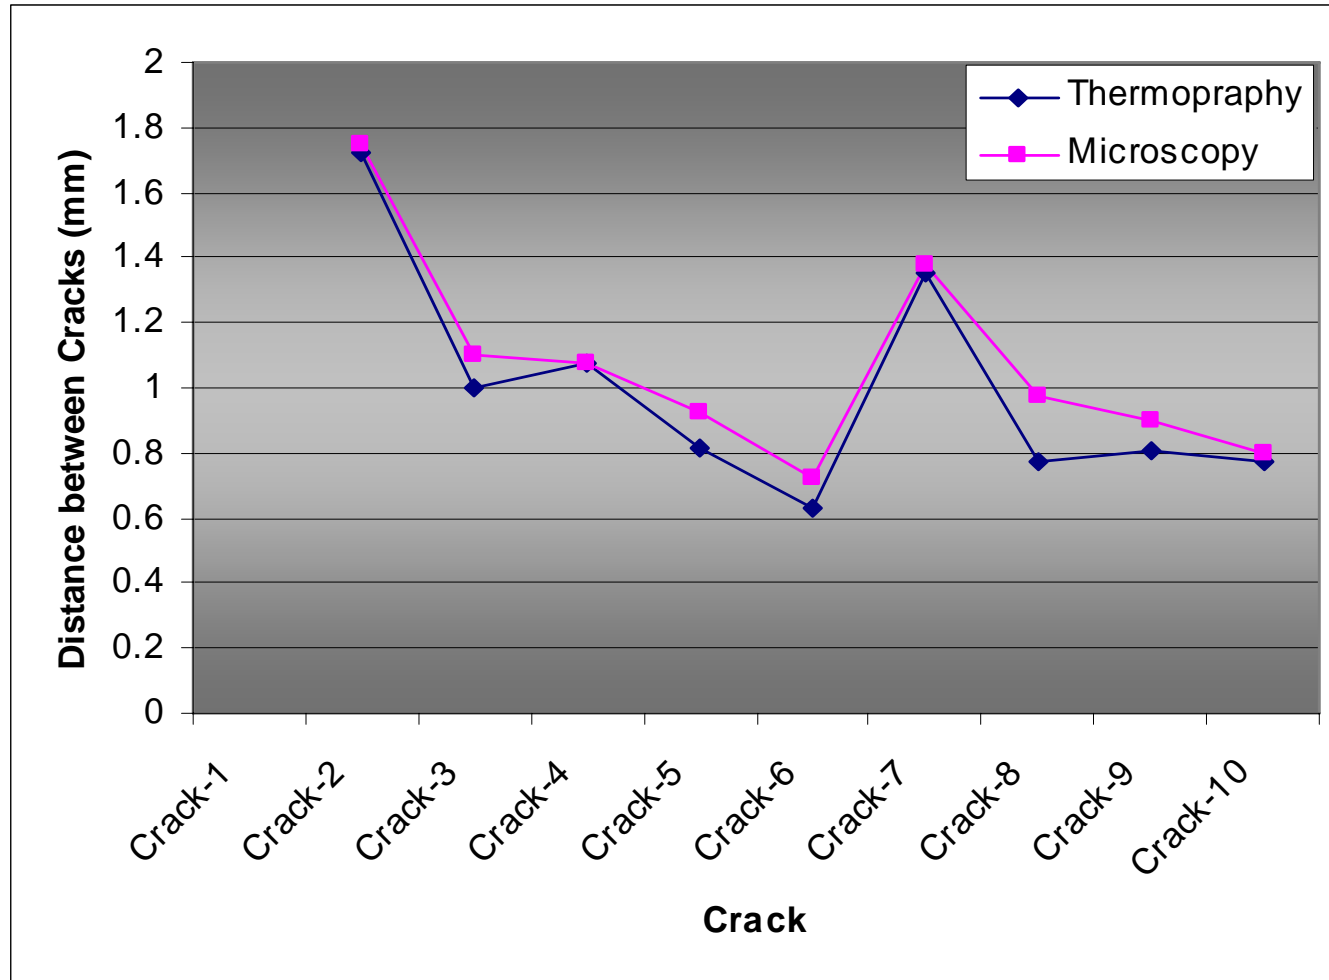
Validation of Crack Position by Microscopy

MI-CNRC 15.0kV 14.4mm x1.00

k YAGBSE 50.0um
