# Project Results

HVOF WC/Co Replacement of  
Chrome – Bench Tests  
Bell Helicopter Textron

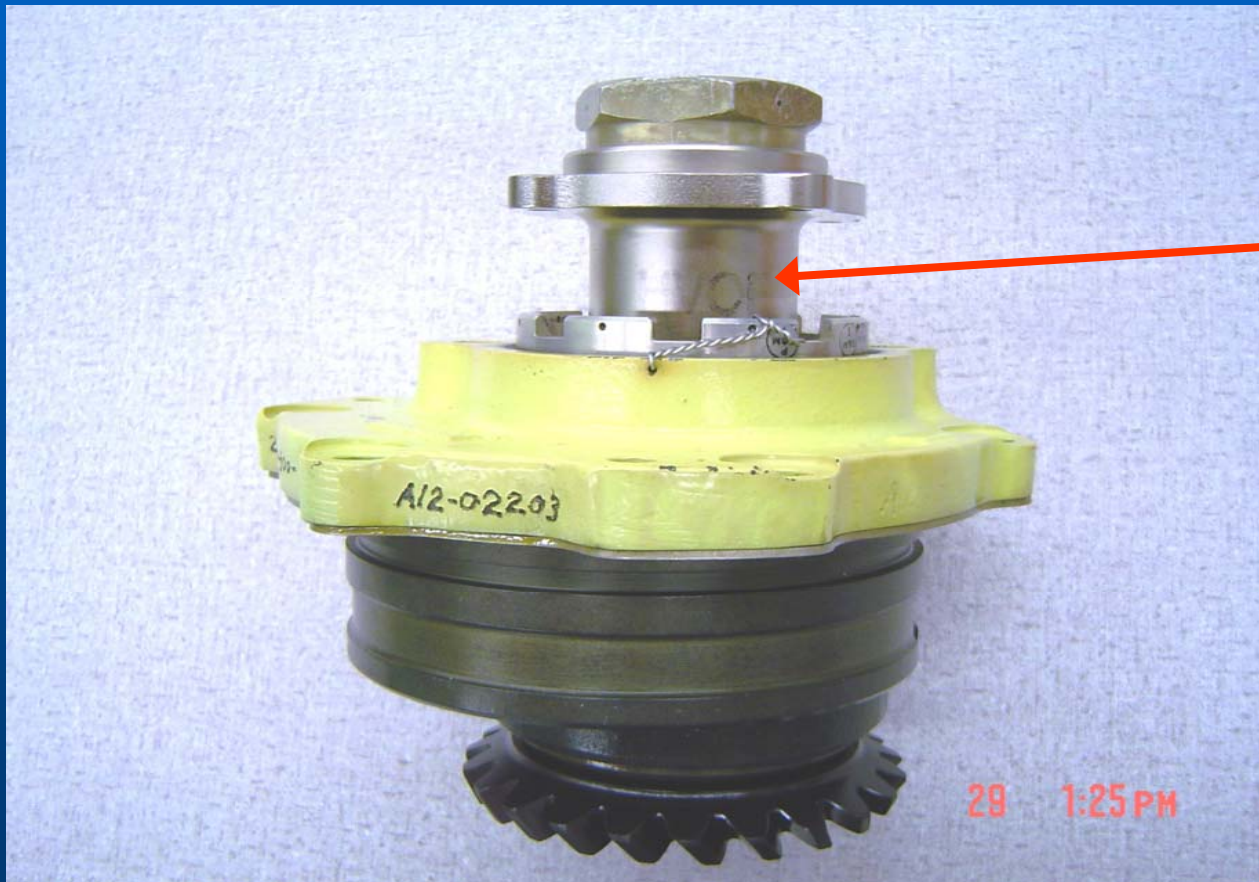
# Rotor Brake Disc Flange Adapter in Brake Disc Quill Assembly

Flange  
Adapter

- Due to time limitations only seal riding surface was HVOF WC/Co Coated. E-nickel plated over non-functional surfaces.
- Diameter A of flange adapter allowed to be little larger to allow for thicker WC/Co coating of 0.002” compared to 0.0005-0.0006” call-out for chrome plating. 100 hr test proved out larger diameter.

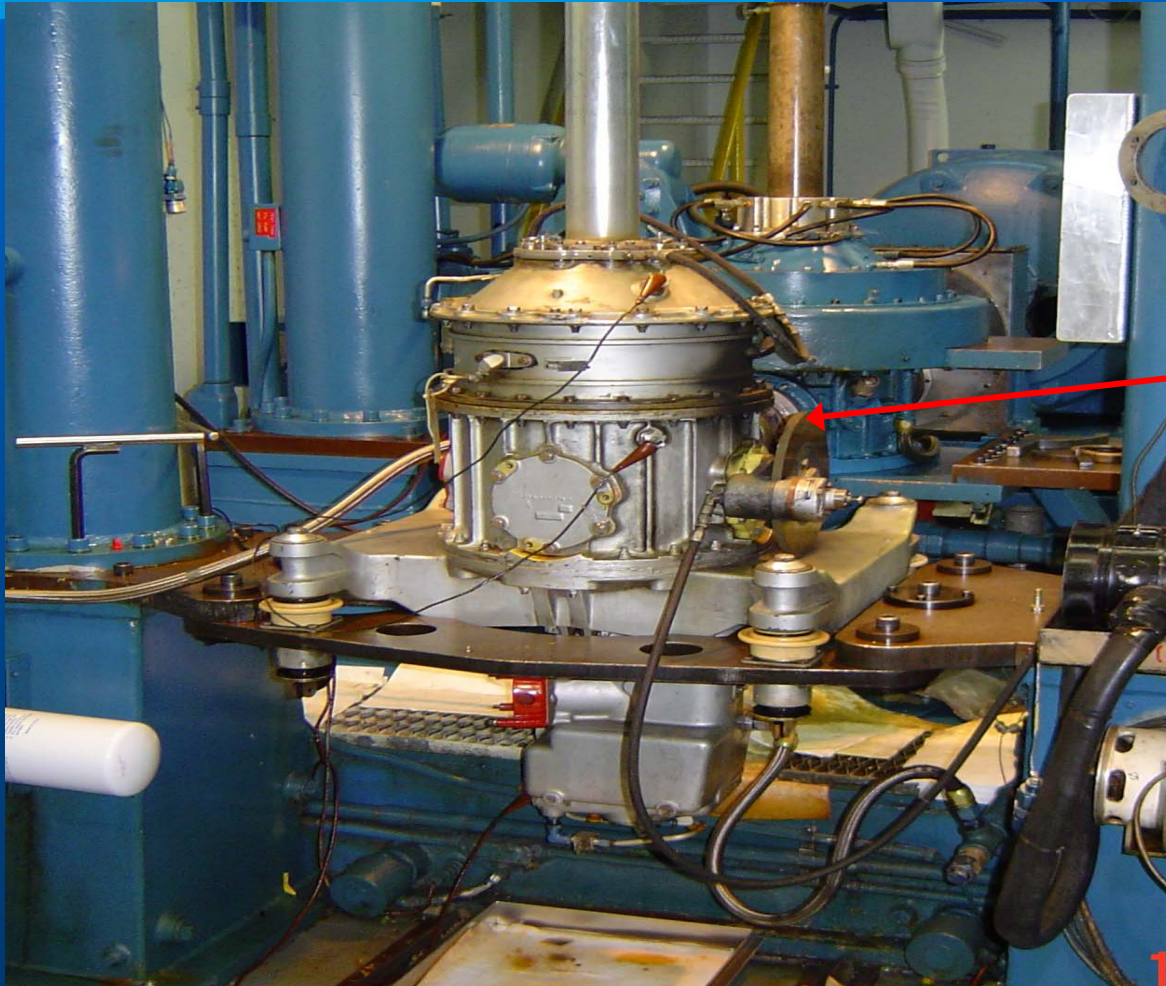
# Rotor Brake Disk Quill Assy Installed in XMSN and in Test Stand

Rotor  
Brake  
Disc Quill  
Assy

- The 100 hour drive system test included 2 rotor brake stops every 2 hours for a total of 100 brake stops. Temperature during the brake stops reached above 270 °F but below 330 °F as indicated by temperature indicating Templates. This temperature change indicated successful thermal cycling of the component
- After disassembly and inspection, no damage to or leakage from the oil seal was detected
