# P-3 HVOF Piston WC-Co Coating Analysis

# P-3 HVOF Strut

# P-3 Strut Service History

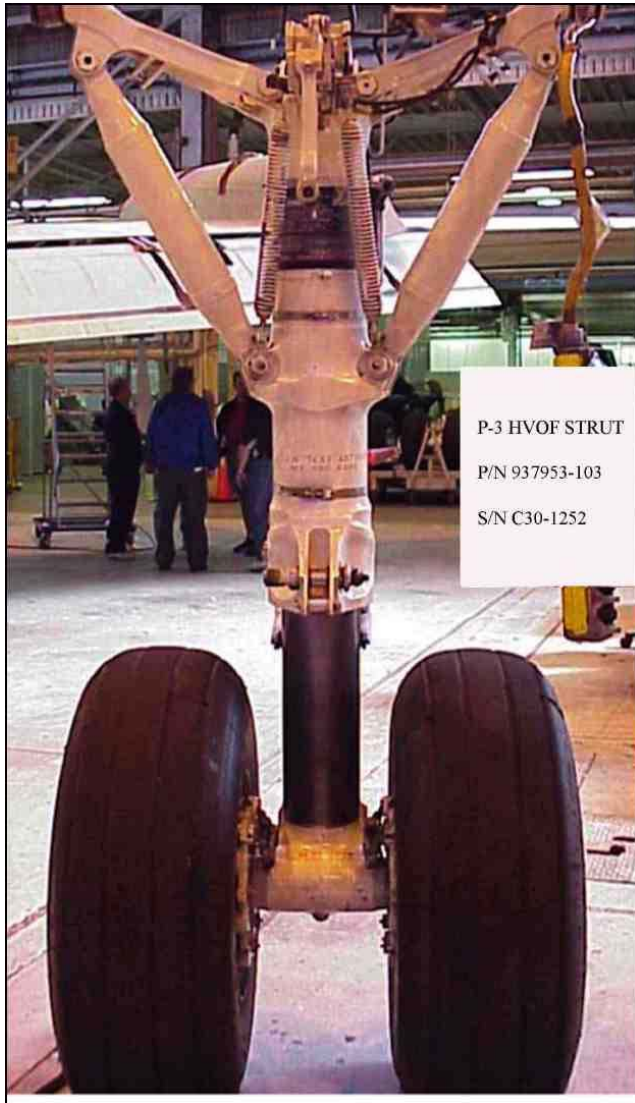
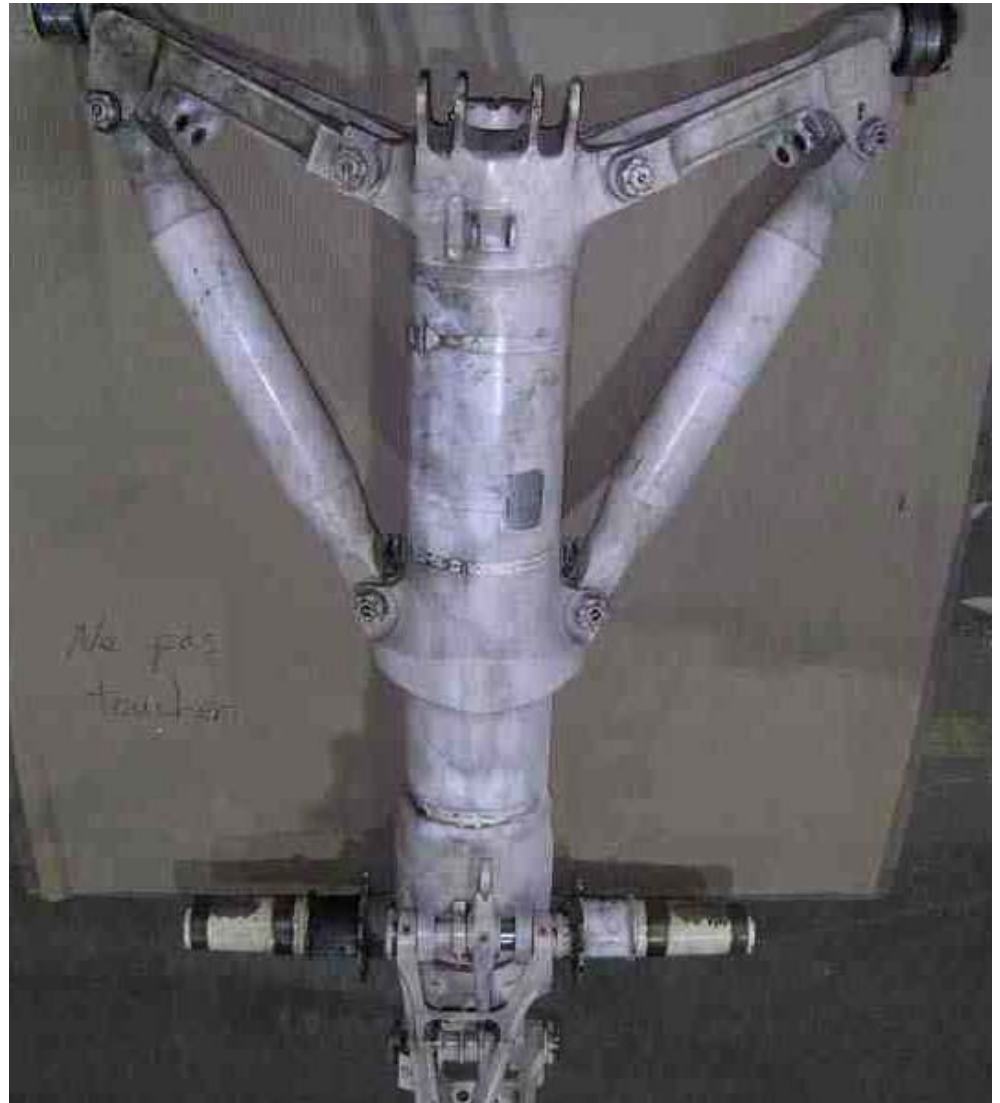
Table 1. HVOF MLG Shock Strut Service History			
P-3 R/H MLG Shock Strut Assembly P/N 937958-103, S/N C30-1252, HVOF Piston P/N 978536-103, S/N 703			
Date	Landings	Aircraft	Comments
26 Apr 99	0	156522	Installed at VP-30
01 Aug 99	850	156522	Removed due Non-HVOF related leak
25 Apr 01	850	160284	Installed on new Aircraft after JAX repair
23 Aug 01	1,078	160284	
13 Aug 03	2,858	160284	Aircraft to JAX for PDM
06 Feb 04		160284	Aircraft returns from JAX to VP-30
07 May 04	3,329	160284	
01 Mar 05	4,410	160284	
15 Jan 06	6,378	160284	Returned to Supply IAW AFB 383

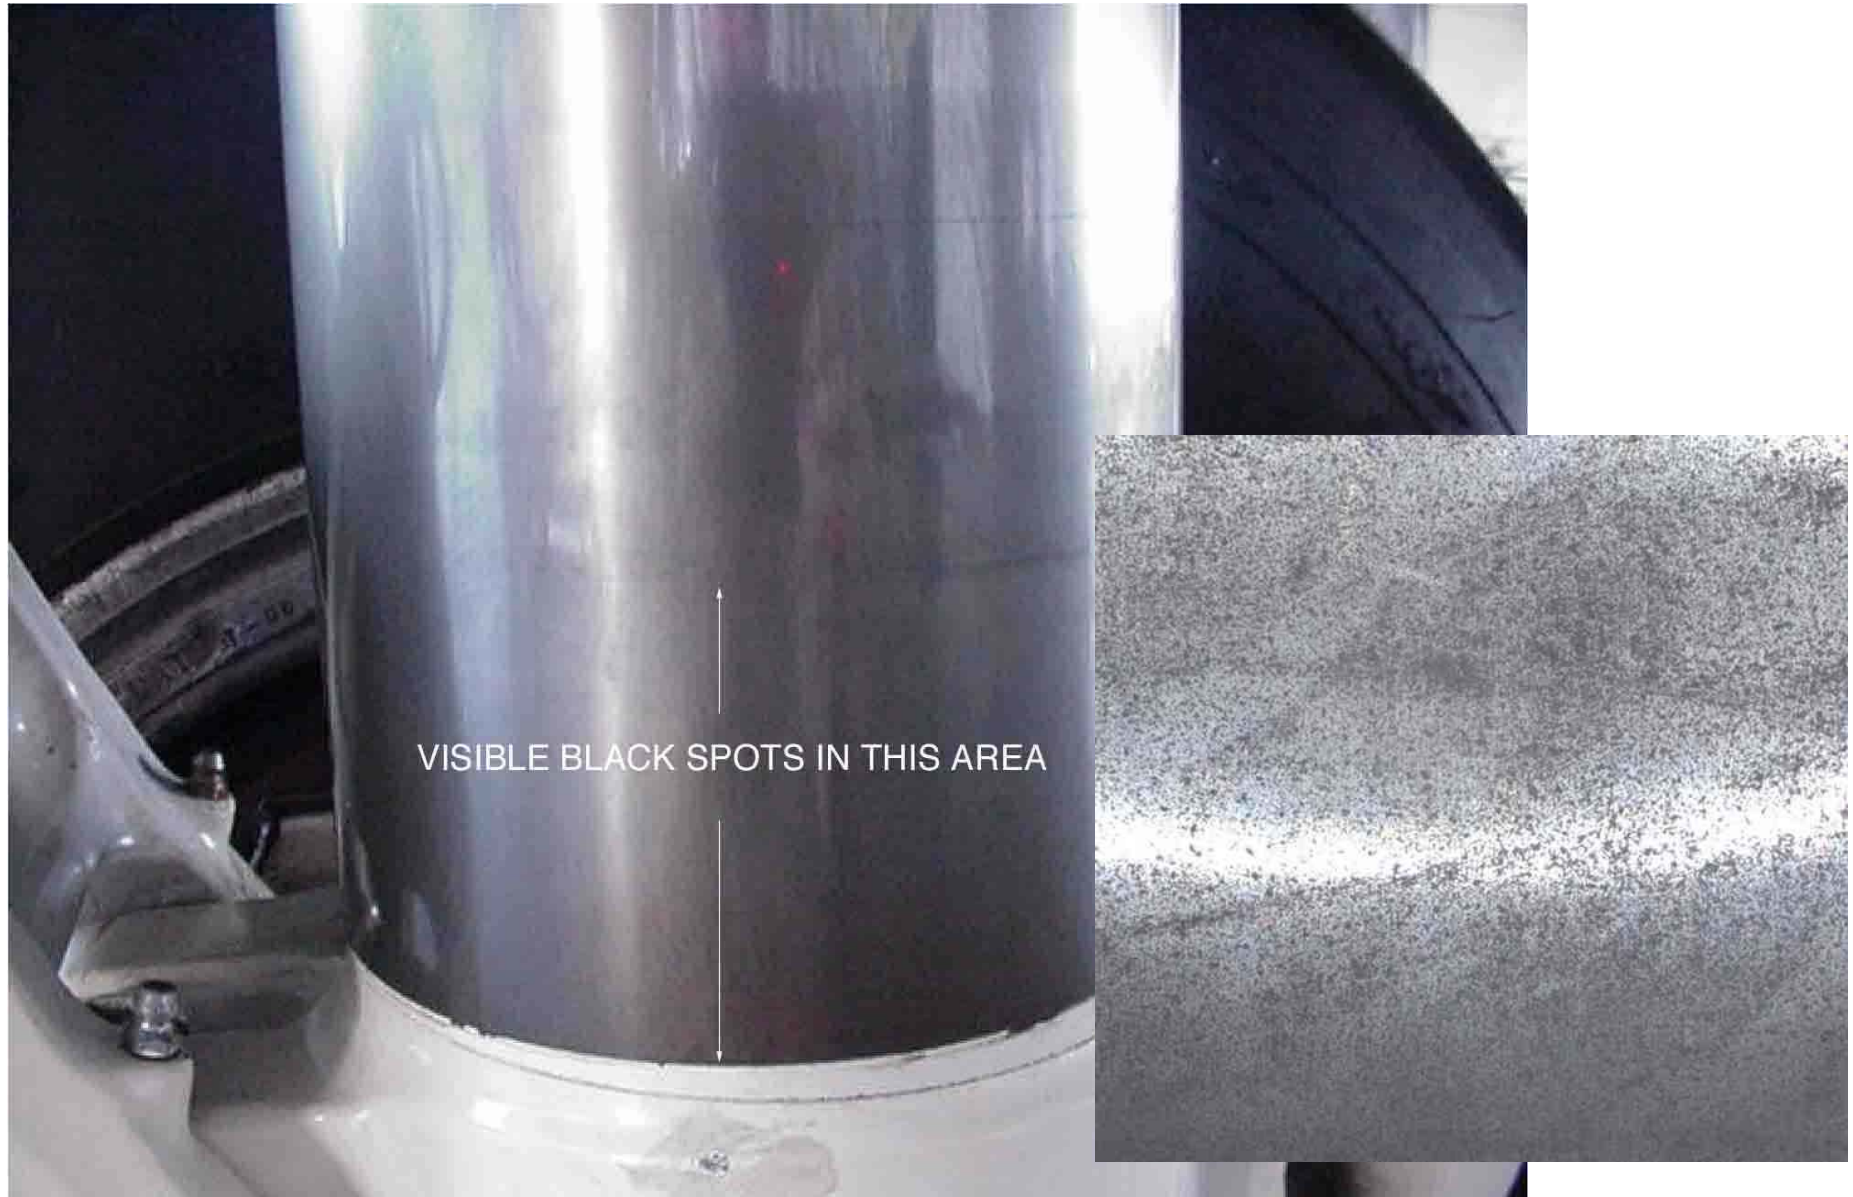
# Surface Roughness Inspection

Table 5- P-3 Piston Barrel Surface Finish Results		
Barrel ID	Forward Average Ra	Aft Average Ra
Top	2	3
¼ Down	5	4
Middle	7	7
Static Position	12*	12*
Bottom	57	40

\* Area is "dirty" possible lower bearing phenolic material embedded.

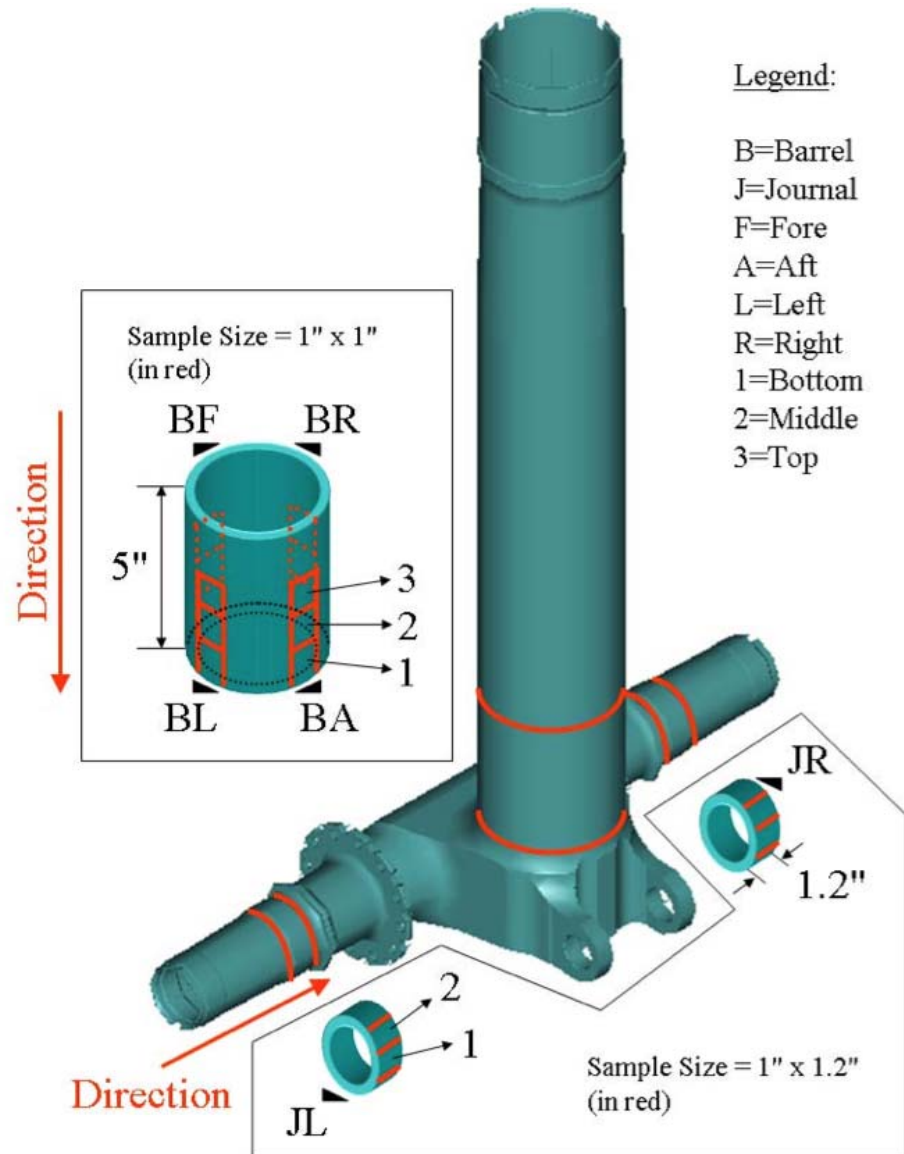
# Additional Coating Analysis

- Black spots are actually shallow pits
  - Selective leaching Co corrosive attack
  - Pit size
    - Larger/deeper than ave. HVOF porosity
    - Largest pits 10 mils dia. x 1.5 mils deep
  - EDS x-ray Spectra of pits
    - Na, Cl, K, Ca (seawater, cleaners)
    - O (corrosion bi-product)
- Axle journal “indications”
  - No indication remained after polish
  - No cracking found- coupons sectioned
