# ***Final Report-Process Mapping***

**Jean-Gabriel Legoux, Salim Bouaricha  
and John P. Sauer**

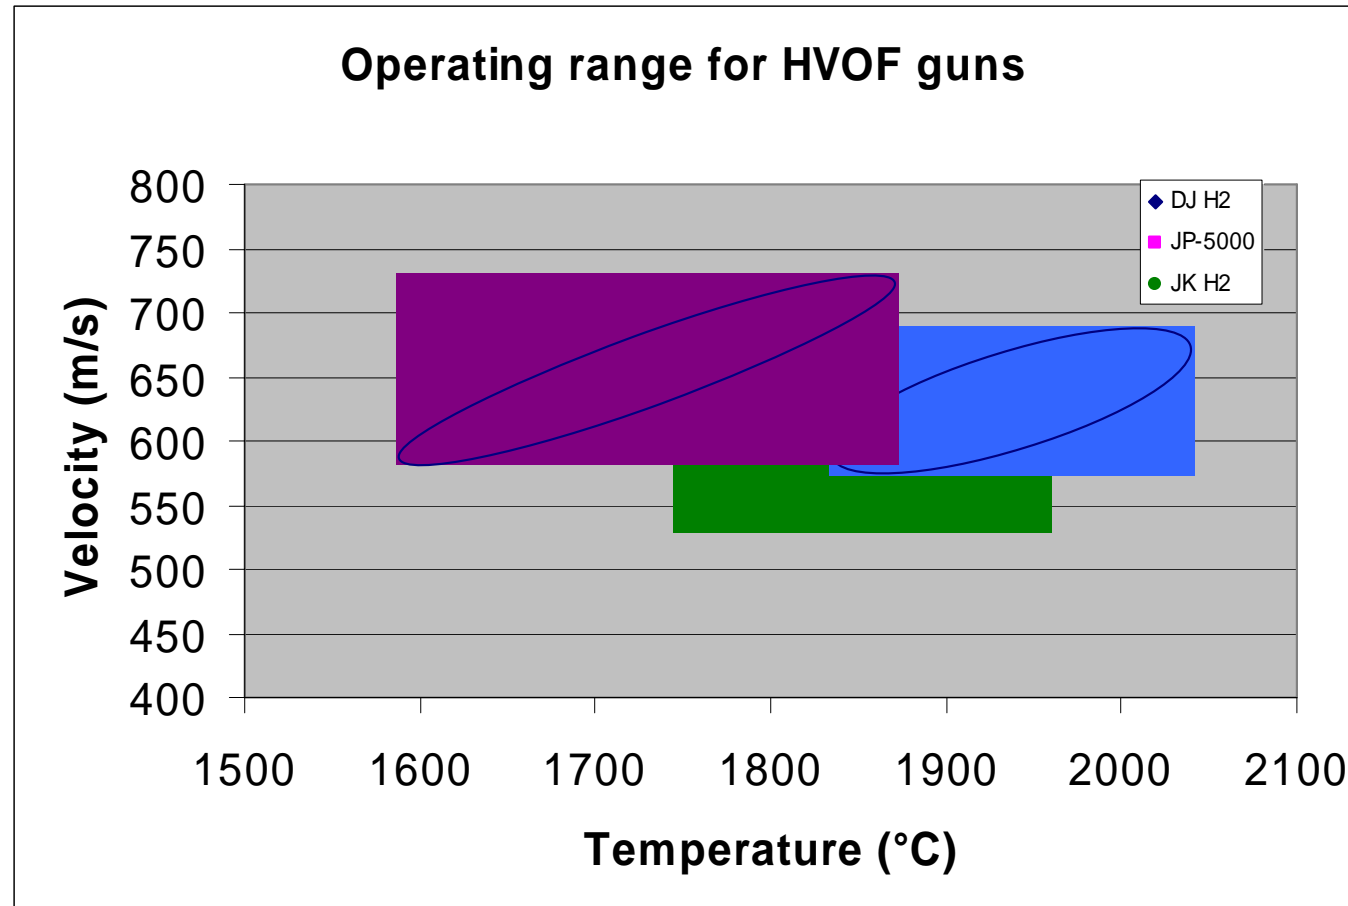
# Operating Ranges

DJ H2:  
Diamond Jet  
using H2 as fuel  
(D-2005)  
JP-5000 using  
Kerosene  
(1343 VM)  
JK H2: Jet Kote  
III using H2 as  
Fuel  
(Stelcar JK 117)

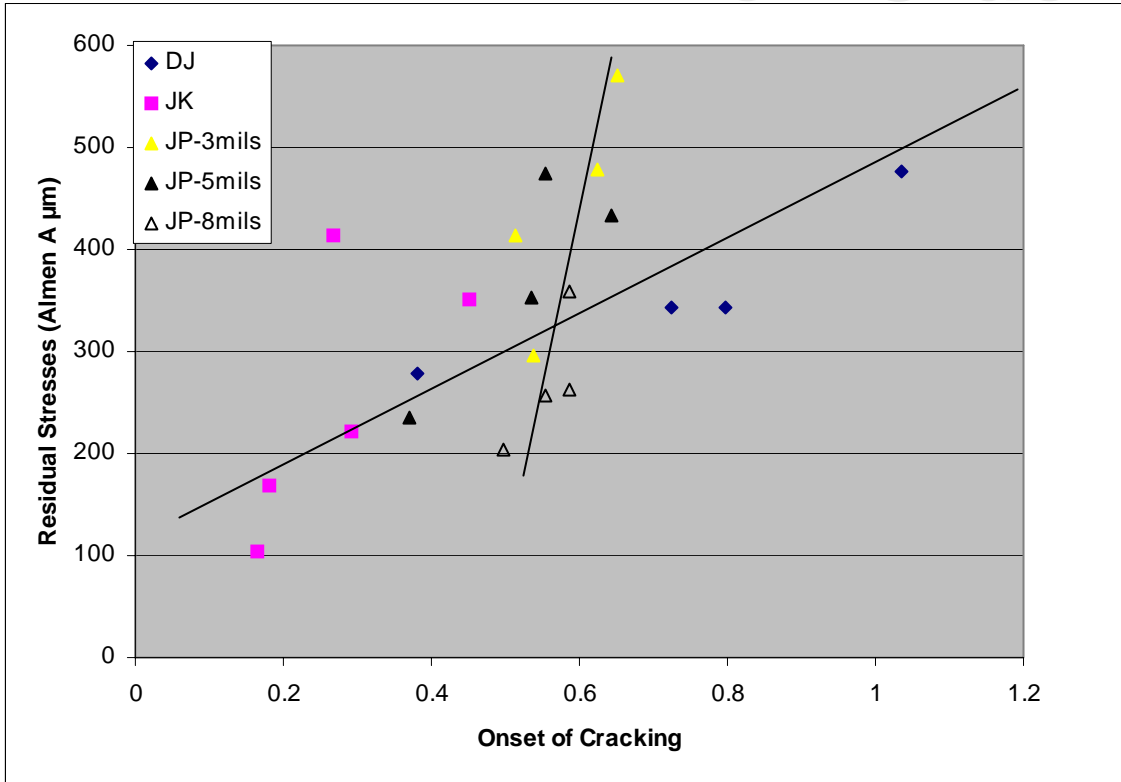
# Effect of Residual Stresses on Crack Initiation

- Increasing compressive residual stress delay the onset of cracking.
- The effect is gun or powder dependant

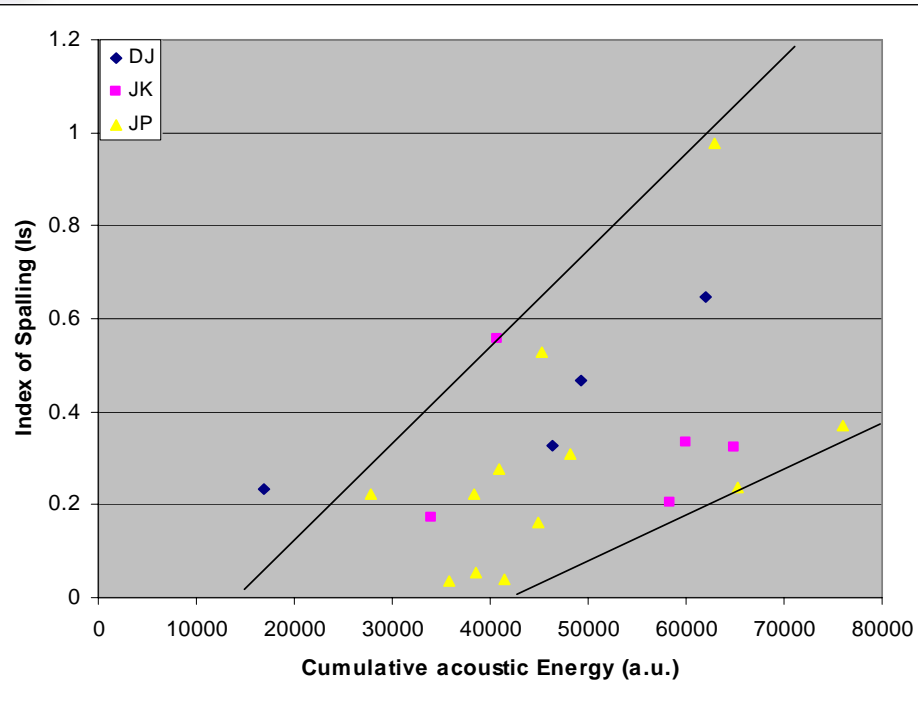
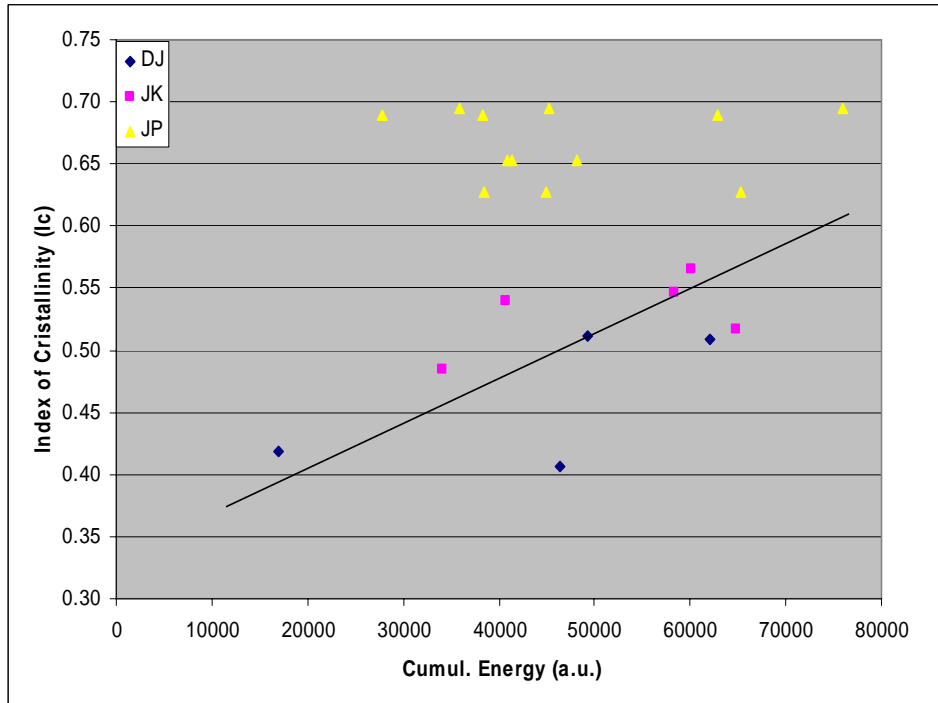
# Acoustic Emission ( Relationship to Microstructure )

- A coating more prone to spalling produces longer cracks and thus releases more energy
  - Is Ratio of “Dint/D”, ( cracks join together at ratio of 1 for spalling)
- More crystalline coatings tend to have a higher propensity to spall and thus again releases more energy.

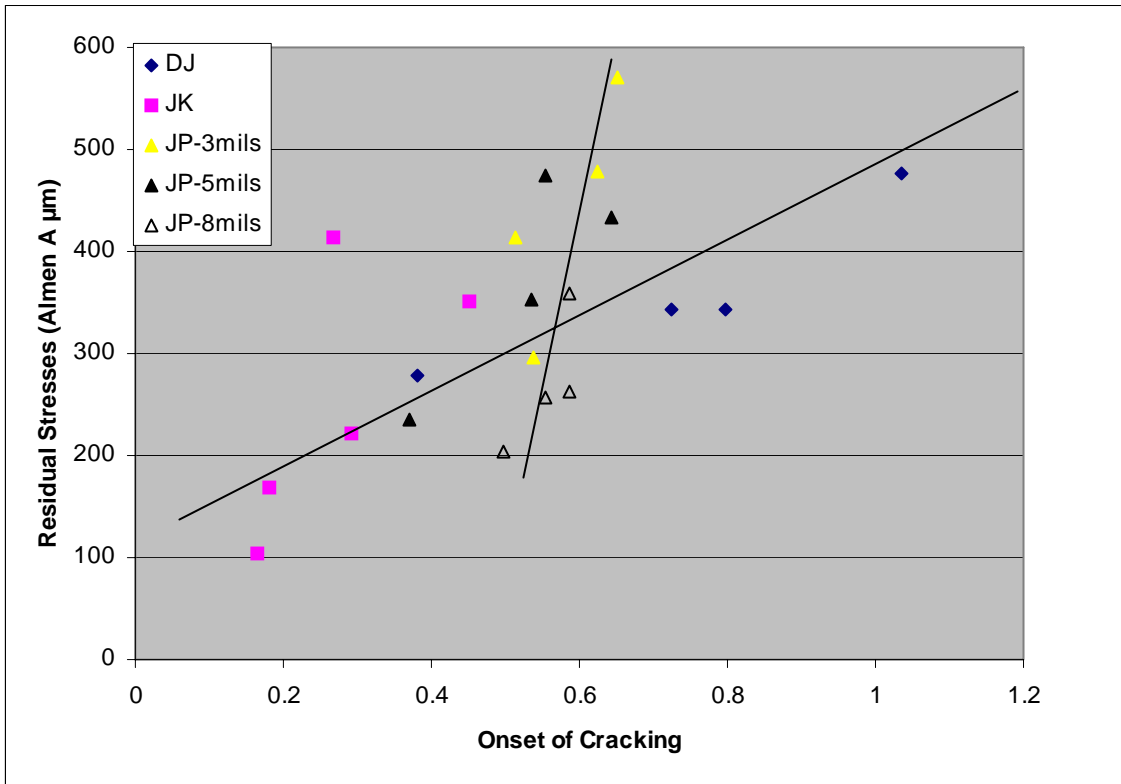
# Effect of Residual Stresses on Crack Initiation

- Increasing compressive residual stress delay the onset of cracking.
- The effect is gun or powder dependant

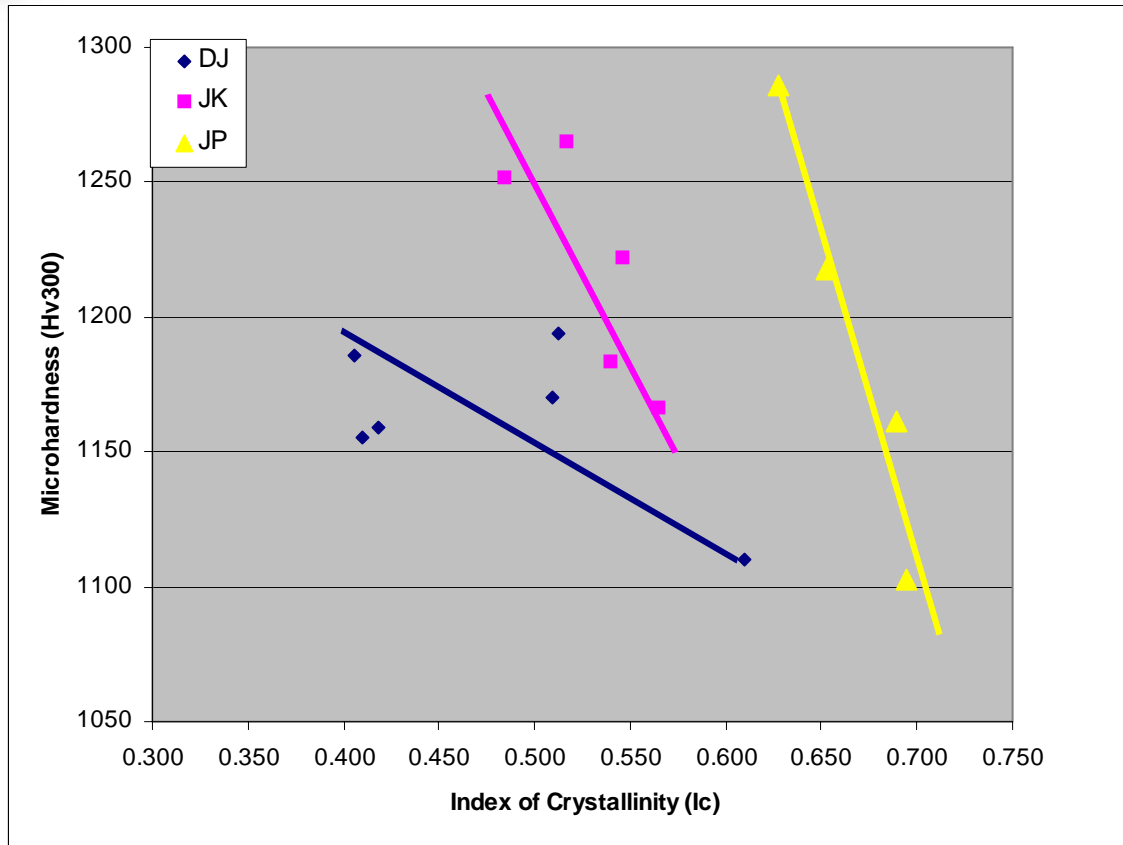
# Effect of Structure on Microhardness

- Coating hardness is strongly related to the phase content.
- The effect is strongly material or gun dependant

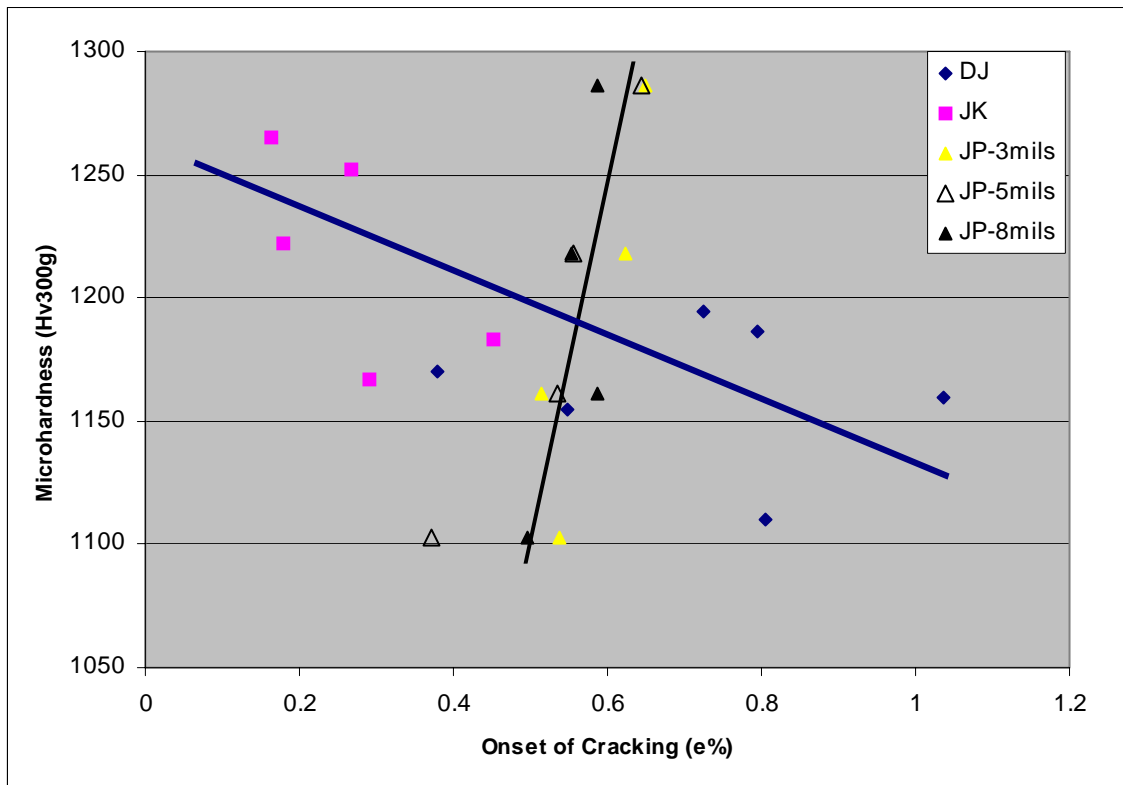
# Effect of Hardness on Crack Initiation

- For the DJ and the JK softer coatings tend to delay crack initiation
- An inverse relation is observed for the JP-5000 indicating a strong gun or material dependence

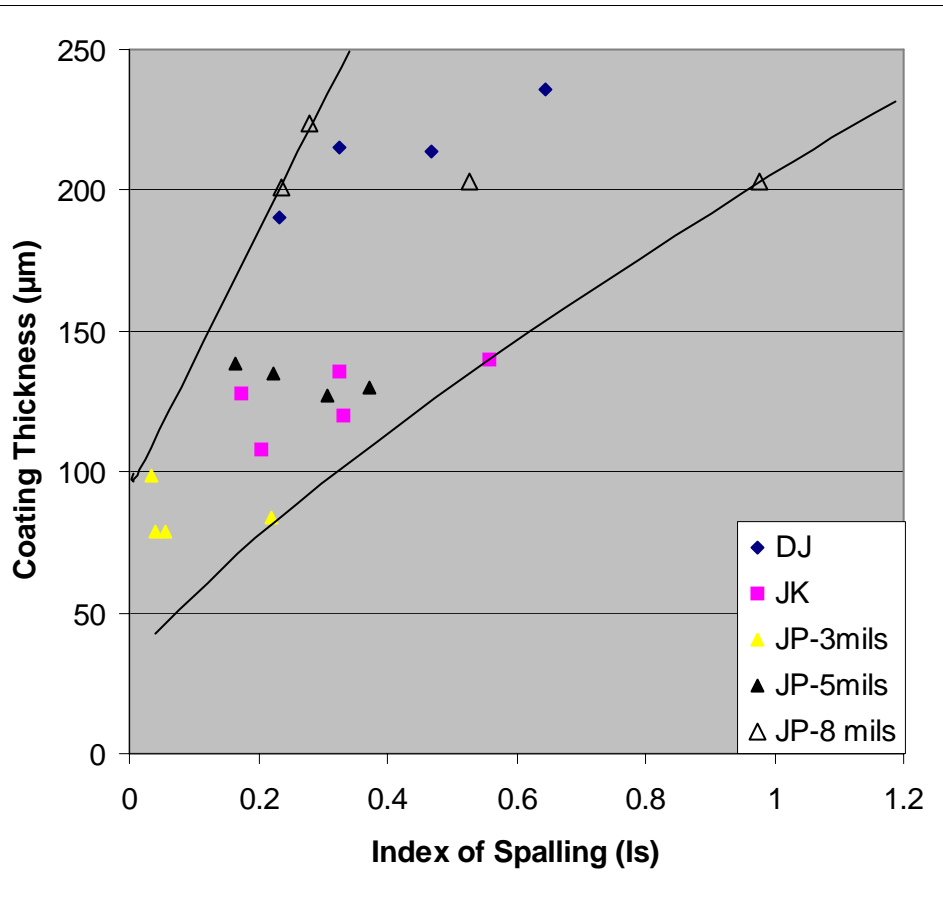
# Effect of Coating Thickness on Spalling

Thicker Coating are more prone to spall

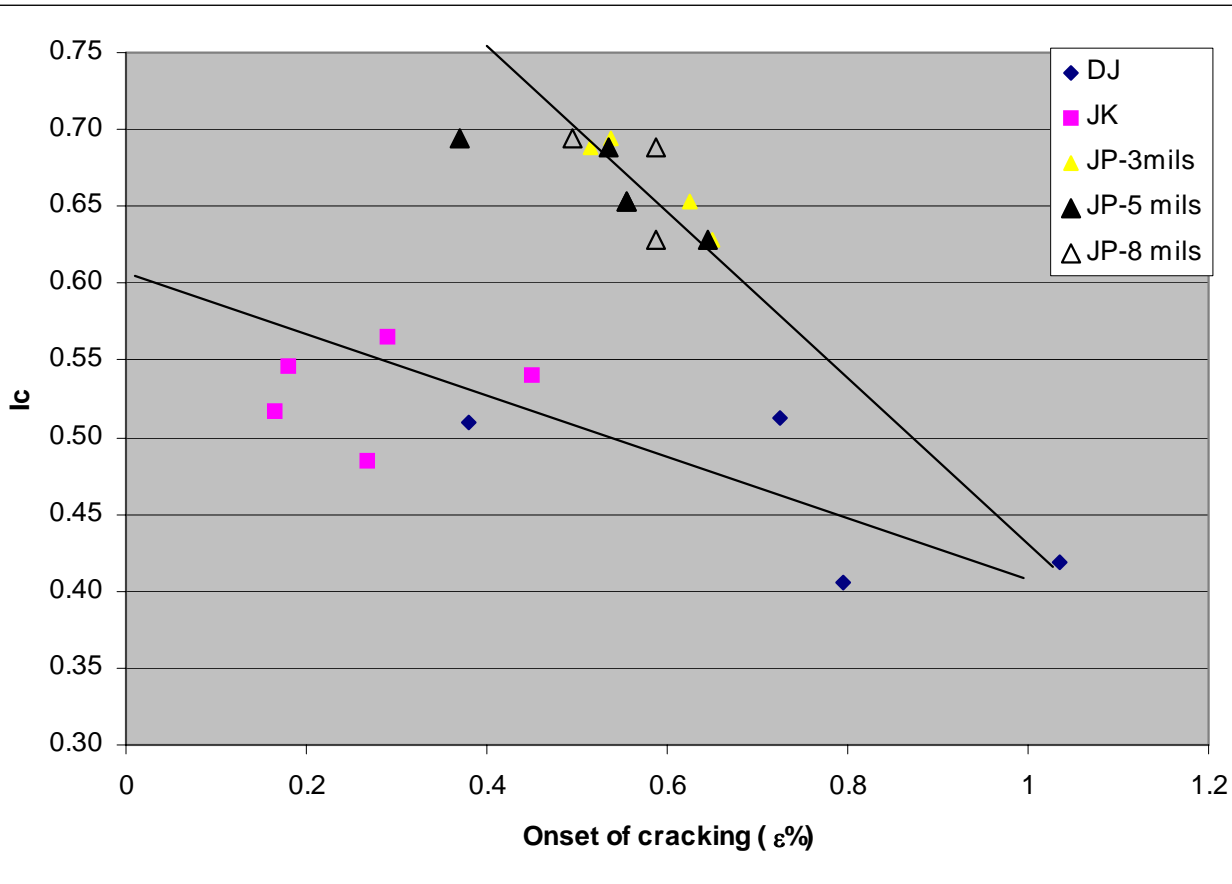
# Effect of Structure on Crack Initiation

- More crystallinity for coatings tend to favour crack initiation.
- Again there is a strong component related to material or gun

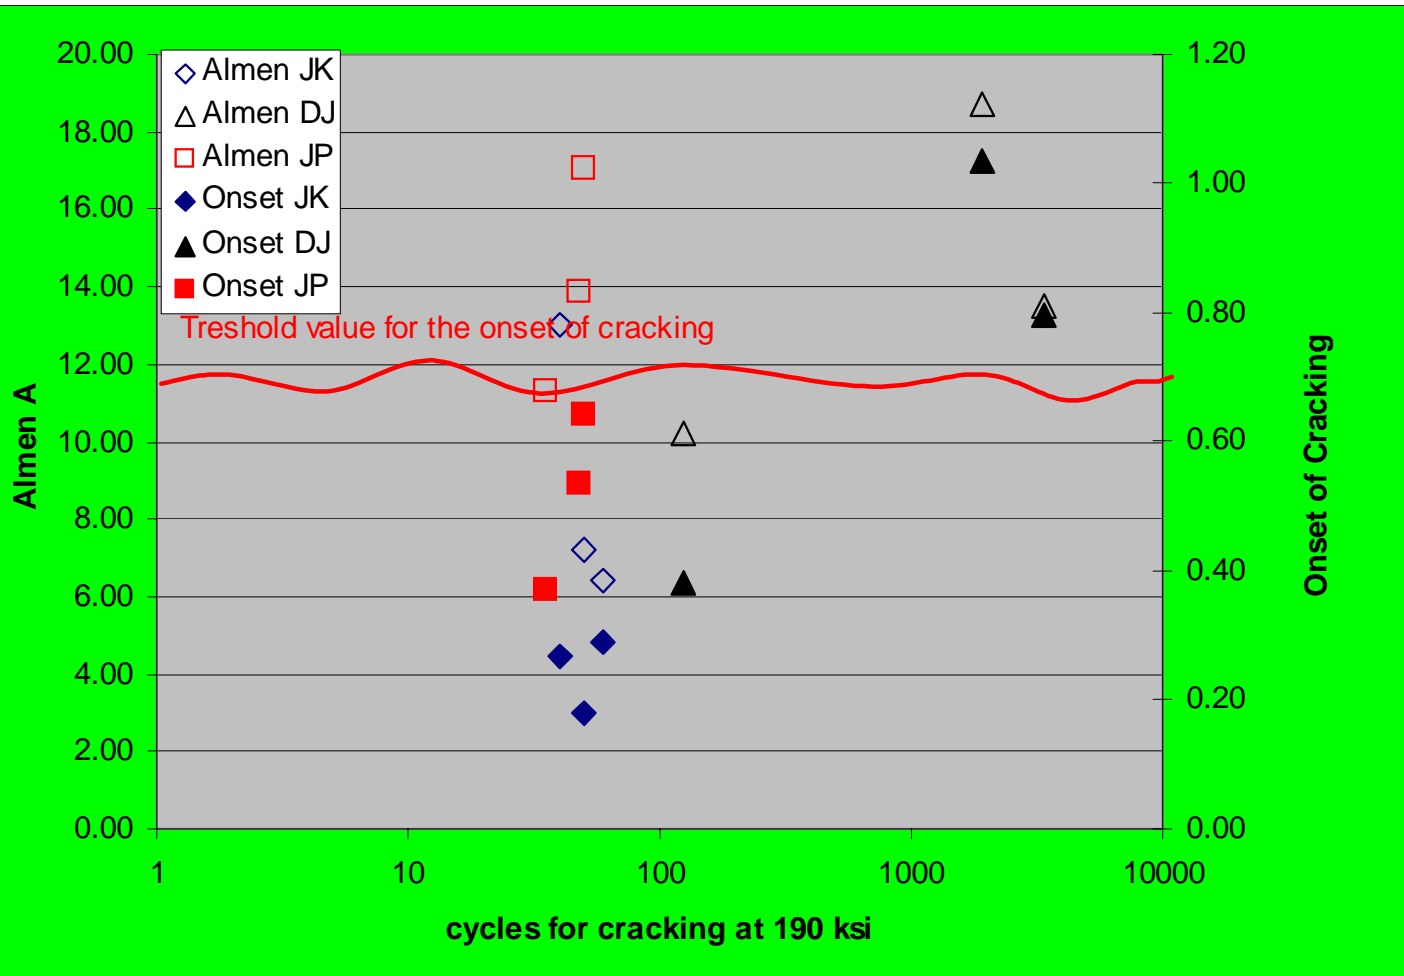
# Crack initiation in relation to static properties

- No relationship between crack initiation and residual stresses
- The onset of cracking seems to have a strong influence on the crack initiation.

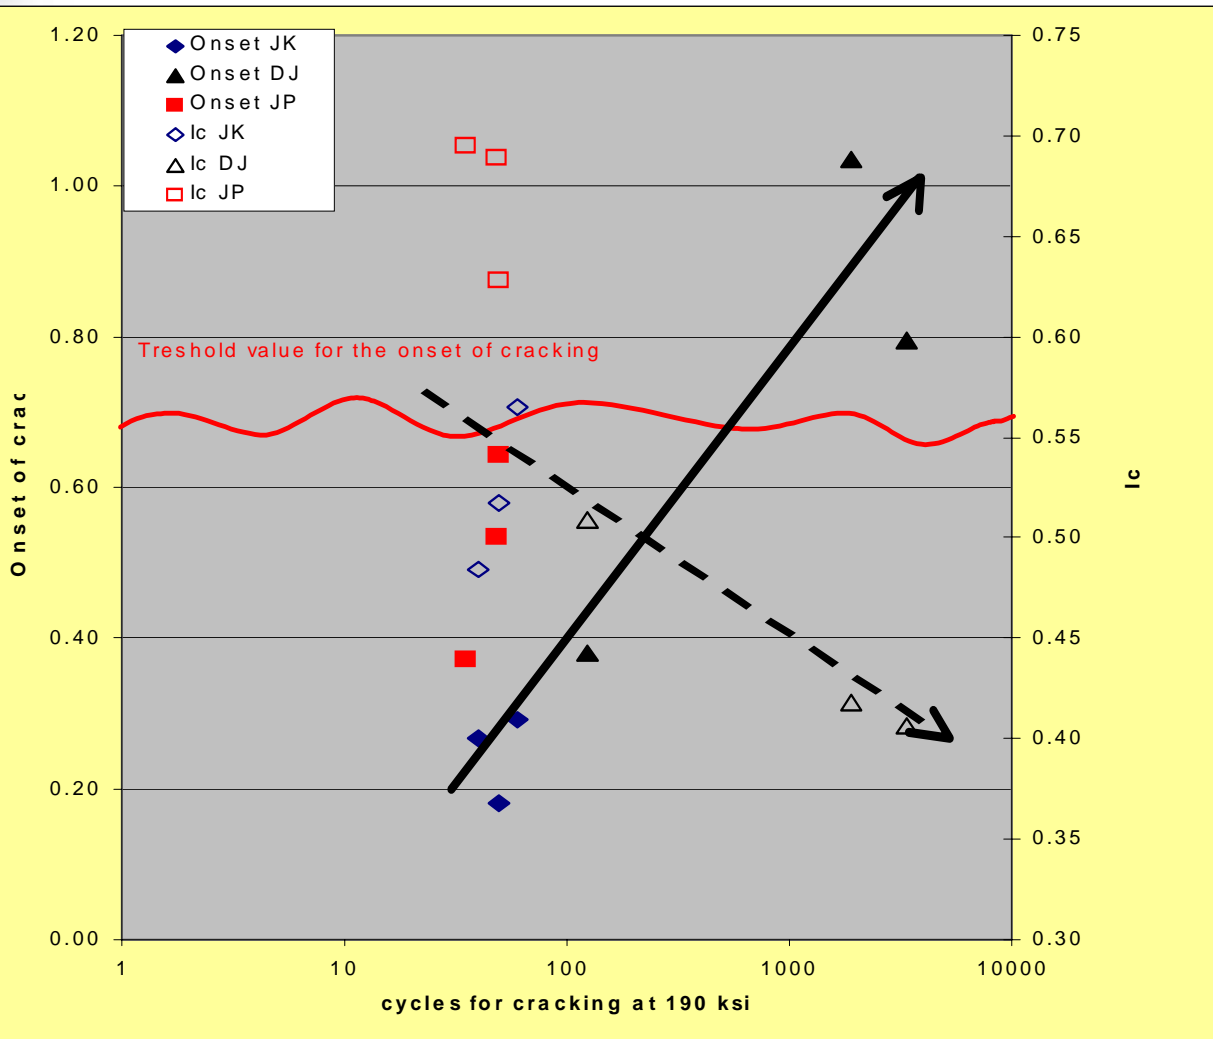
# Crack initiation in relation to coating structure

- The index of crystallinity and the static onset of cracking seems to have inverse effect on the cyclic crack initiation.

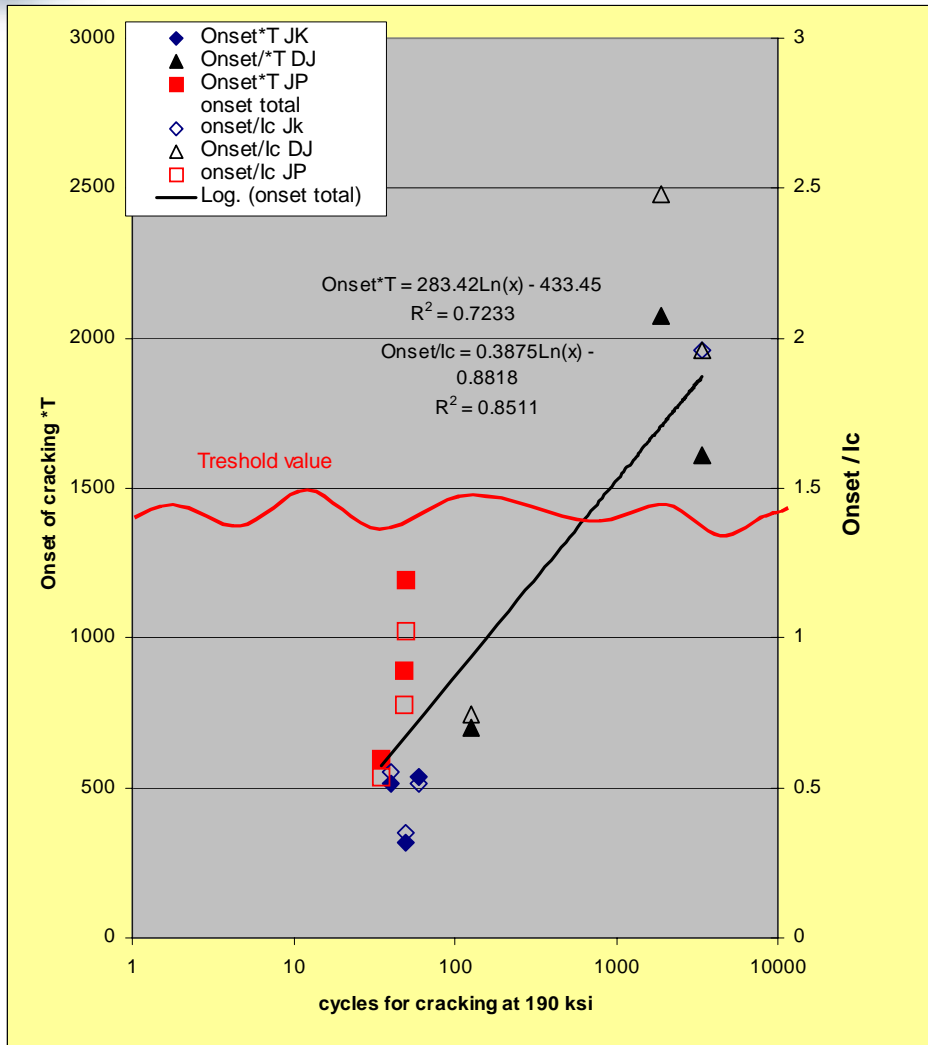
# Proposed indicator of cyclic performance

- Combining static bend test results (onset) and coating structure seams to correlate well with the cyclic behaviour of coatings.
- More work is needed to confirm the validity of the indicator.
