Environmental Embrittlement Studies

- *Studies to determine if there is environmental embrittlement of Actuator JTP materials due to galvanic couple between base material and HVOF coating*

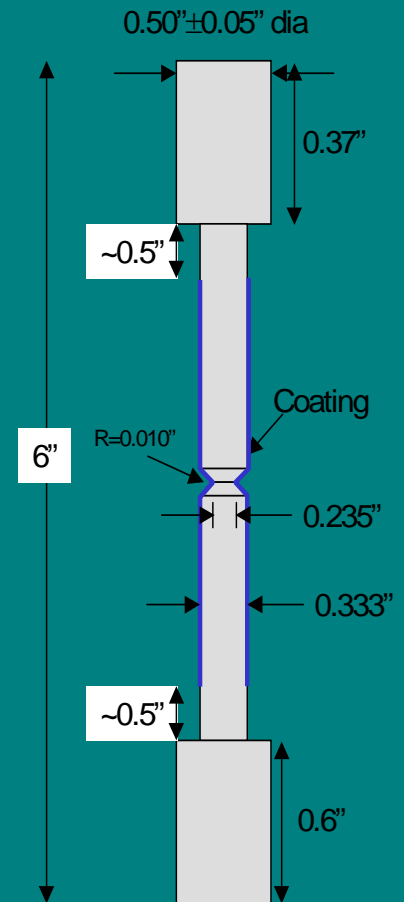
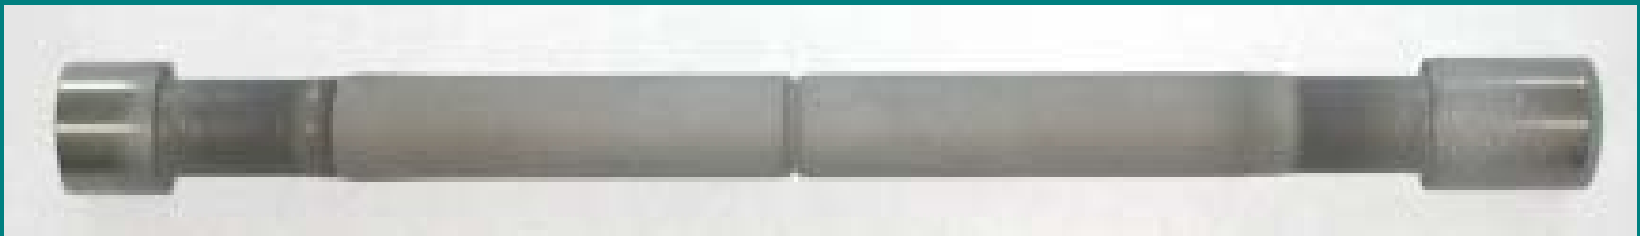
Coating Application to Specimens

- Specimens were notched Type 1a.2 round bars as defined in ASTM F519-97
- Specimens were not shot peened
- Grit blasting performed (54-60 mesh aluminum oxide for HVOF and #13 glass bead for EHC)
- 0.003"-thick coatings applied into notch and approximately 2 inches either side of notch

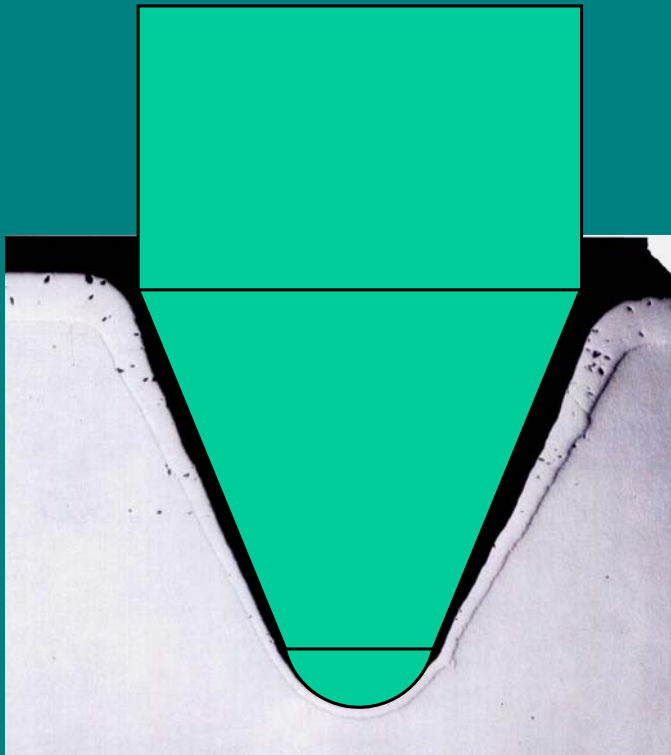
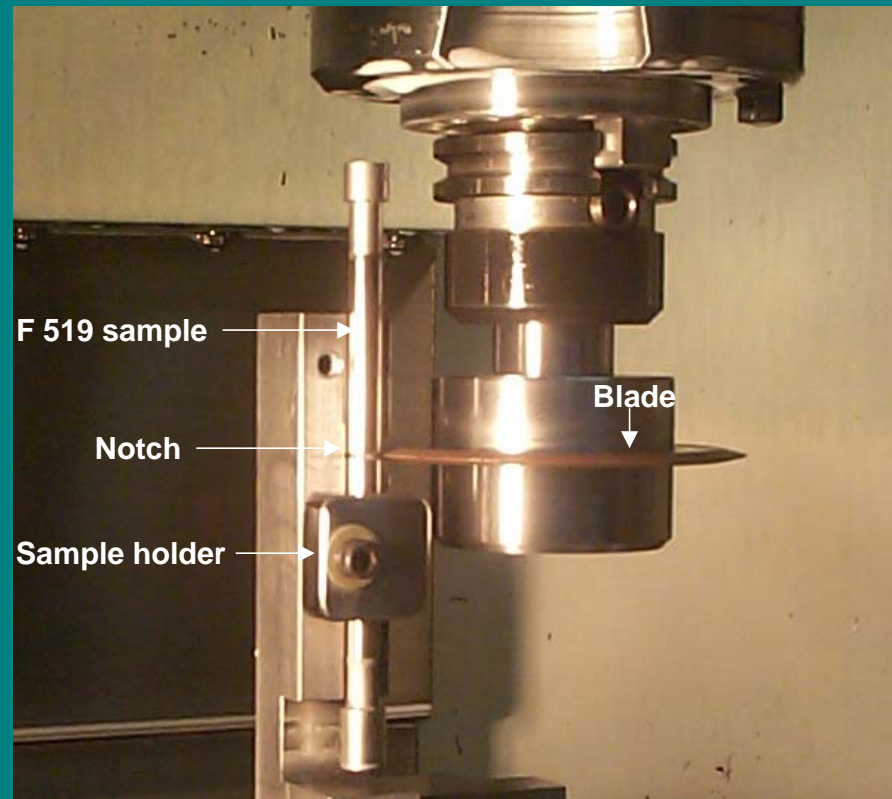
Cutting Through Coating at Base of Notch

Coating removed from base of notch with a diamond cutting wheel with a 45 degree angle and 0.010" radius
