PAX RIVER HCAT ROD TESTING

Jeff Gribble / James Magno

July 2004 HCAT

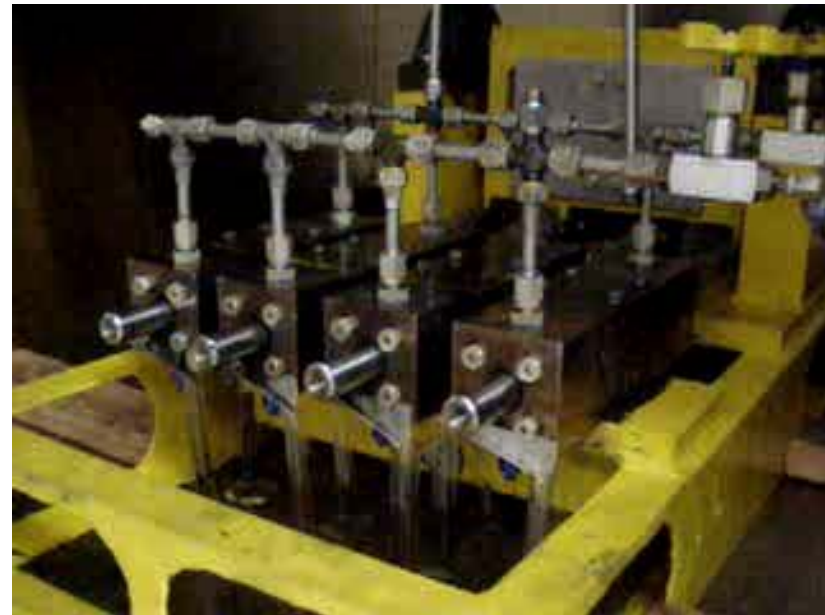
Test Rod and Block/Seal Configuration:

- There are two seal configurations per block and two blocks per rod so that 16 rod/seal configurations are being evaluated per test.
- Primary seals are indicated in blue and the secondary seals in magenta.

- Located at NAVAIR Patuxent River Hydraulic Lab.
- Master hydraulic piston drives four test rods. Each rod passes through two blocks (“Near End Block” and “Far End Block”).
- Apparatus is mounted inside an environmental chamber capable of maintaining a temperature between -65° and $+300^{\circ}$ F.
- The master piston passes through a sealed port on the environmental chamber.
- The hydraulic power supply is located outside the chamber for increased reliability of the test hardware.
- Hydraulic lines to the fixture are single-ended and thus should not heat or cool the test hardware.

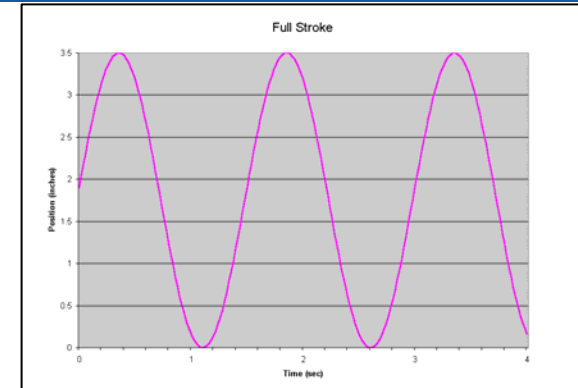
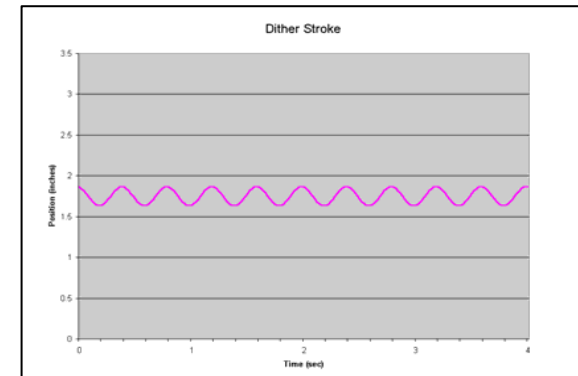
Stroke Profile:

- Full Stroke (3.5” Stroke, 1.5 second Period, 20 Minute Duration per Hour)
- Superimposed Dither (2” Main Stroke, 0.25” Dither stroke, 4 second Period, 4 Hz Frequency, 20 Minute Duration per Hour)
- Dither (0.25” Dither stroke, 4 Hz Frequency, 20 Minute Duration per Hour)

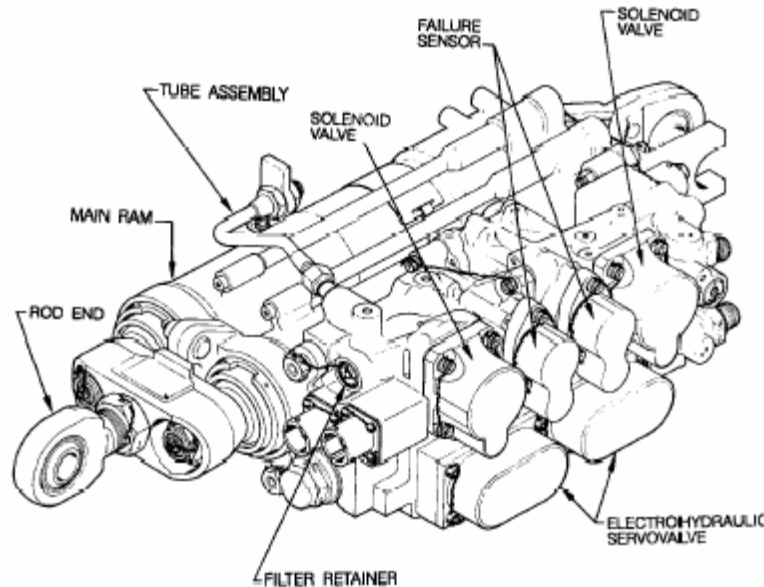
F/A-18 C/D Trailing Edge Flap:

- Same dynamic and static seal materials used for TEF as proven on STAB.
- Side by side design allows one chrome rod and one HVOF rod to evaluate seals against both rod surfaces.
- Endurance testing of TEF has begun and is 2/3 complete. Currently awaiting a different seal configuration to resume the evaluation.
