Weight Loss Immersion Test of Thermal Spray-coated Disk Specimens

- Various thermal spray coatings applied by the high velocity oxygen-fuel (HVOF) technique are candidates for replacing hard-chromium plating on certain aircraft components. These components are likely to contact a variety of fluids that might affect the HVOF coating. ARINC conducted immersion tests of HVOF-coated disk specimens to evaluate resistance to fluids that might be present during aircraft operation and maintenance.

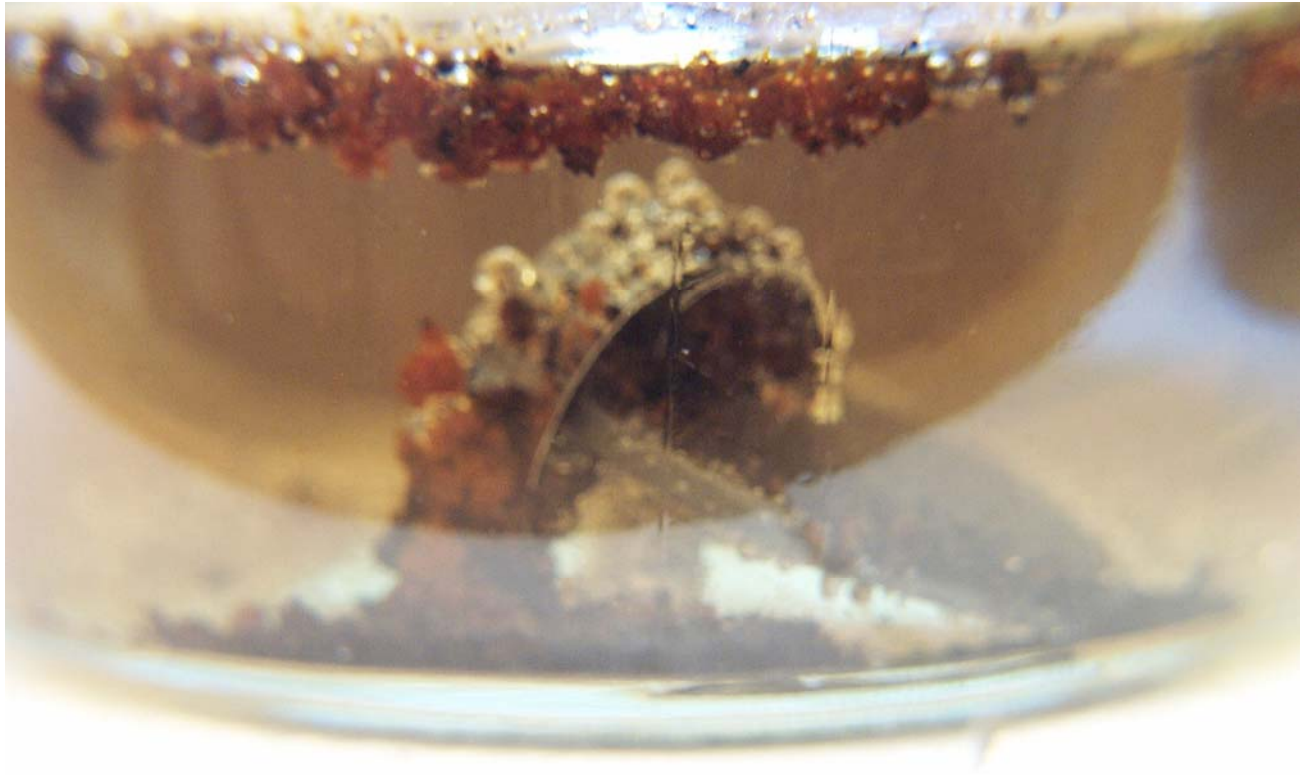
- The bleach solution aggressively attacked WC/CoCr, and the effect was visually obvious, both during the immersion and after cleaning. The bleach solution attacked the cobalt-containing Tribaloy-400 even more aggressively than the WC/CoCr.
- The bleach had little effect on CrC/NiCr, which contained no cobalt.

Specimen Immersed in Chlorine Bleach, Sodium Hypochlorite

- Mass change after immersion: Decreased significantly.
- Mass change after extended air-dry: Further decrease, perhaps loose particles lost.
- Visual examination comparison before and after immersion: Obvious degradation.
- Surface roughness measurement: Obvious surface effect and roughening of the Tribaloy-400.

- The Tribaloy-400 HVOF coating might be ill-suited to applications where it might be exposed to strong cleaning agents or other reactive chemicals.
- CrC/NiCr HVOF coating and WC/CoCr HVOF coating can both be expected to resist common liquids during service and maintenance, but procedures should emphasize the danger of exposing WC/CoCr sodium hypochlorite bleach, and measures should be implemented to guard against its use.
