SERDP / ESTCP Workshop
Surface Finishing & Repair Issues for
Sustaining New Military Aircraft

Cadmium Alternatives for High-Strength Steel
JTP – Phase II

Fiesta Resort and Conference Center
Tempe, AZ
27 February 2008

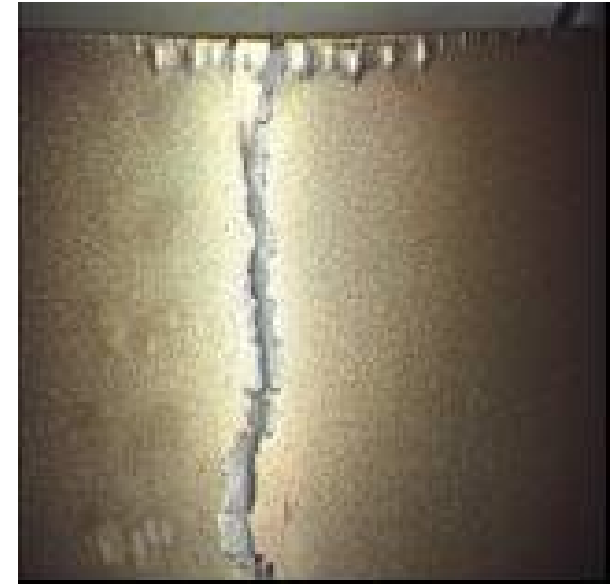
- All primary coatings passed appearance testing
- Mixed stripability results
 - LHE Zinc-Ni failed due to change in bend adhesion in 1-2 bend cycles
- Mixed Bend Adhesion Results
 - All Primary Coatings passed using both 4130 steel & 17-4 stainless
 - LHE Zinc-Ni and electroplated Al failed bend adhesion for Ti-6-4 due to spalling and edge buckling respectively

Electroplated
Aluminum on Ti-6-4

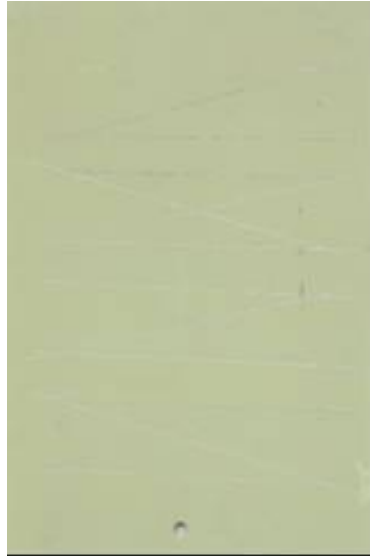
**IVD Al with MIL-PRF-85582 C1,
after 4 days**

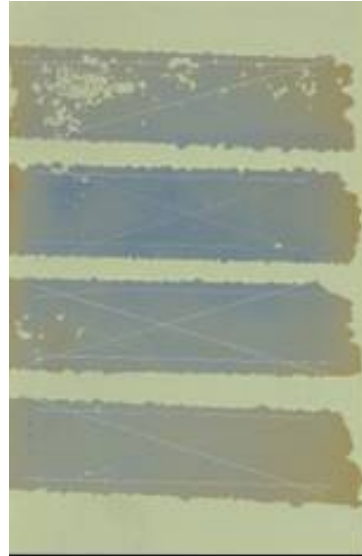
- **Primary Coatings Passed Paint Adhesion Testing with one exception (LHE Zinc-Ni failed for 85582 Class C1 after 4 and 7 days)**
- **Run On/Breakaway torque test results:**
 - Passed for 3/8" fastener
 - 5/8" fastener need to be discussed

**LHE Zn-Ni with MIL-PRF-85582
C1, after 4 days**

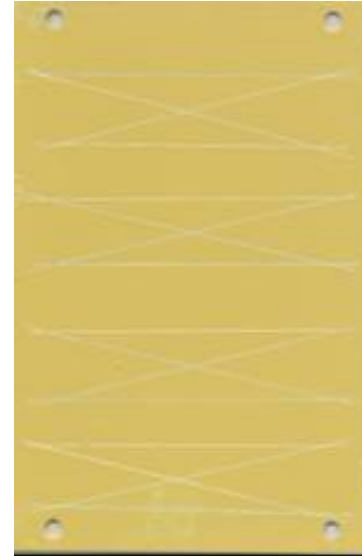
**Electroplated Al
with MIL-PRF-
23377, after 7 days**

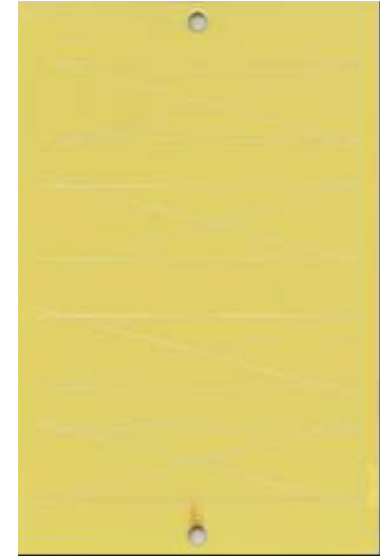
**Sputtered Al with MIL-PRF-23377,
after 4 days**
