Cadmium Coating Alternatives for High-Strength Steel JTP – Phase II

Westminster, CO
3 September 2009

Air Force Technical Point of Contact: Dr. Elizabeth Berman
CTC Subtask Manager: Clayton Drees

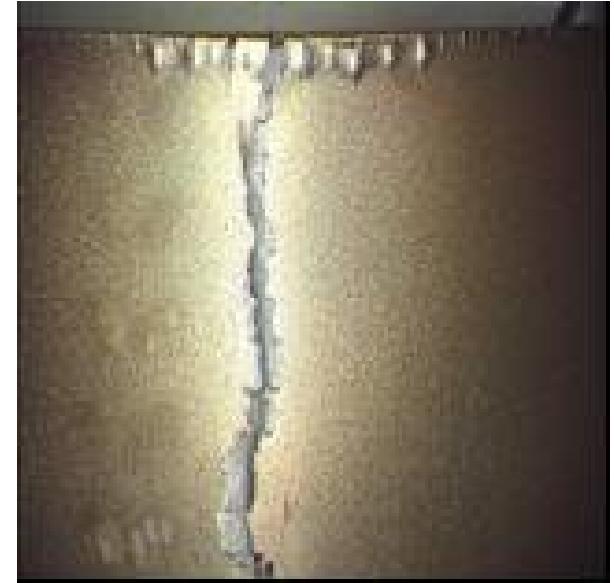
Electroplated
Aluminum on Ti-6-4

- All primary coatings passed using both 4130 steel & 17-4 stainless
- LHE Zinc-Ni and electroplated Al failed bend adhesion for Ti-6-4 due to spalling and edge buckling respectively

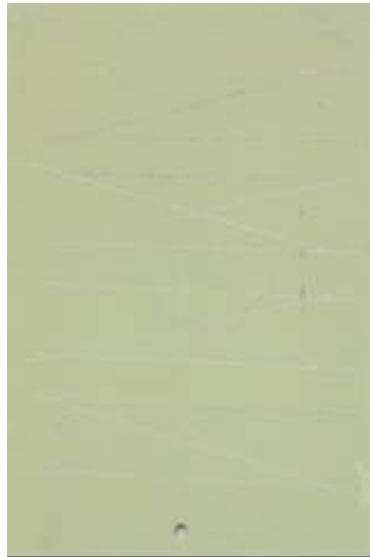
**IVD Al with MIL-PRF-85582 C1,
after 4 days**

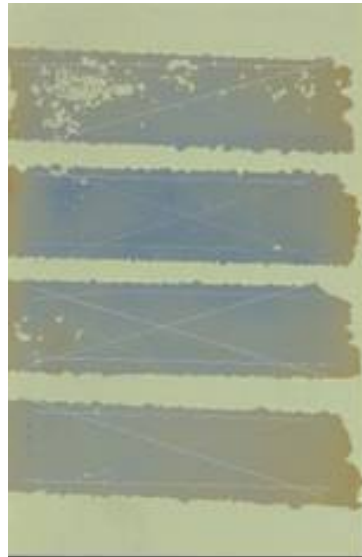
**LHE Zn-Ni with
MIL-PRF-85582
C1, after 4 days**

- **Primary coatings passed paint adhesion testing with one exception (LHE Zinc-Ni failed for 85582 Class C1 after 4 and 7 days)**

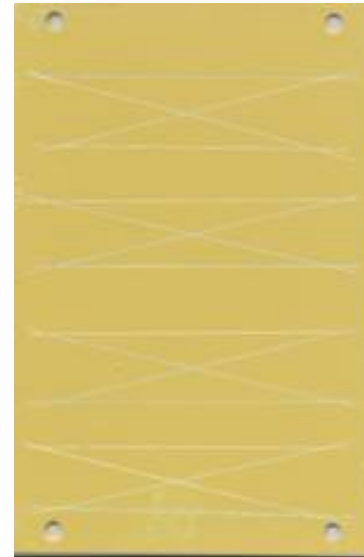
**Electroplated Al
with MIL-PRF-
23377, after 7 days**

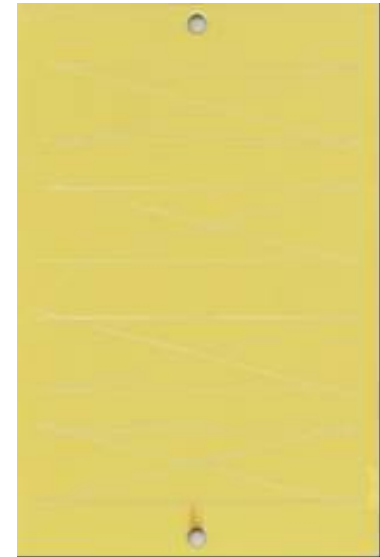
**Sputtered Al with
MIL-PRF-23377,
after 4 days**

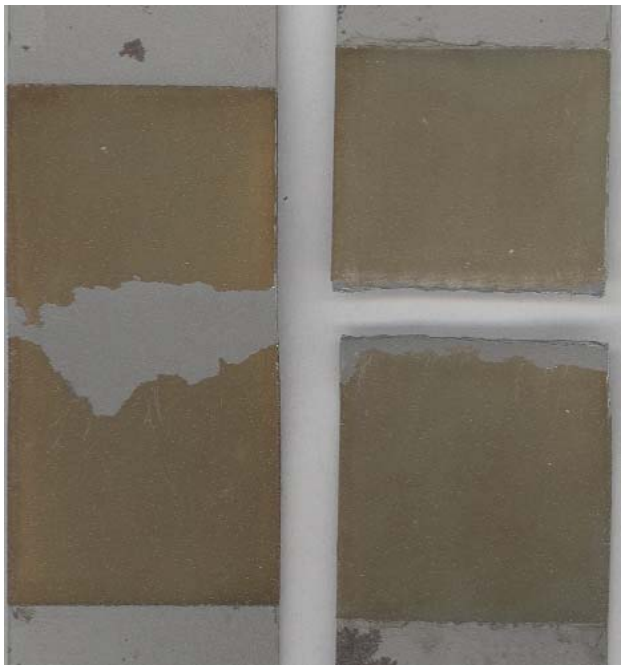
Brush Plated Cd (baseline)

- Brush plated Cd and sprayed Aluminum-ceramic exhibit significant adhesion losses during bend testing
- Brush plated Sn-Zn and Zn-Ni passed adhesion testing
- Results consistent with those observed during Phase I testing

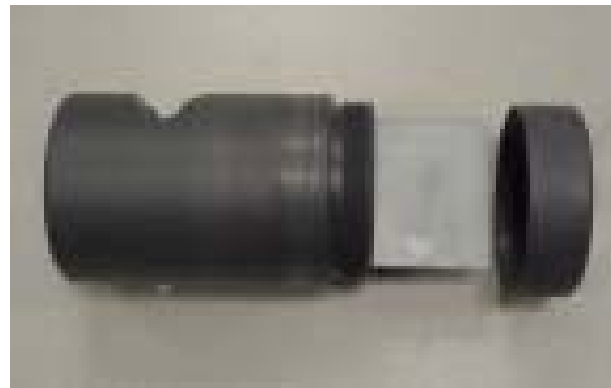
Throwing Power Fixture

- Test coupon is inserted in fixture and entire assembly is submerged in plating solution
- Fixture alignment can be varied to simulate multiple complex geometries
- Composition readings taken every 0.5" down the length of the coupon
